4.3 OUTFALL REPAIR SUMMARY REPORTS

OUTFALL SUMMARY REPORT

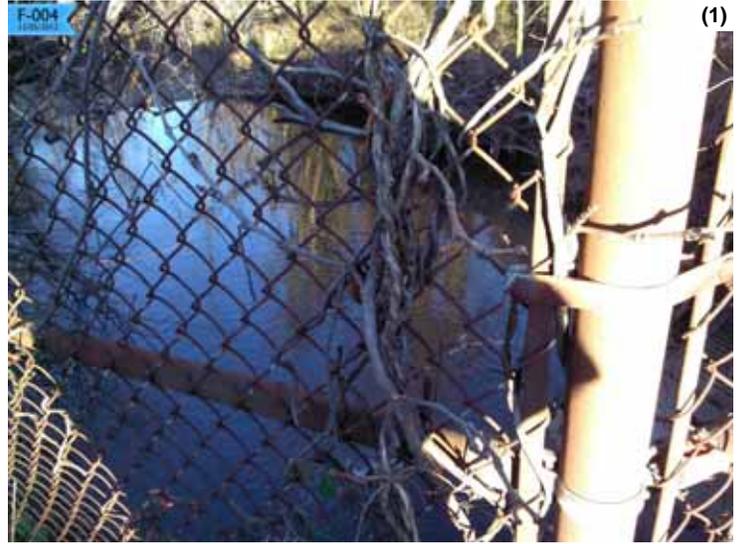
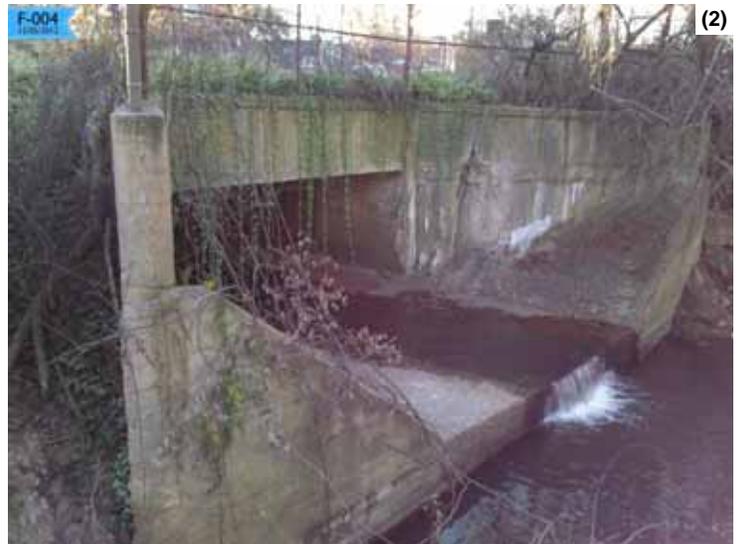
Erosion behind wingwalls and under spillway. Cracked wingwall (left) Unable to get close enough to inspect.

N/A

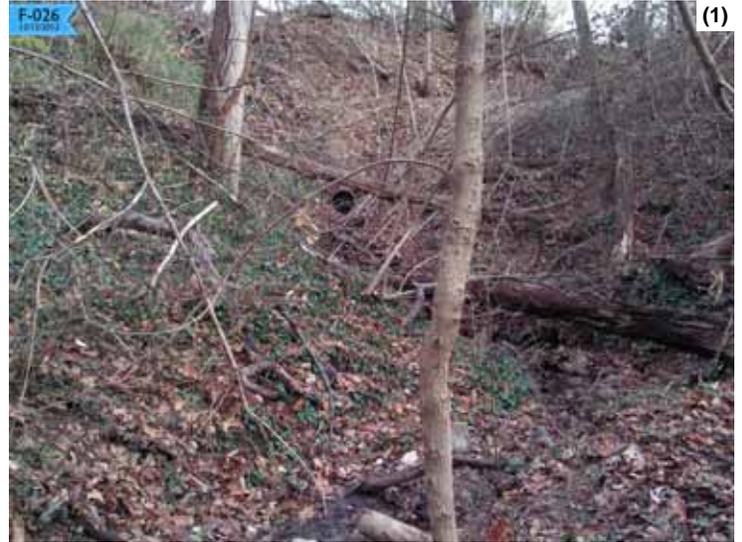
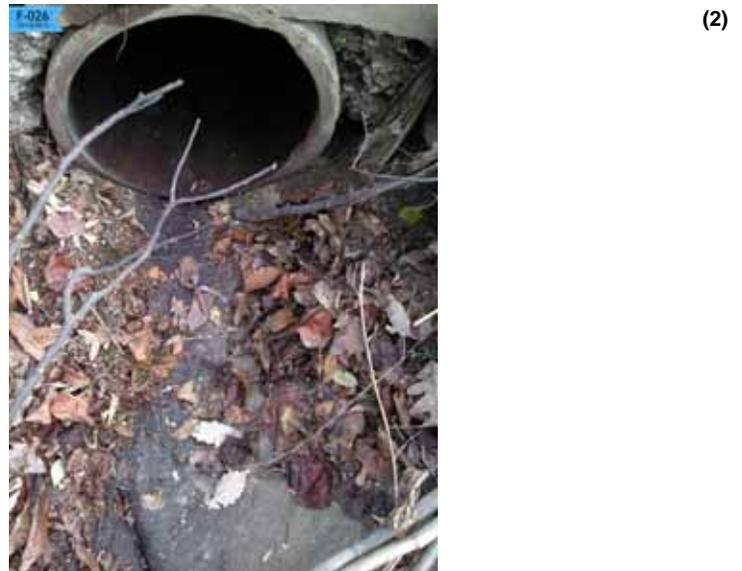
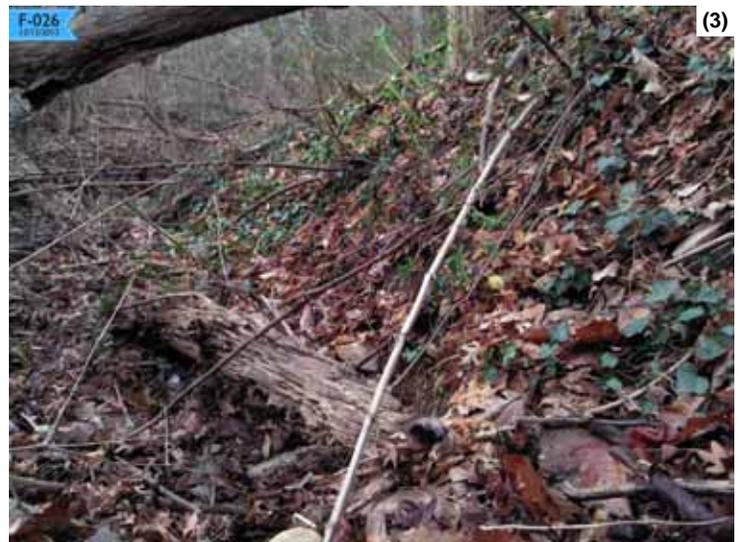
Spillway cracked and with some erosion underneath.

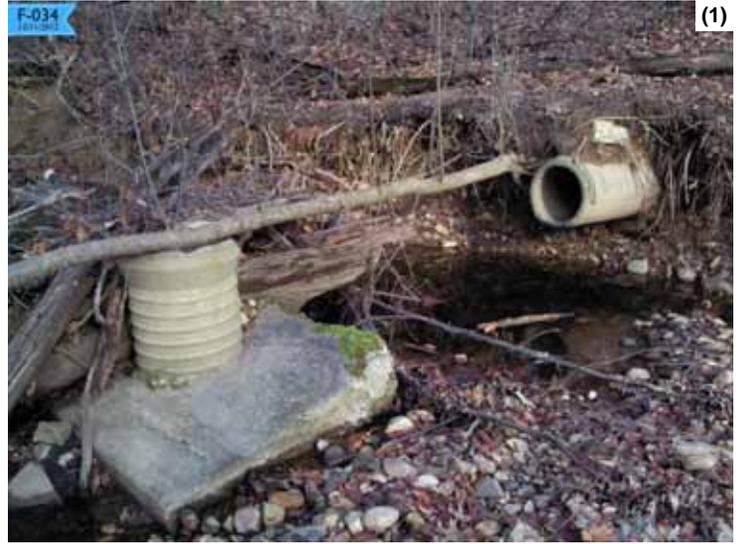
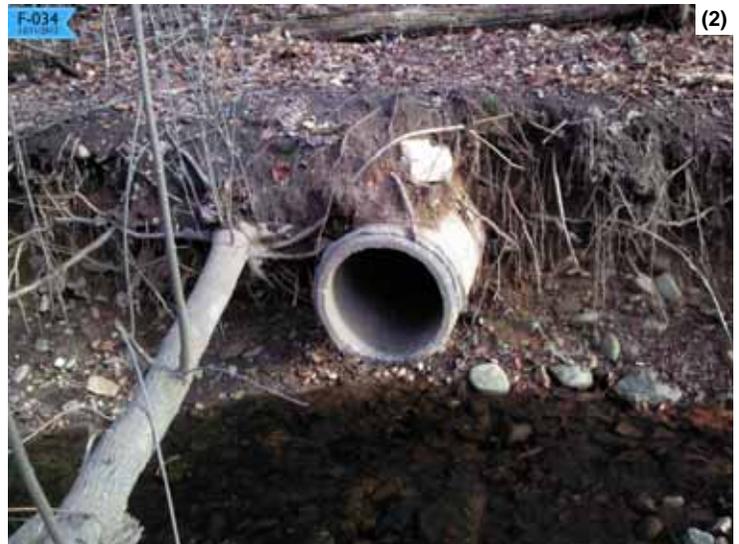
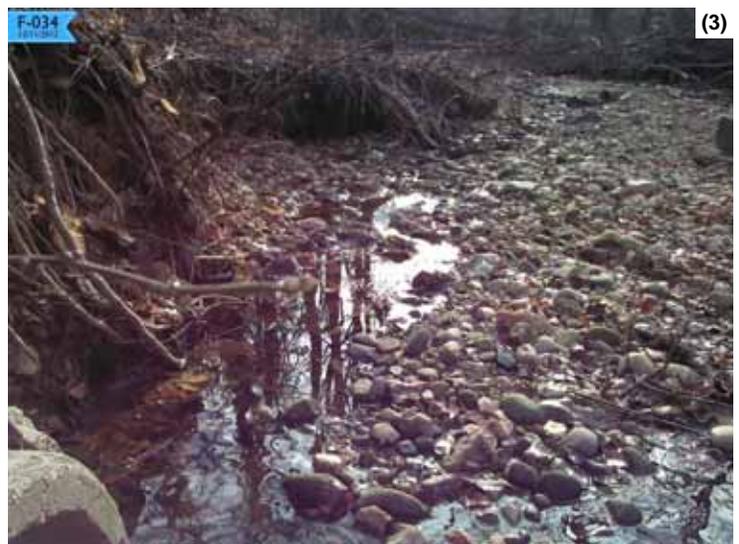
Concrete spillway, headwall, several pipe segments have fallen into the stream. Severe upstream channel erosion appears to be the cause of the problem.

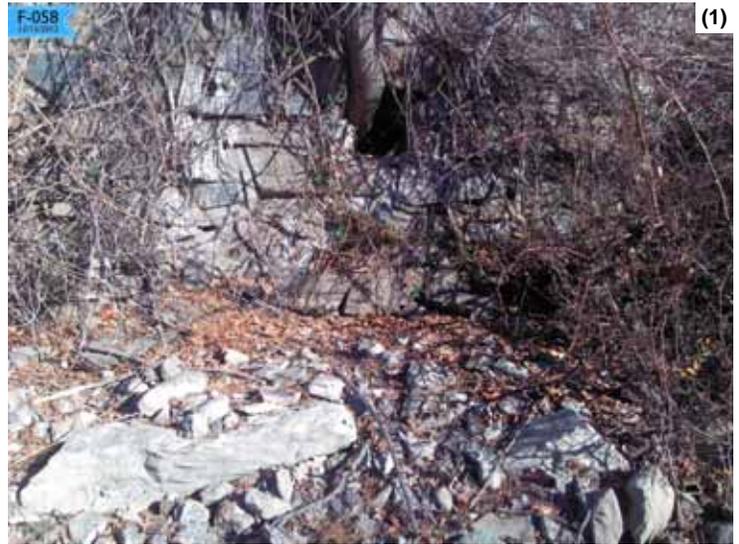
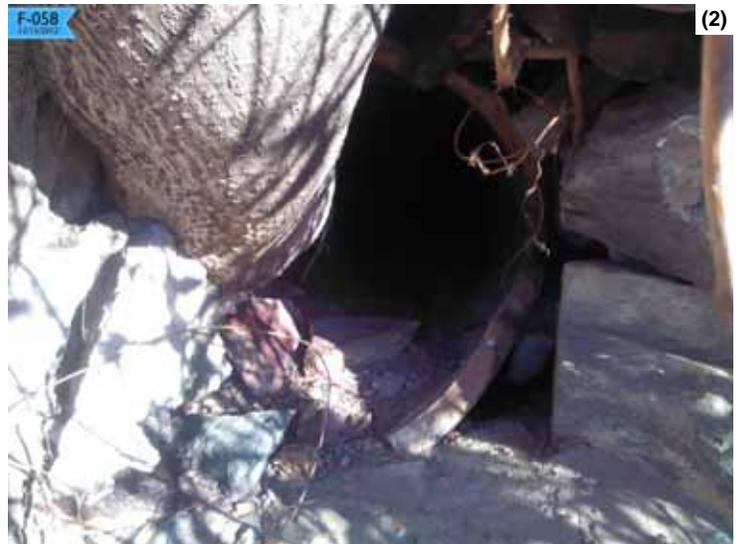
Broken pipe.

Point Repair

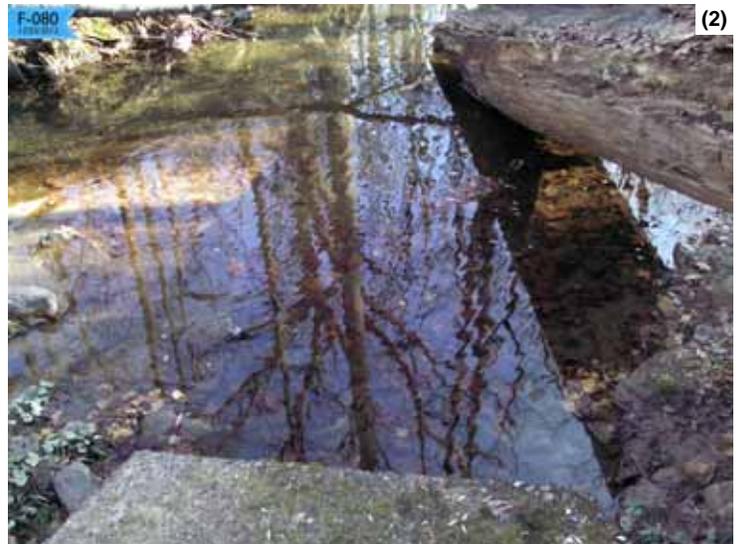
Erosion around spillway. Need additional photos of surrounding area to define extent of repair.

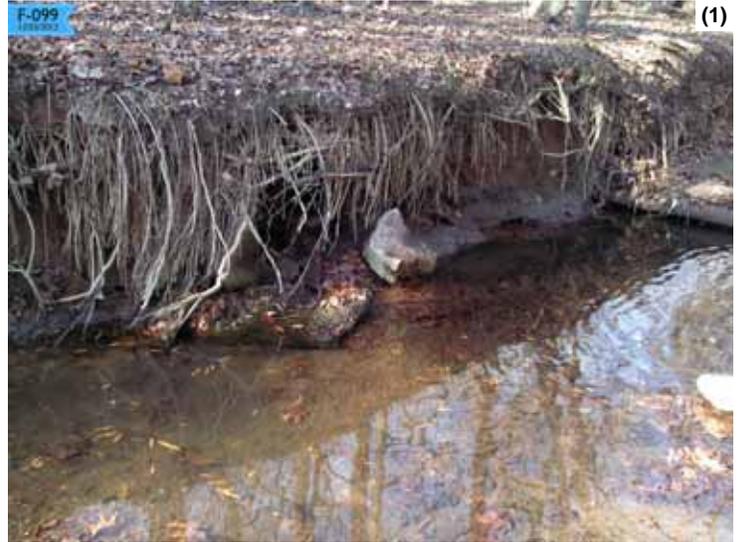
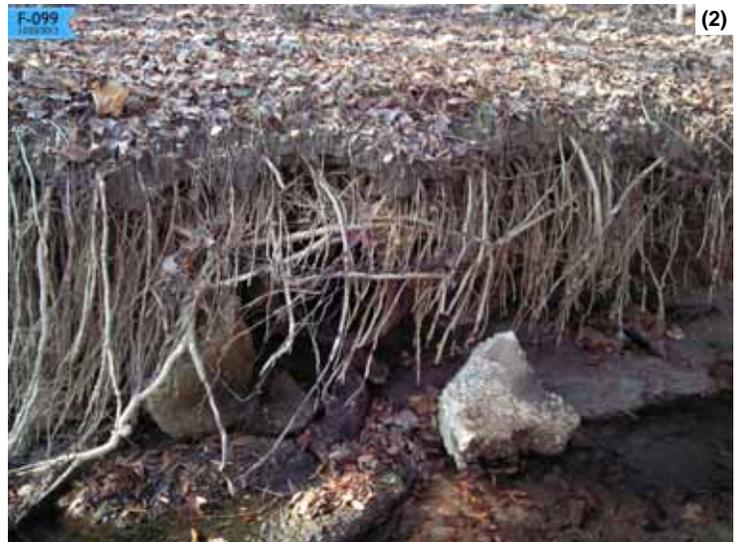
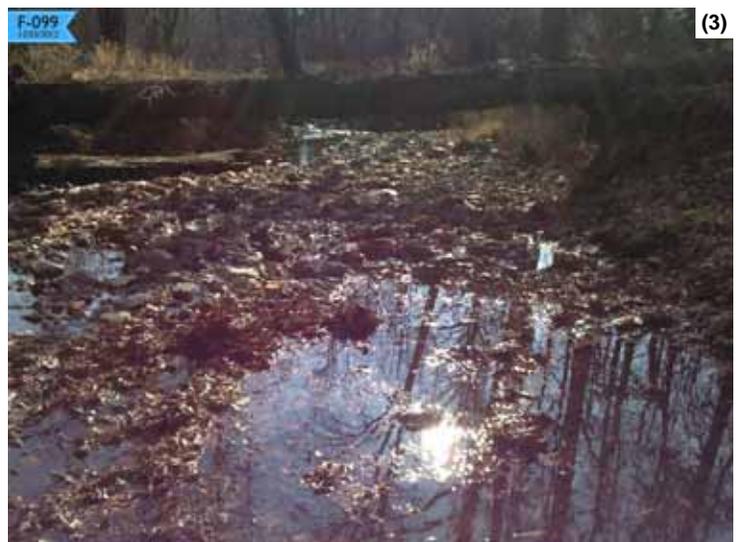
Stream has relocated and cut off the meander. Outfall pipe is broken and separated at new stream meander location. Original outfall structure is now abandoned and remains in the old stream channel.

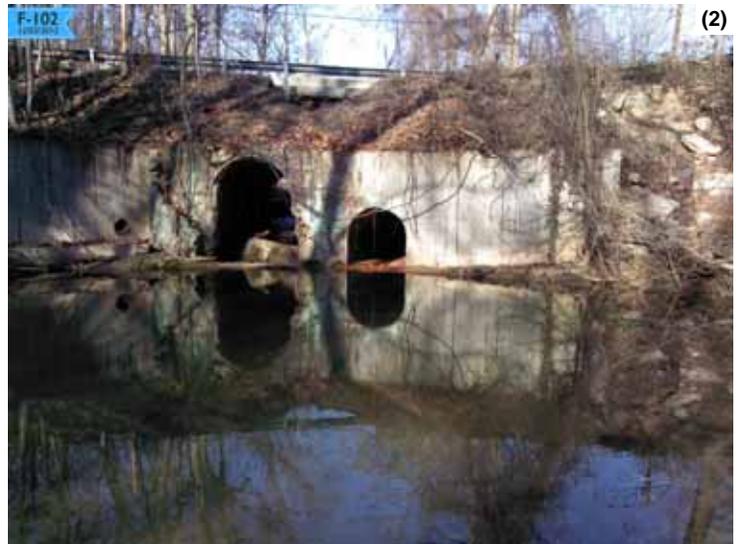
This inspection is for the smaller of the two pipes. DDOT is in process of repairing this outfall between road and outfall due to collapse of the adjacent roadway culvert.

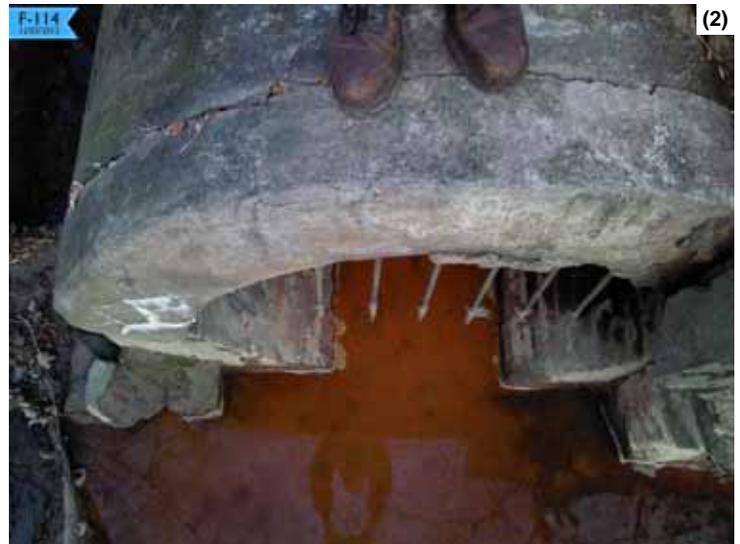
Stream widening has caused headwall to collapse. Remaining protruding pipe likely to fail in the future.

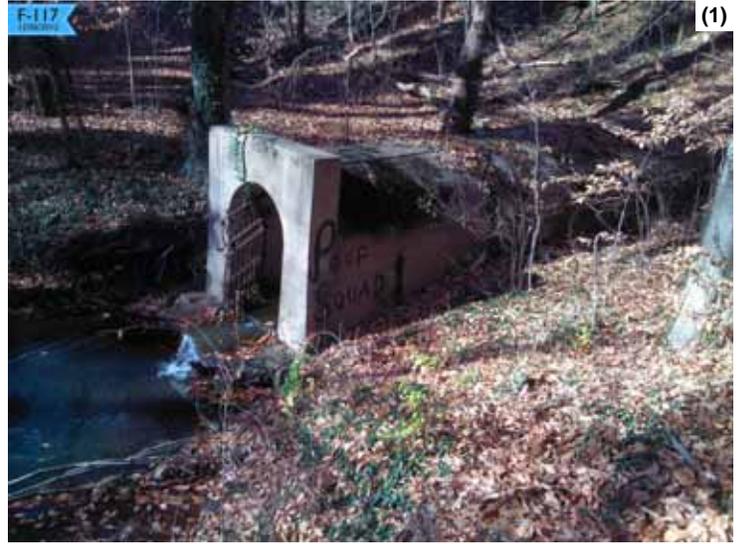
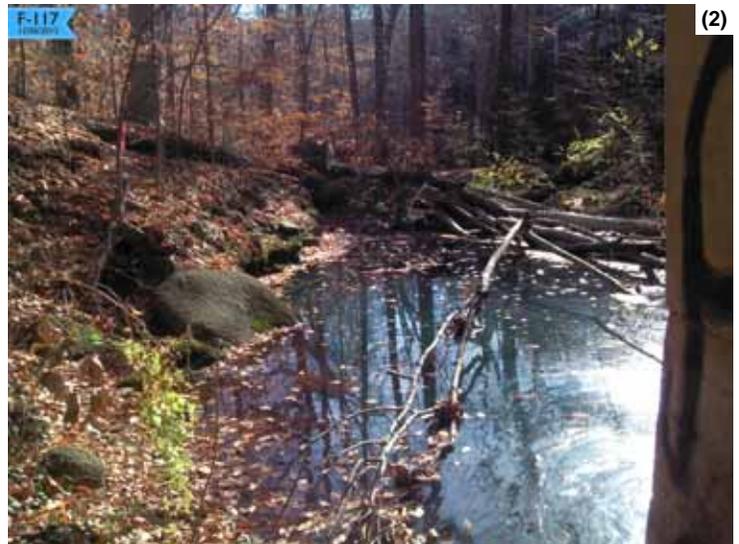
Minor erosion under spillway; broken pipe and security gate.

Point Repair

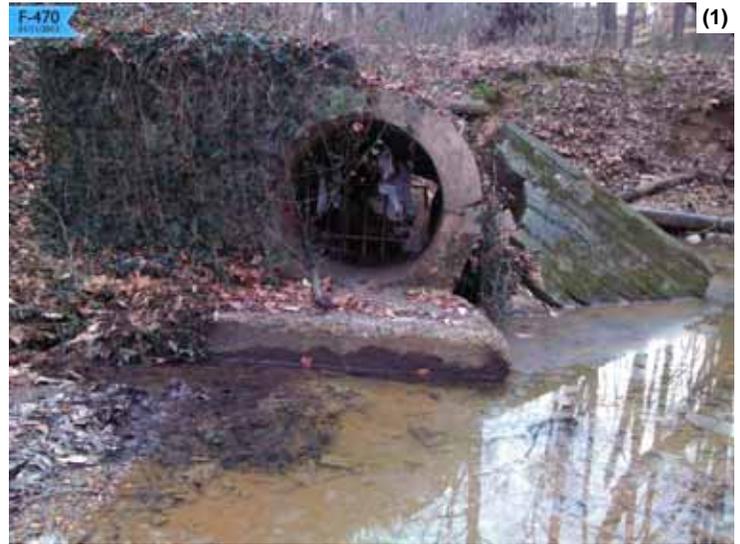
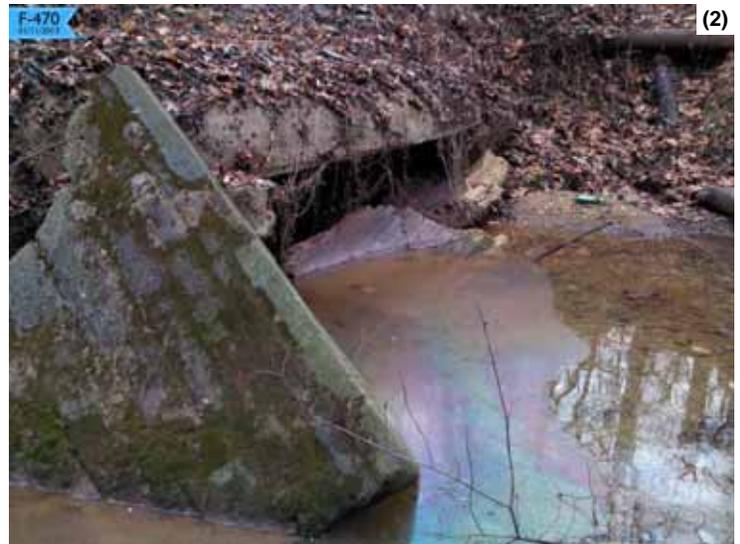
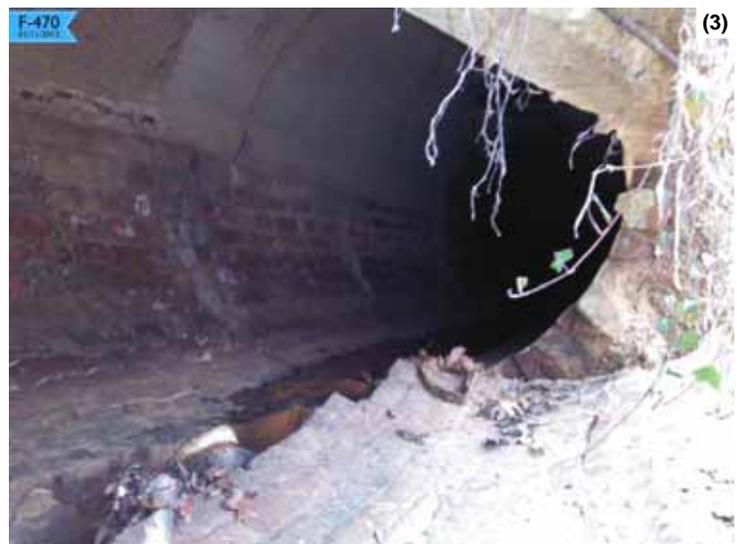
Headwall partially collapsed. Pipe behind head wall is broken and collapsed. Severe upstream/downstream erosion.

Point Repair
