REPORT OF HAZARDOUS MATERIALS SURVEY

BUZZARD POINT
WASHINGTON, DC

ECS PROJECT NO. 37:1524

JULY 28, 2015

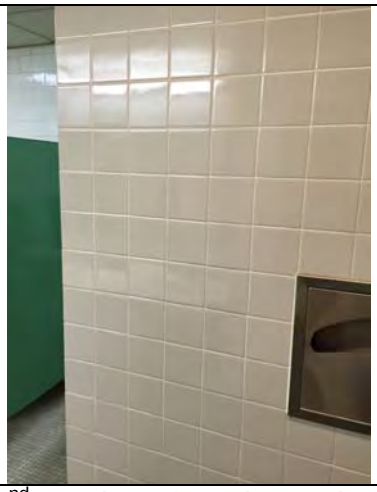
7.	1714 2nd St: View of 2nd Roof Layer (ACM). Sample No. BS-68.

8.	1714 2nd St: View of Black Vent Caulk (ACM) on the Roof. Sample No. BS-61.

10.	1714 2nd St: View of Caulking (ACM) on the Roof Flashing. Sample No. BS-64.

11.	1714 2nd St: View of Lead-Based Glaze on White Ceramic Wall Tiles in the 2nd Floor Break Room. XRF Reading No. 52.

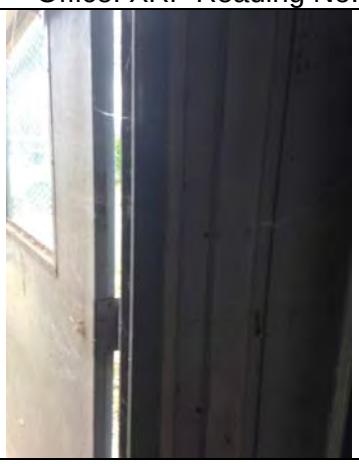
31.	2nd and S St: View of Lead-Based Paint on Brown Wood Window Sash in the Warehouse Office. XRF Reading No. 12.

32.	2nd and S St: View of Lead-Based Paint on Gray Metal Exterior Door Casing. XRF Reading No. 08.
