4.3 OUTFALL REPAIR SUMMARY REPORTS

OUTFALL SUMMARY REPORT

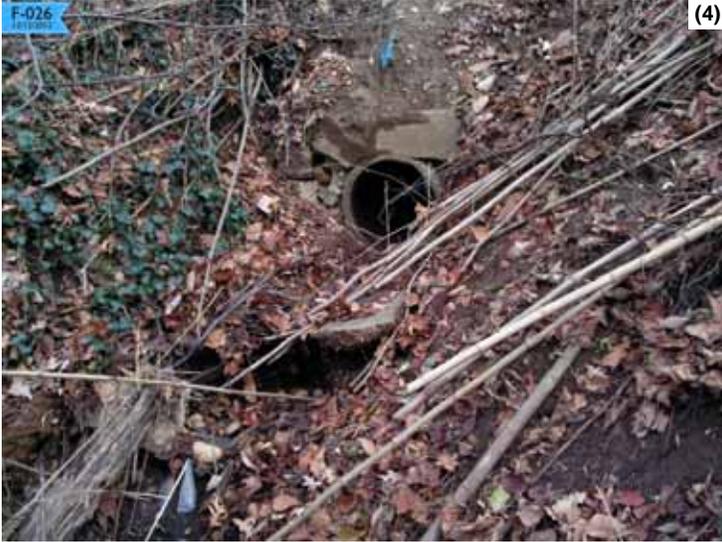
(4)

Spillway cracked and with some erosion underneath.

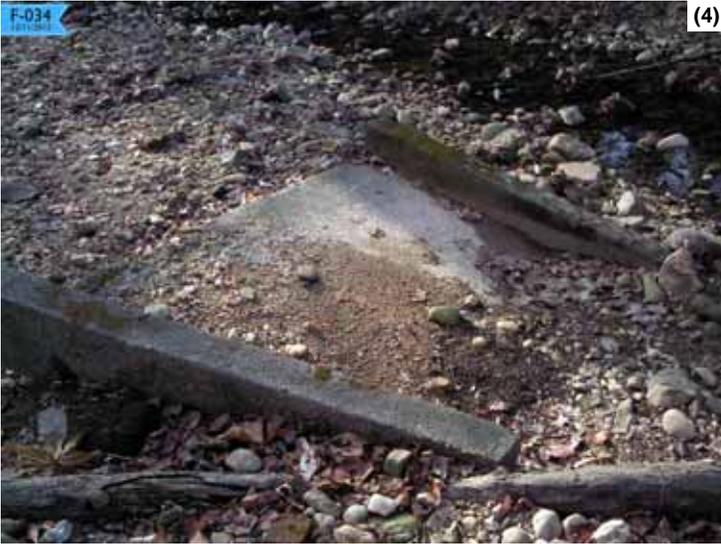
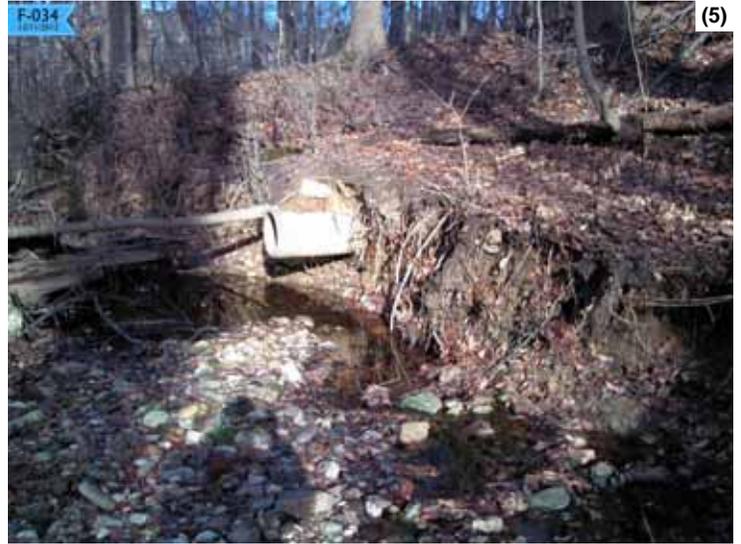
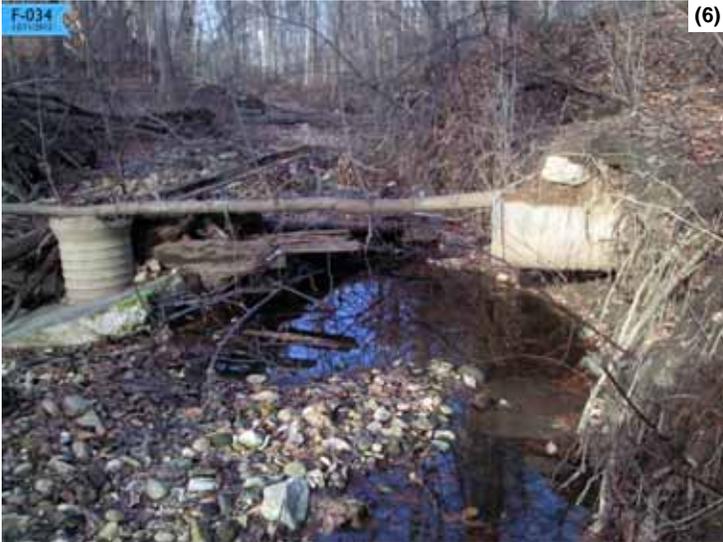
Concrete spillway, headwall, several pipe segments have fallen into the stream. Severe upstream channel erosion appears to be the cause of the problem.

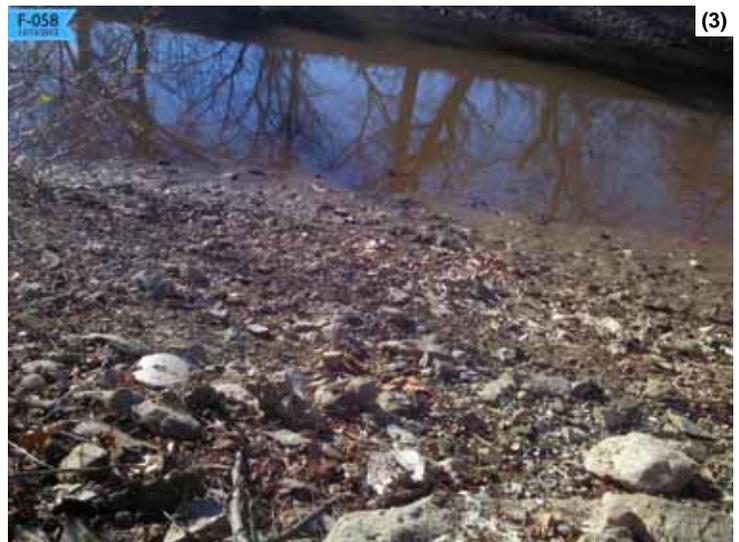
Broken pipe.

Point Repair

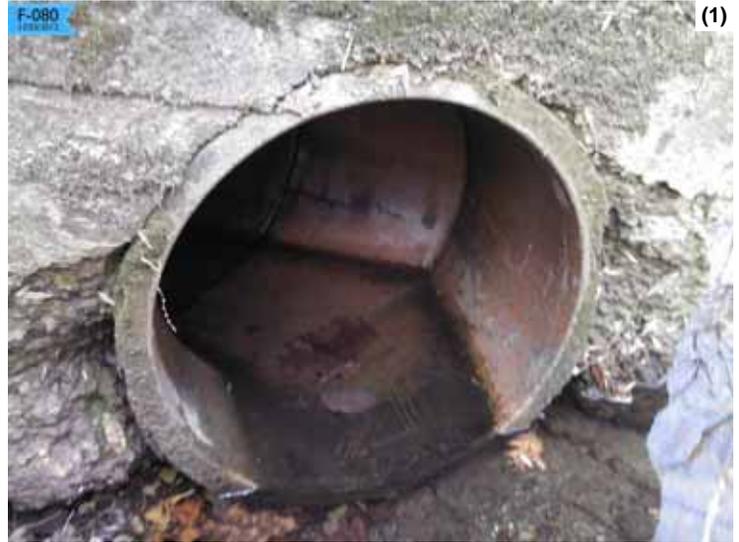
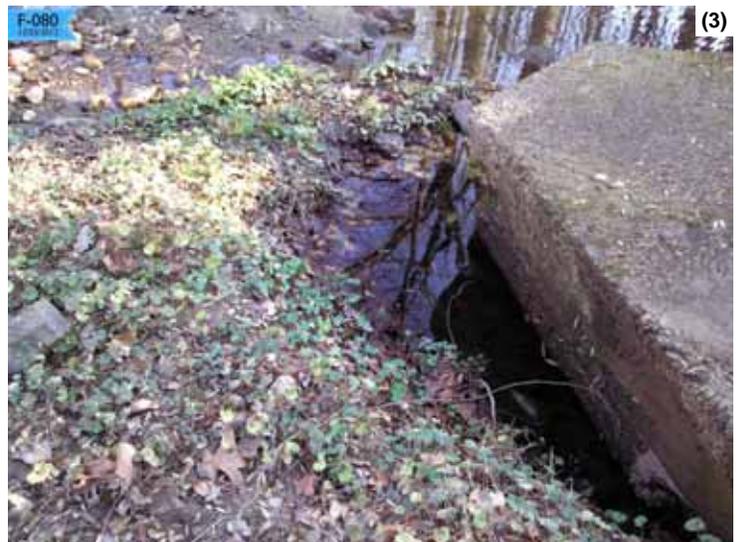
Erosion around spillway. Need additional photos of surrounding area to define extent of repair.

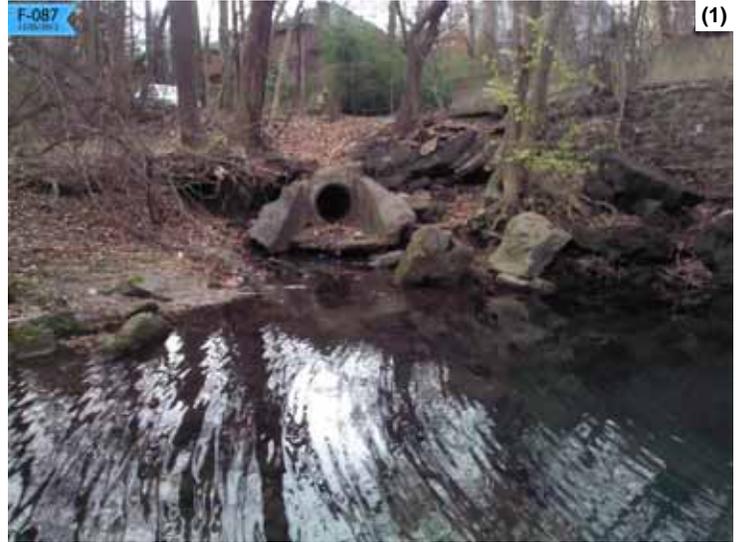
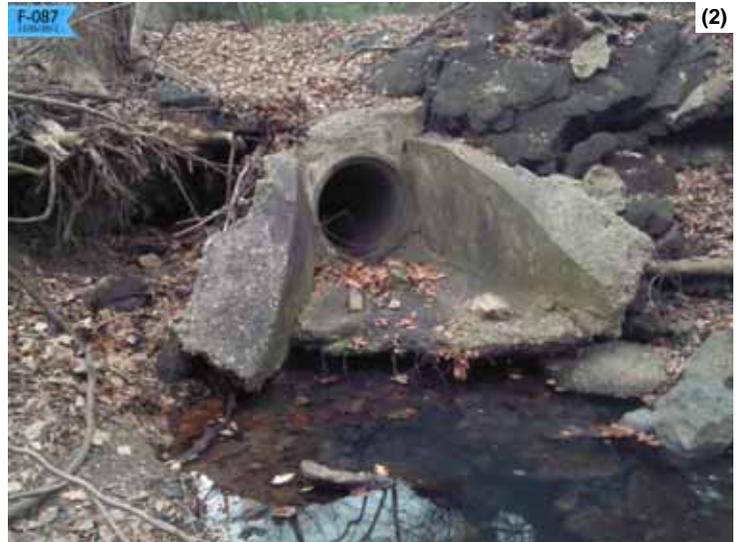
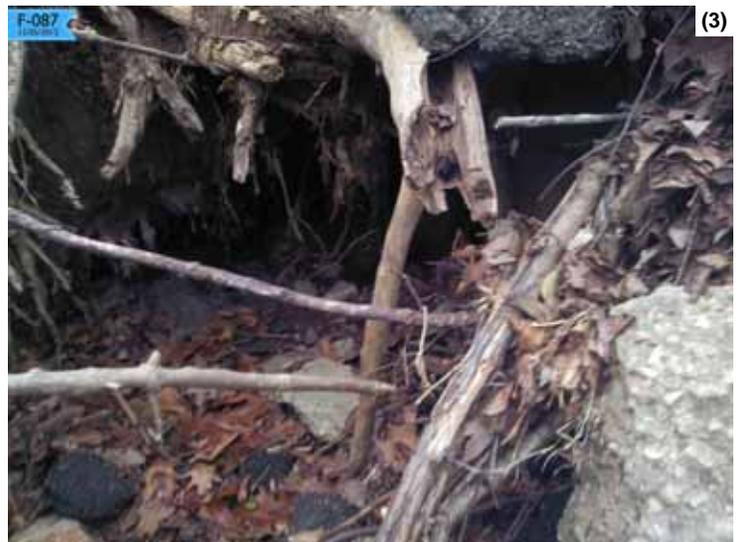
Upstream stream erosion contributing to outfall failure.

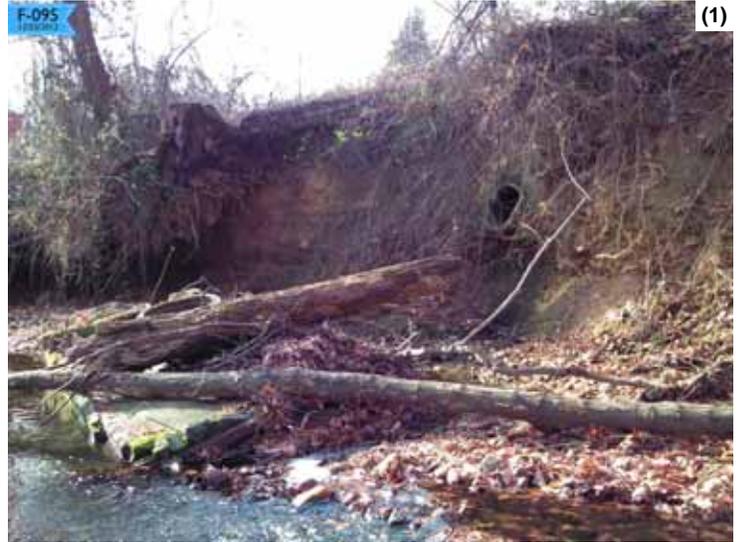
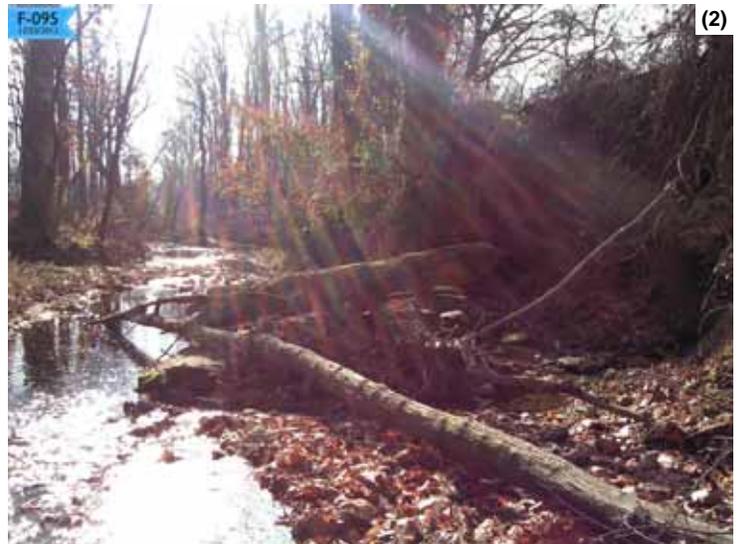
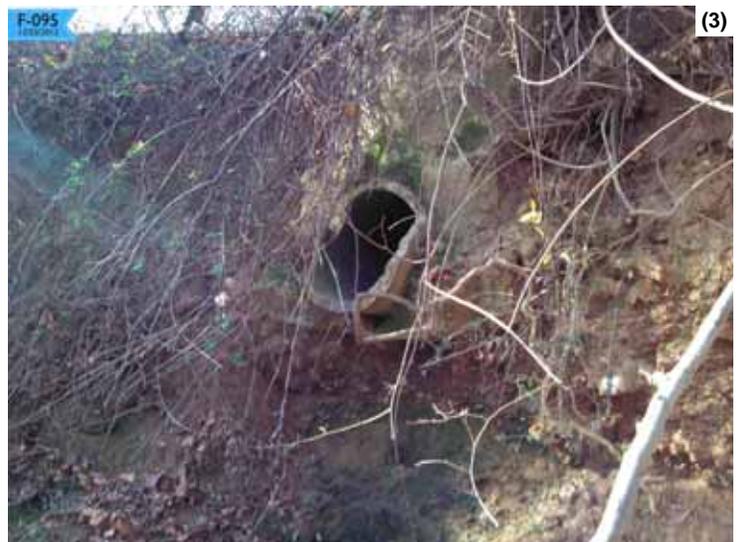
Stream Bank / Pool Severe Erosion

Repairs Recommended?
YES

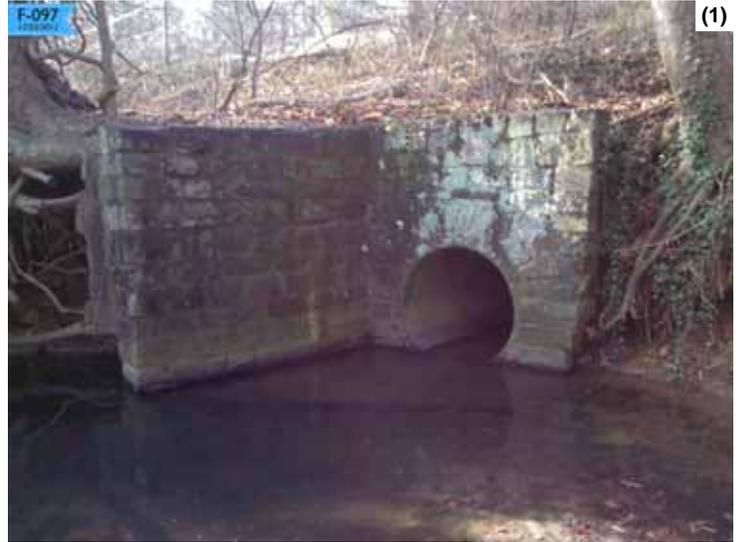
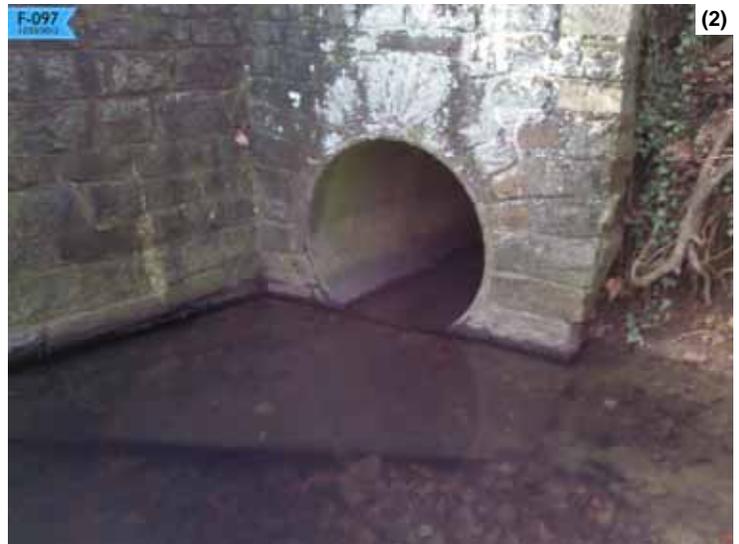
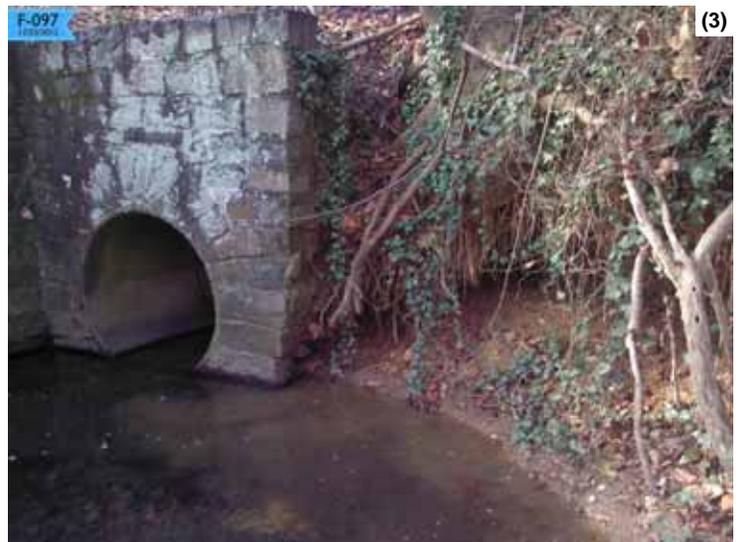
Stream Bank / Pool	<input type="text" value="3"/>	<input type="text" value="Severe Erosion"/>	Repairs Recommended? YES
Stream Bank / Pool (x2)	<input type="text" value="6"/>		
Structure	<input type="text" value="1"/>	<input type="text" value="Moderate"/>	
Criticality	<input type="text" value="0"/>	<input type="text" value="Normal"/>	
Total Score	<input type="text" value="7"/>	<small>Total = Stream Bank / Pool x2 + Structure + Criticality</small>

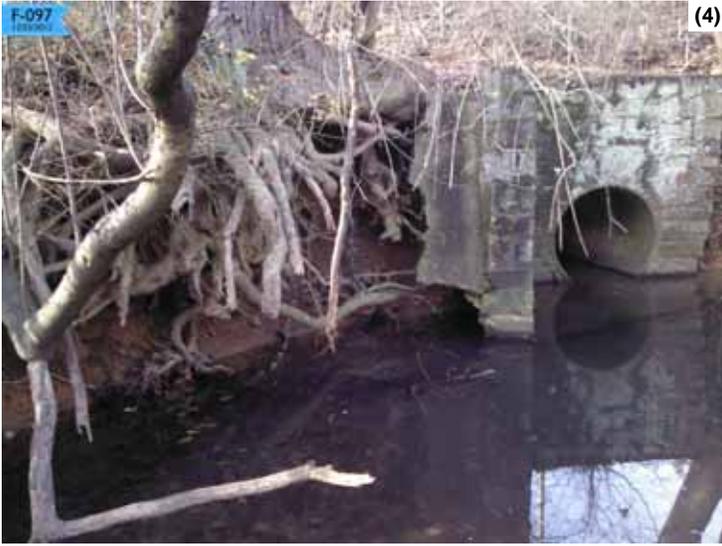
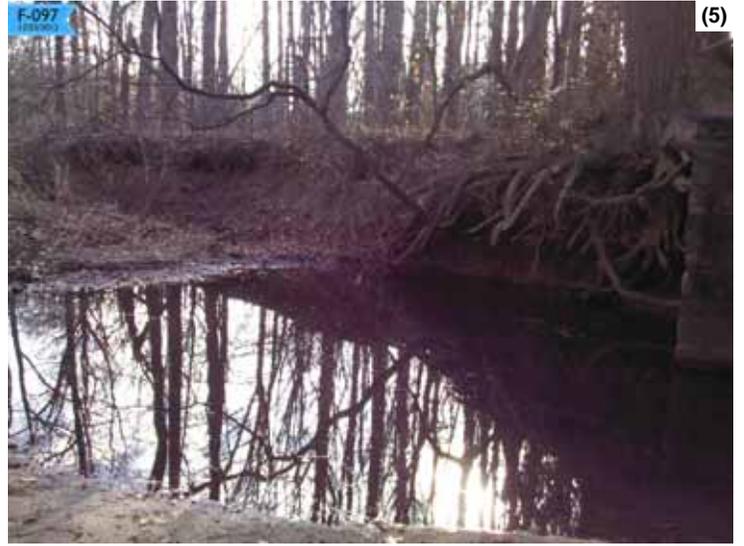
Stream Bank / Pool	<input type="text" value="2"/>	<input type="text" value="Active Erosion"/>	Repairs Recommended? NO
Stream Bank / Pool (x2)	<input type="text" value="4"/>		
Structure	<input type="text" value="3"/>	<input type="text" value="Very Poor"/>	
Criticality	<input type="text" value="0"/>	<input type="text" value="Normal"/>	
Total Score	<input type="text" value="7"/>	<small>Total = Stream Bank / Pool x2 + Structure + Criticality</small>

Stream has relocated and cut off the meander. Outfall pipe is broken and separated at new stream meander location. Original outfall structure is now abandoned and remains in the old stream channel.

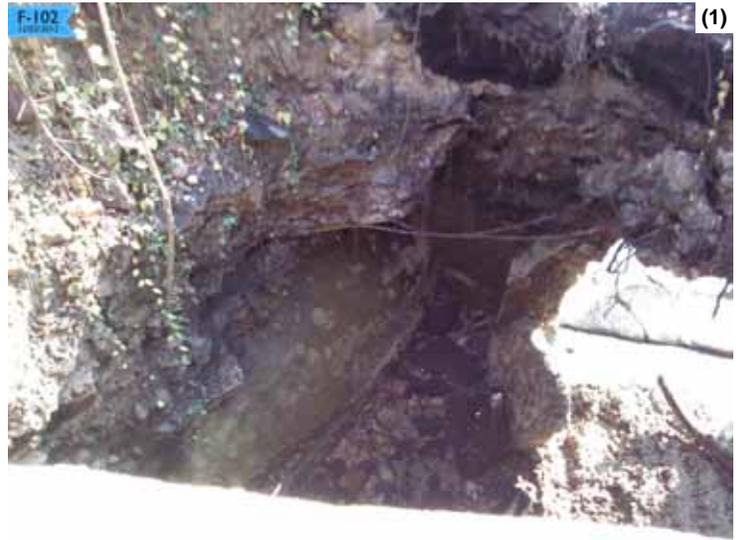
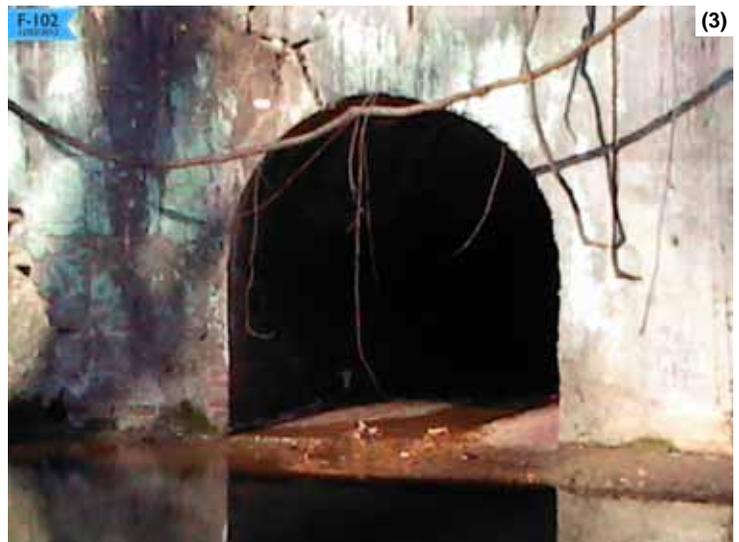
Stream Bank / Pool	<input type="text" value="0"/>	<input type="text" value="Stable"/>	Repairs Recommended? NO
Stream Bank / Pool (x2)	<input type="text" value="0"/>		
Structure	<input type="text" value="3"/>	<input type="text" value="Very Poor"/>	
Criticality	<input type="text" value="2"/>	<input type="text" value="Critical"/>	
Total Score	<input type="text" value="5"/>	<small>Total = Stream Bank / Pool x2 + Structure + Criticality</small>

This inspection is for the smaller of the two pipes. DDOT is in process of repairing this outfall between road and outfall due to collapse of the adjacent roadway culvert.

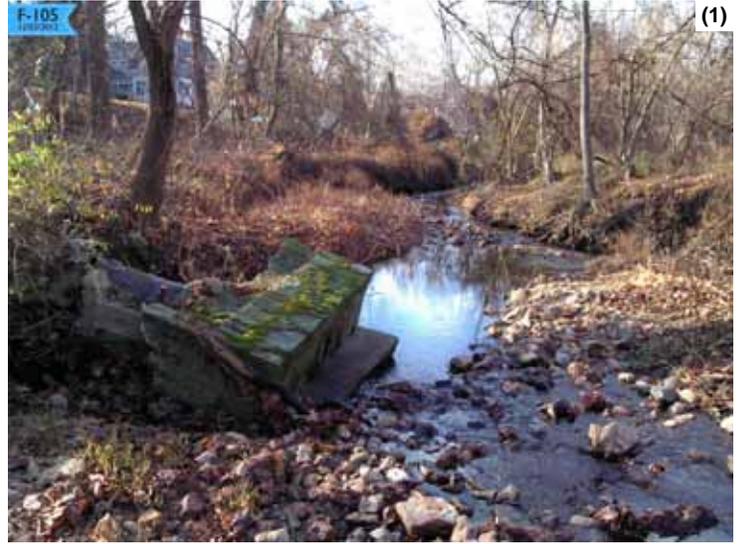
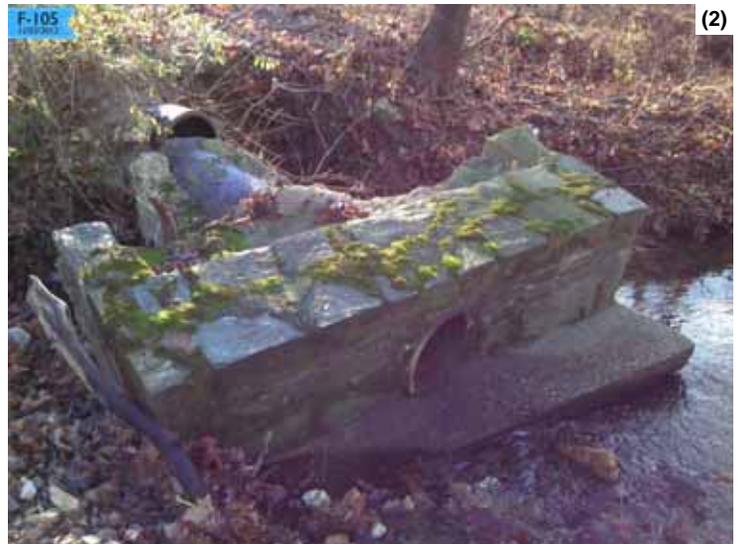
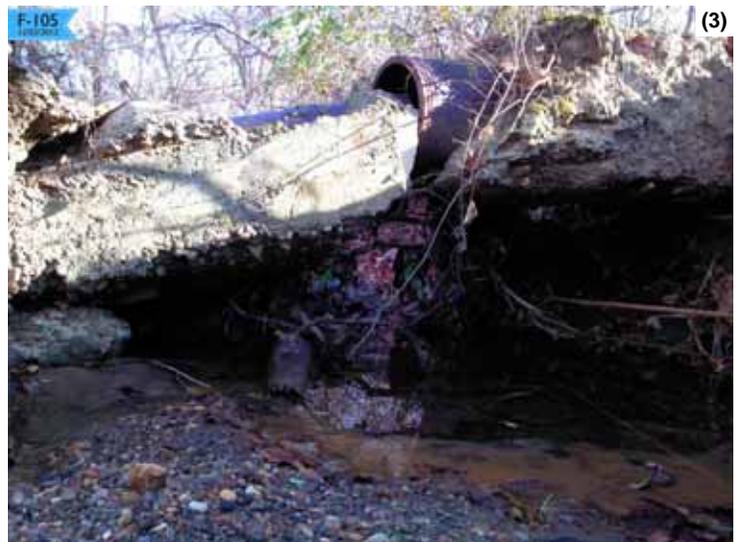
Stream Bank / Pool	<input type="text" value="3"/>	<input type="text" value="Severe Erosion"/>	Repairs Recommended? YES
Stream Bank / Pool (x2)	<input type="text" value="6"/>		
Structure	<input type="text" value="3"/>	<input type="text" value="Very Poor"/>	
Criticality	<input type="text" value="0"/>	<input type="text" value="Normal"/>	
Total Score	<input type="text" value="9"/>	<small>Total = Stream Bank / Pool x2 + Structure + Criticality</small>

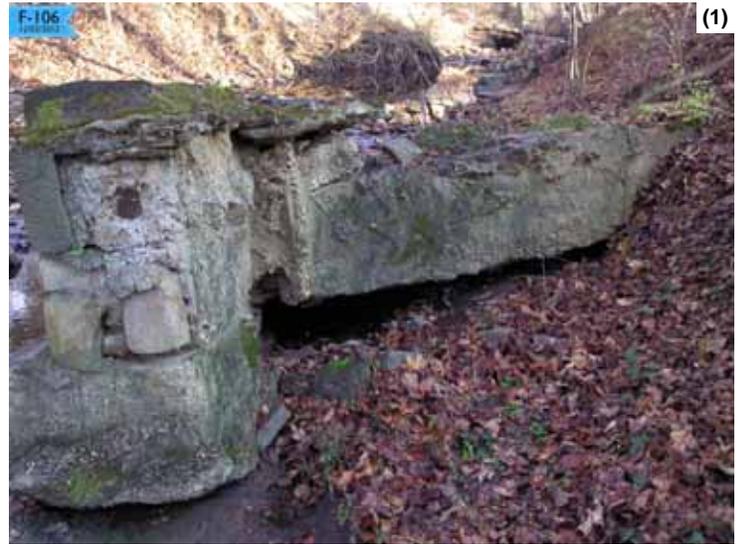
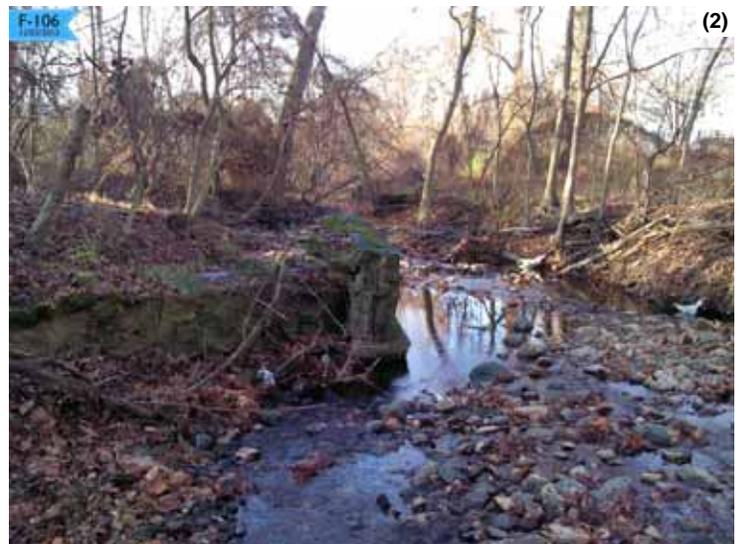
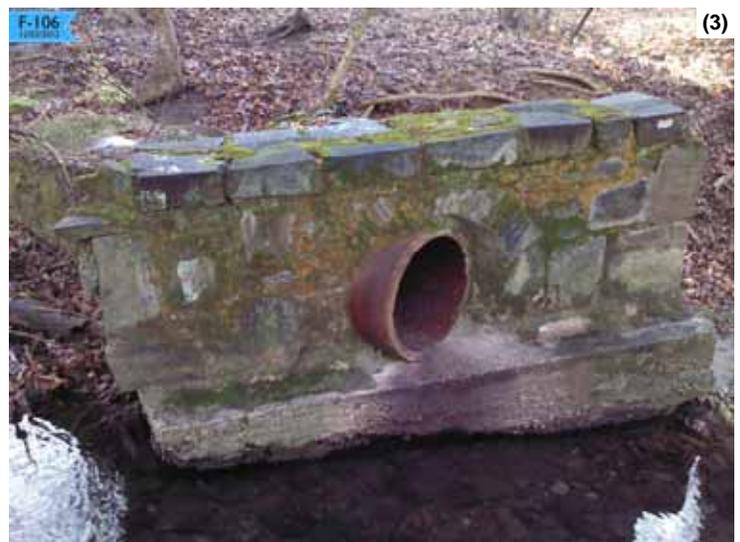
Stream Bank / Pool	<input type="text" value="2"/>	<input type="text" value="Active Erosion"/>	Repairs Recommended? YES
Stream Bank / Pool (x2)	<input type="text" value="4"/>		
Structure	<input type="text" value="2"/>	<input type="text" value="Poor"/>	
Criticality	<input type="text" value="0"/>	<input type="text" value="Normal"/>	
Total Score	<input type="text" value="6"/>	<small>Total = Stream Bank / Pool x2 + Structure + Criticality</small>

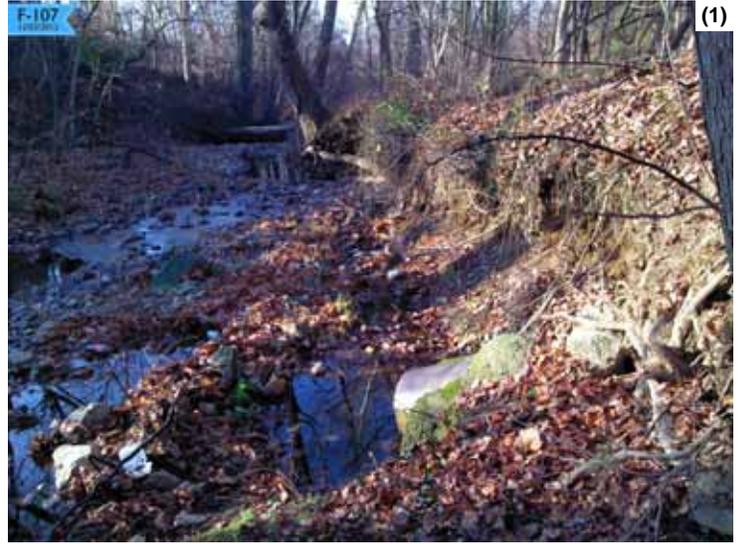
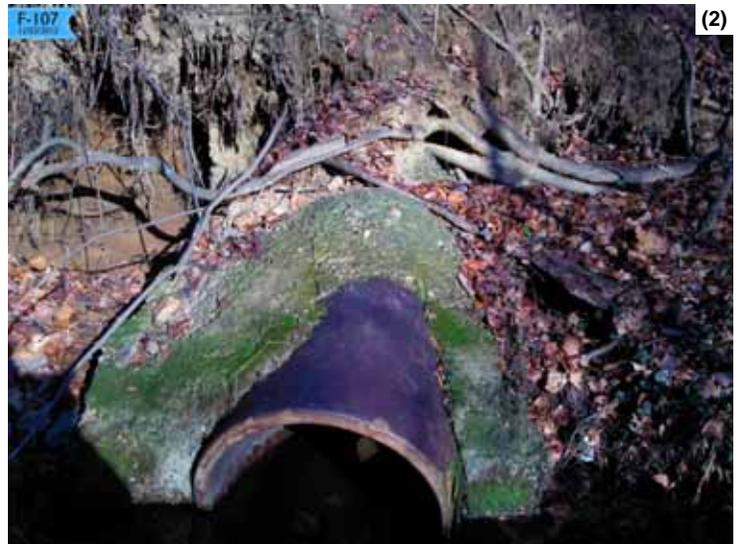
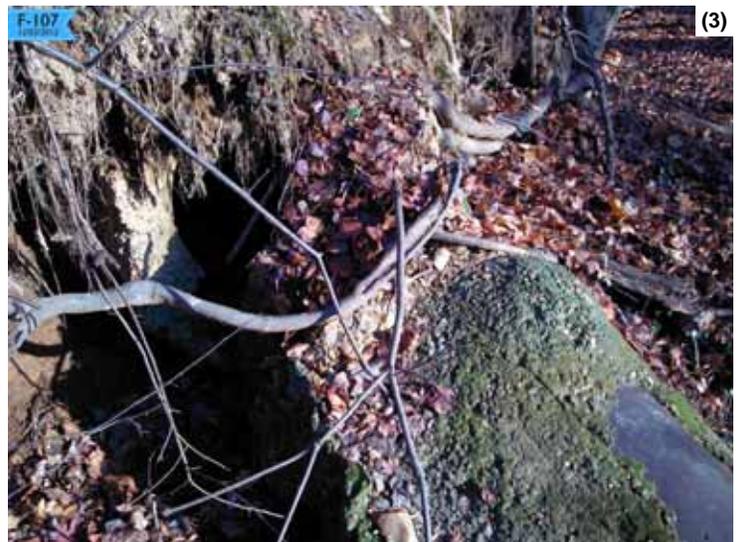
Stream Bank / Pool	<input type="text" value="1"/>	<input type="text" value="Some Erosion"/>	Repairs Recommended? YES
Stream Bank / Pool (x2)	<input type="text" value="2"/>		
Structure	<input type="text" value="2"/>	<input type="text" value="Poor"/>	
Criticality	<input type="text" value="0"/>	<input type="text" value="Normal"/>	
Total Score	<input type="text" value="4"/>	<i>Total = Stream Bank / Pool x2 + Structure + Criticality</i>

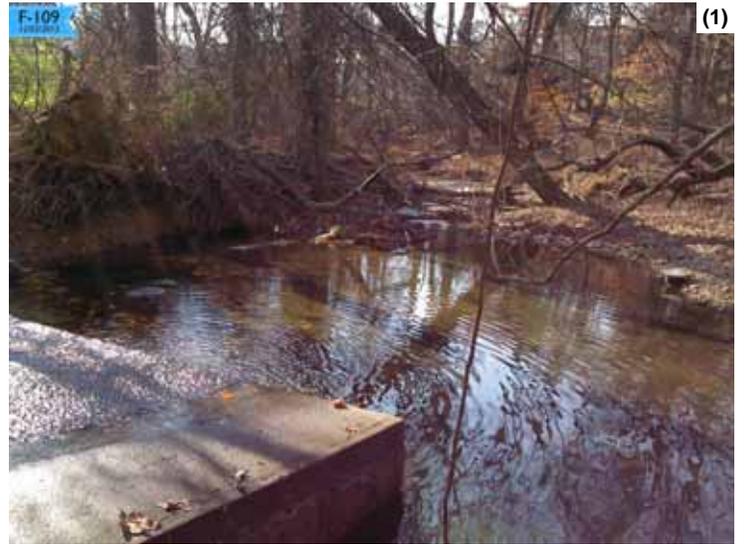
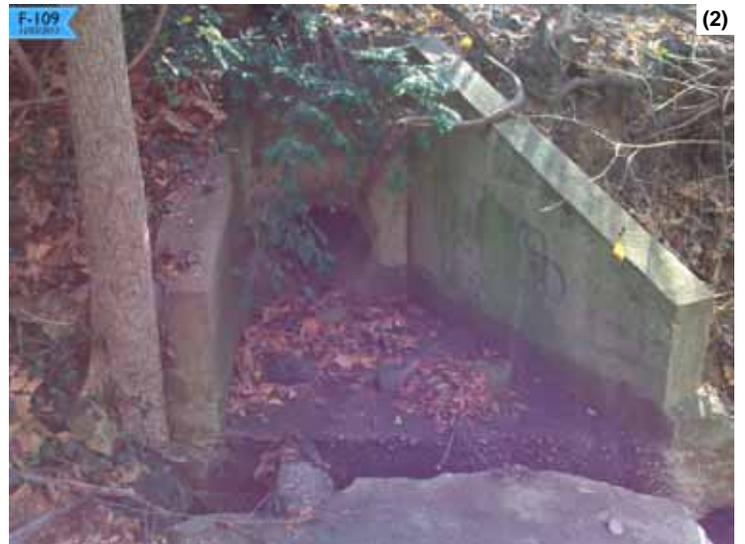
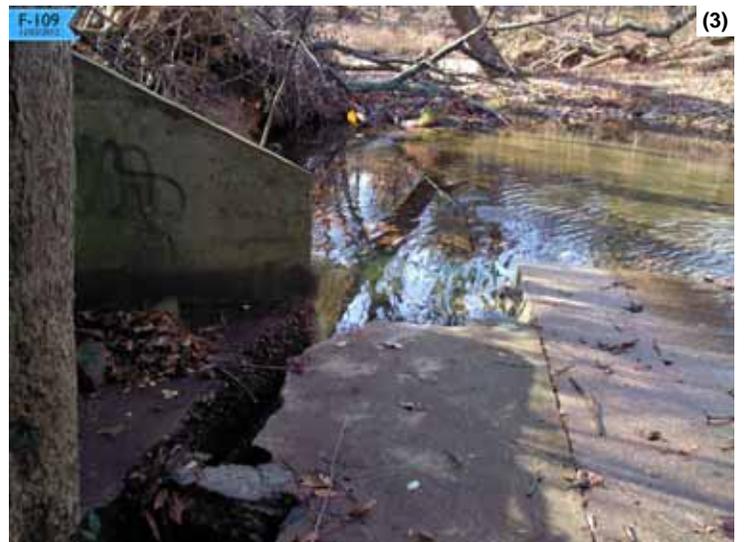
Stream Bank / Pool	<input type="text" value="3"/>	<input type="text" value="Severe Erosion"/>	Repairs Recommended? YES
Stream Bank / Pool (x2)	<input type="text" value="6"/>		
Structure	<input type="text" value="2"/>	<input type="text" value="Poor"/>	
Criticality	<input type="text" value="1"/>	<input type="text" value="Important"/>	
Total Score	<input type="text" value="9"/>	<small>Total = Stream Bank / Pool x2 + Structure + Criticality</small>

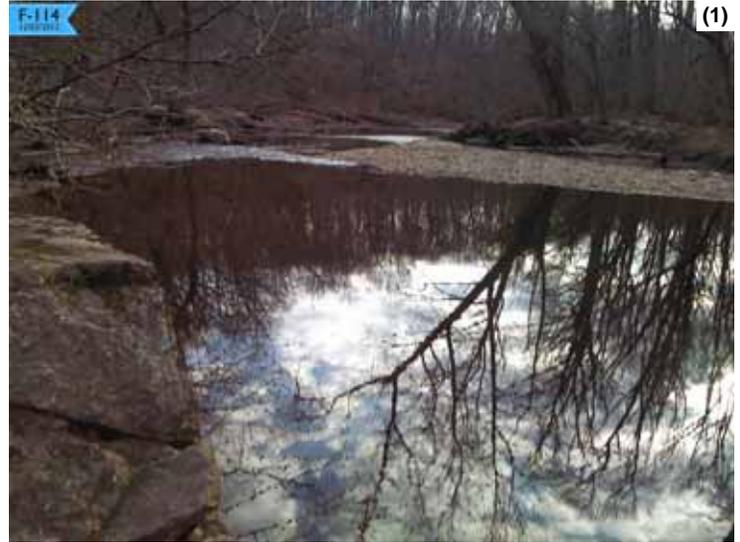
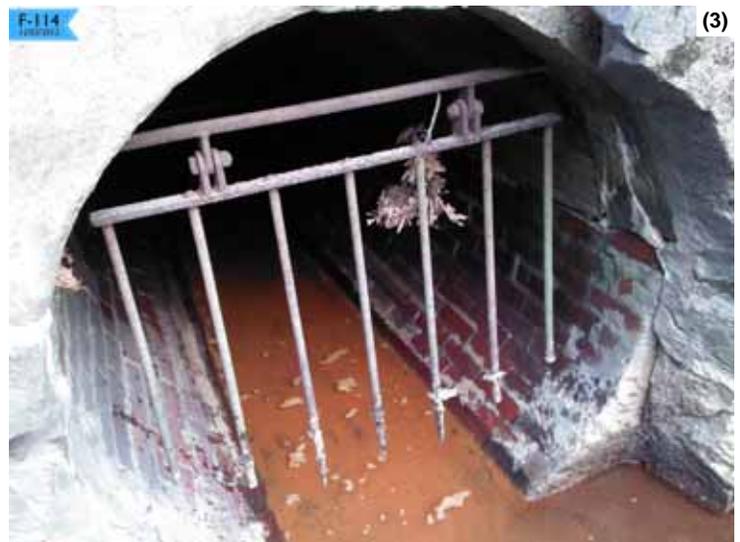
Stream Bank / Pool	<input type="text" value="2"/>	<input type="text" value="Active Erosion"/>	Repairs Recommended? YES
Stream Bank / Pool (x2)	<input type="text" value="4"/>		
Structure	<input type="text" value="2"/>	<input type="text" value="Poor"/>	
Criticality	<input type="text" value="0"/>	<input type="text" value="Normal"/>	
Total Score	<input type="text" value="6"/>	<i>Total = Stream Bank / Pool x2 + Structure + Criticality</i>

Stream widening has caused headwall to collapse. Remaining protruding pipe likely to fail in the future.

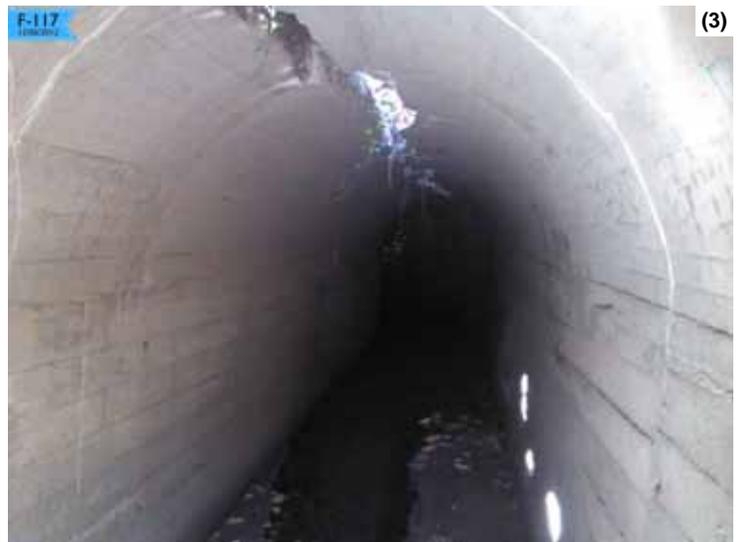
Minor erosion under spillway; broken pipe and security gate.

Point Repair

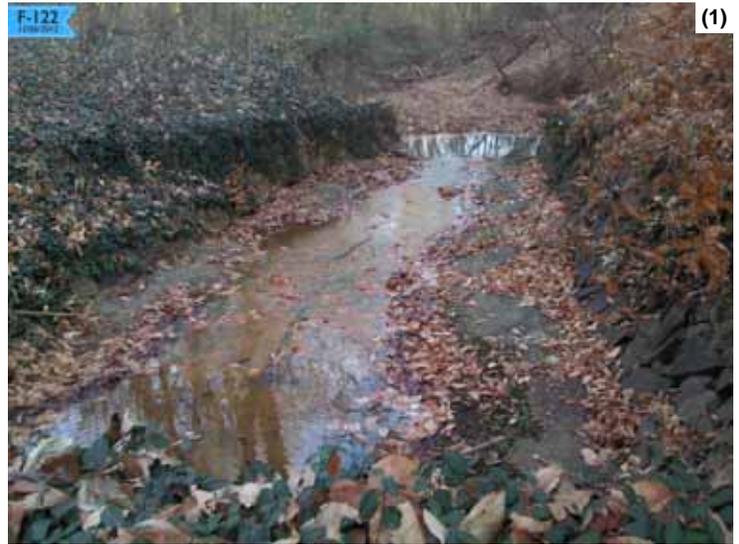
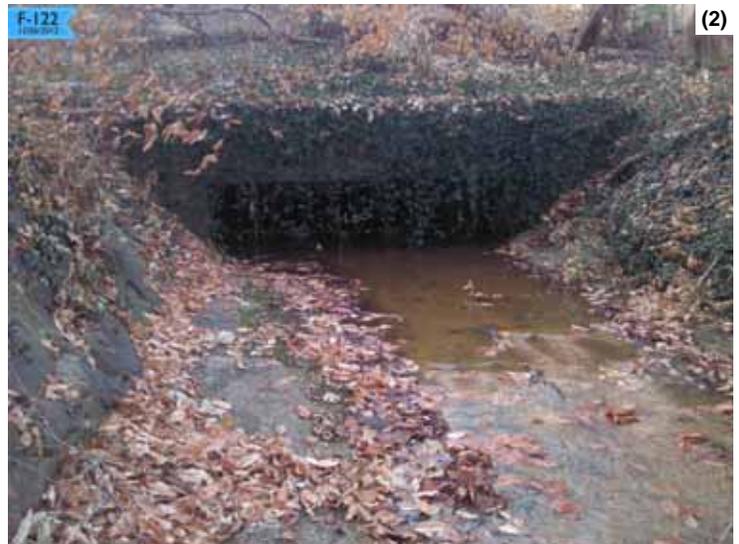
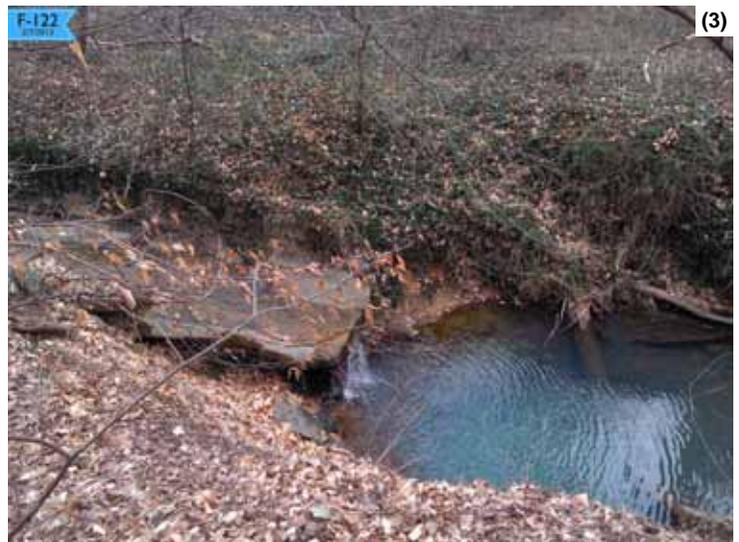
Stream Bank / Pool	<input type="text" value="3"/>	<input type="text" value="Severe Erosion"/>	Repairs Recommended? YES
Stream Bank / Pool (x2)	<input type="text" value="6"/>		
Structure	<input type="text" value="1"/>	<input type="text" value="Moderate"/>	
Criticality	<input type="text" value="0"/>	<input type="text" value="Normal"/>	
Total Score	<input type="text" value="7"/>	<small>Total = Stream Bank / Pool x2 + Structure + Criticality</small>

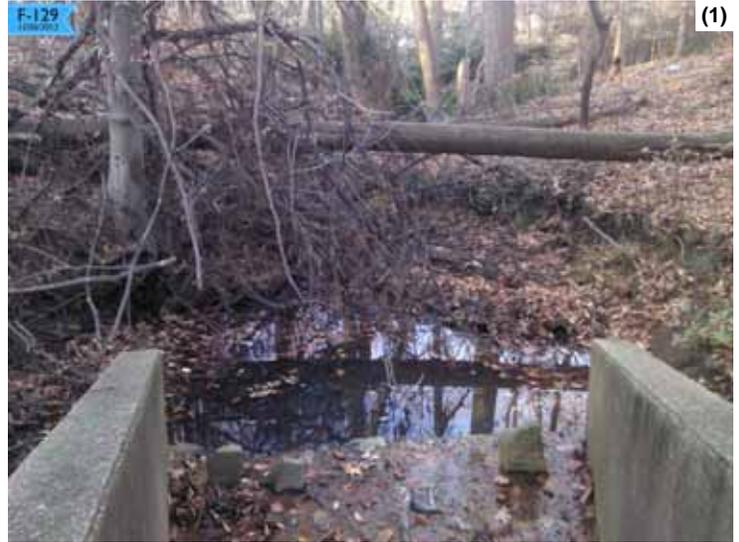
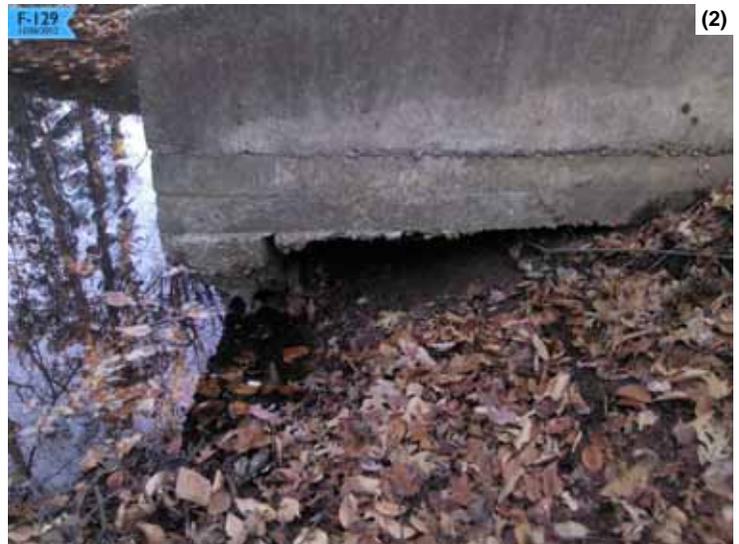
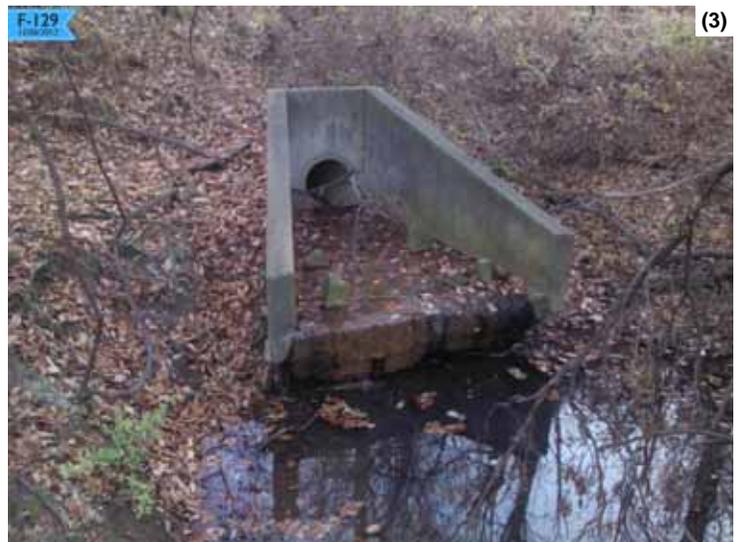
Stream Bank / Pool	<input type="text" value="2"/>	<input type="text" value="Active Erosion"/>	Repairs Recommended? YES
Stream Bank / Pool (x2)	<input type="text" value="4"/>		
Structure	<input type="text" value="1"/>	<input type="text" value="Moderate"/>	
Criticality	<input type="text" value="0"/>	<input type="text" value="Normal"/>	
Total Score	<input type="text" value="5"/>	<small>Total = Stream Bank / Pool x2 + Structure + Criticality</small>

Point Repair

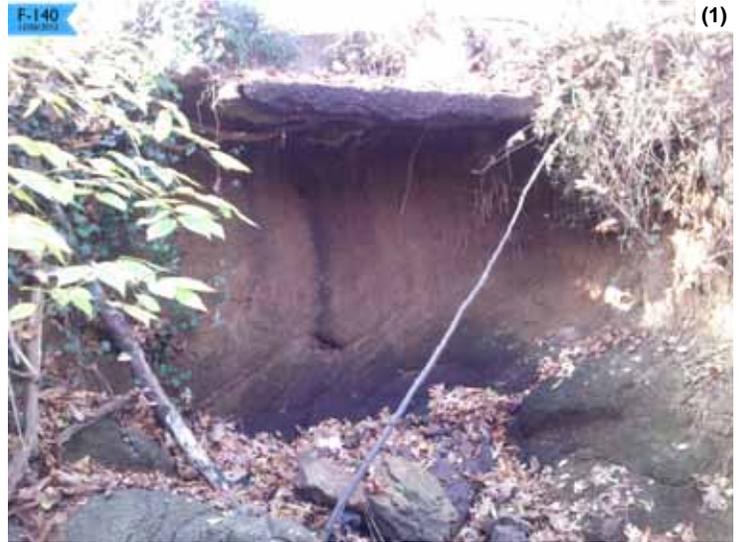
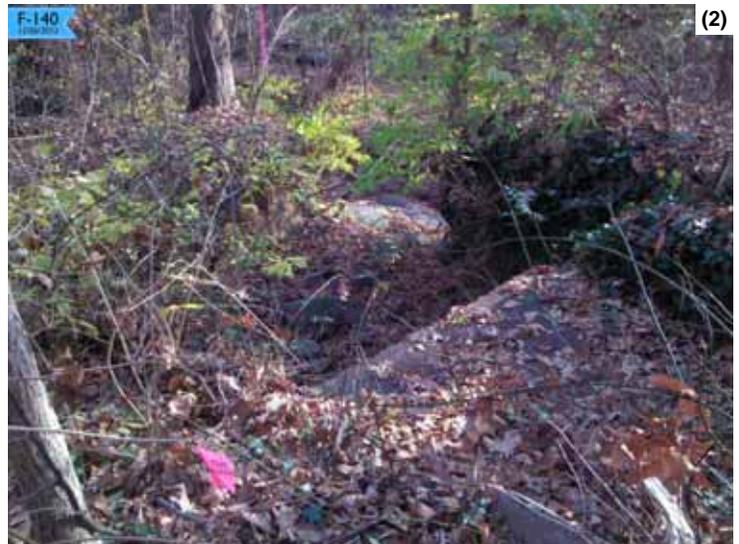
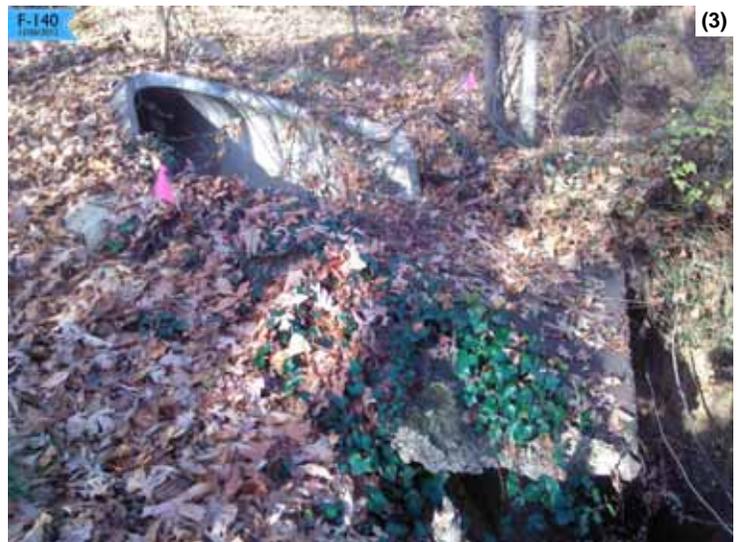
Stream Bank / Pool	<input type="text" value="2"/>	<input type="text" value="Active Erosion"/>	Repairs Recommended? YES
Stream Bank / Pool (x2)	<input type="text" value="4"/>		
Structure	<input type="text" value="2"/>	<input type="text" value="Poor"/>	
Criticality	<input type="text" value="1"/>	<input type="text" value="Important"/>	
Total Score	<input type="text" value="7"/>	<small>Total = Stream Bank / Pool x2 + Structure + Criticality</small>

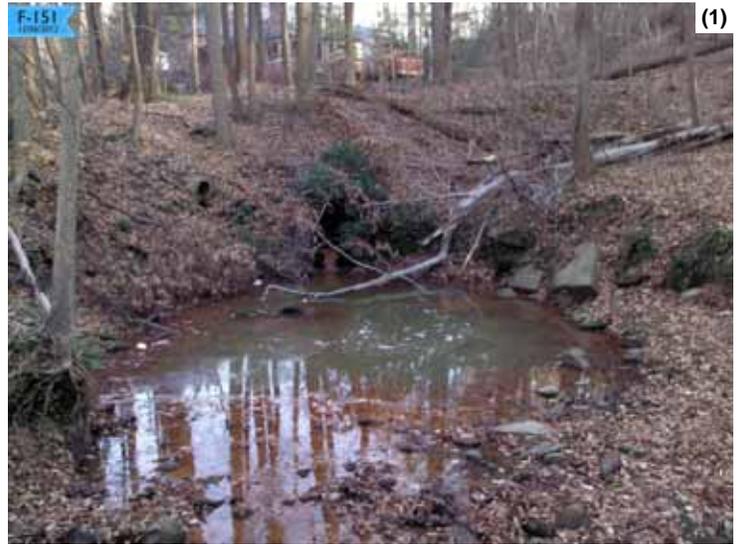
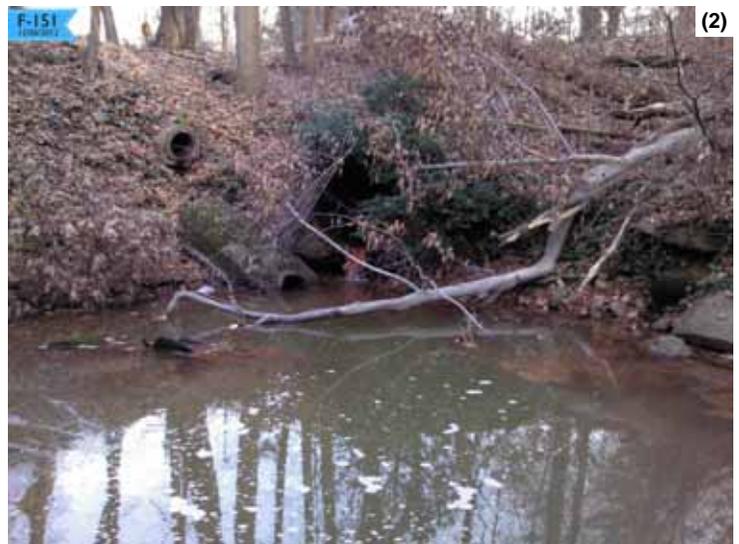
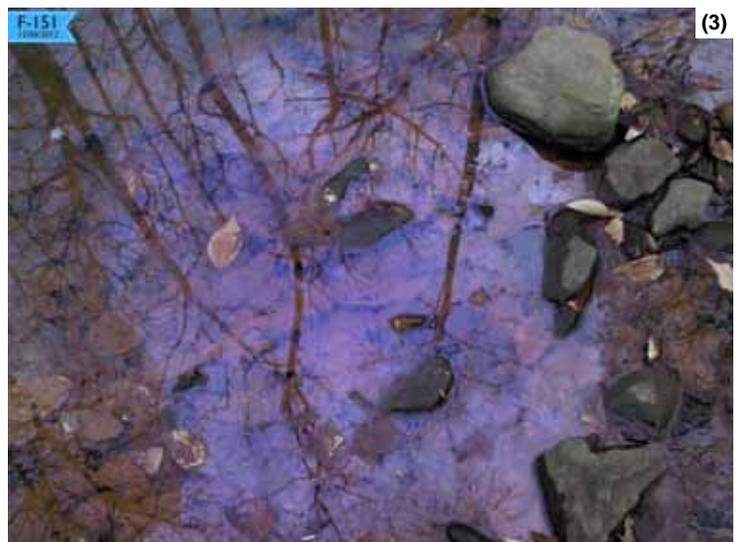
Stream Bank / Pool	<input type="text" value="2"/>	<input type="text" value="Active Erosion"/>	Repairs Recommended? YES
Stream Bank / Pool (x2)	<input type="text" value="4"/>		
Structure	<input type="text" value="2"/>	<input type="text" value="Poor"/>	
Criticality	<input type="text" value="0"/>	<input type="text" value="Normal"/>	
Total Score	<input type="text" value="6"/>	<small>Total = Stream Bank / Pool x2 + Structure + Criticality</small>

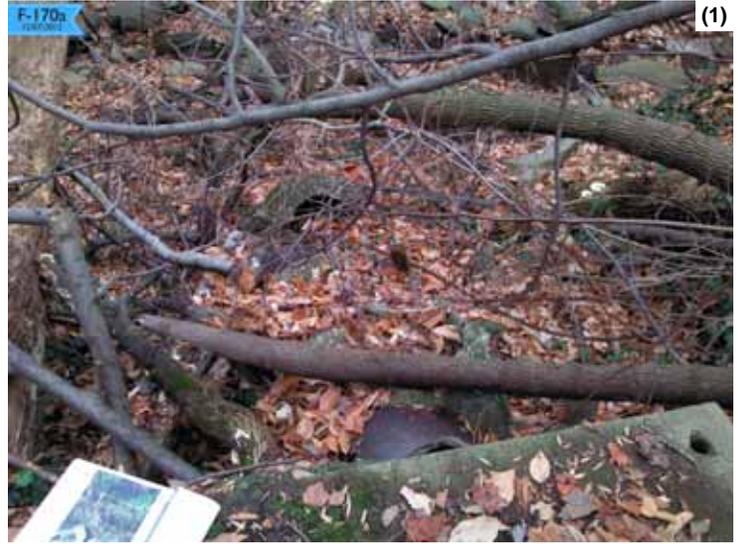
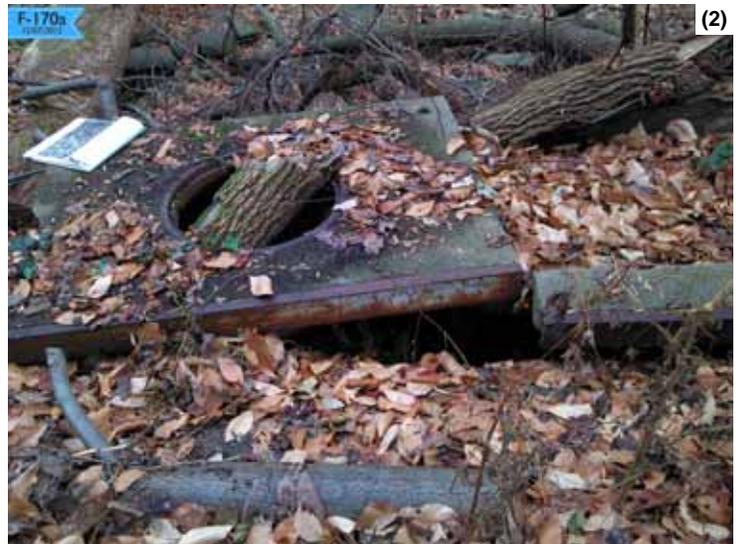
Stream Bank / Pool	<input type="text" value="0"/>	<input type="text" value="Stable"/>	Repairs Recommended? NO
Stream Bank / Pool (x2)	<input type="text" value="0"/>		
Structure	<input type="text" value="3"/>	<input type="text" value="Very Poor"/>	
Criticality	<input type="text" value="2"/>	<input type="text" value="Critical"/>	
Total Score	<input type="text" value="5"/>	<small>Total = Stream Bank / Pool x2 + Structure + Criticality</small>

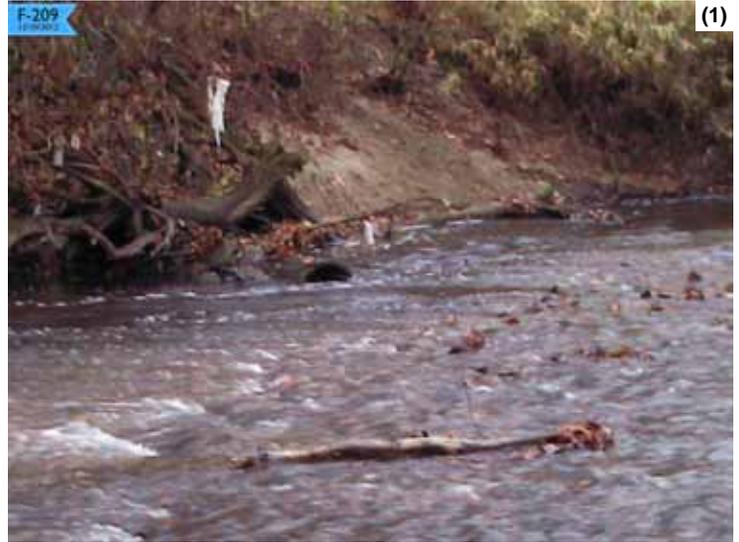
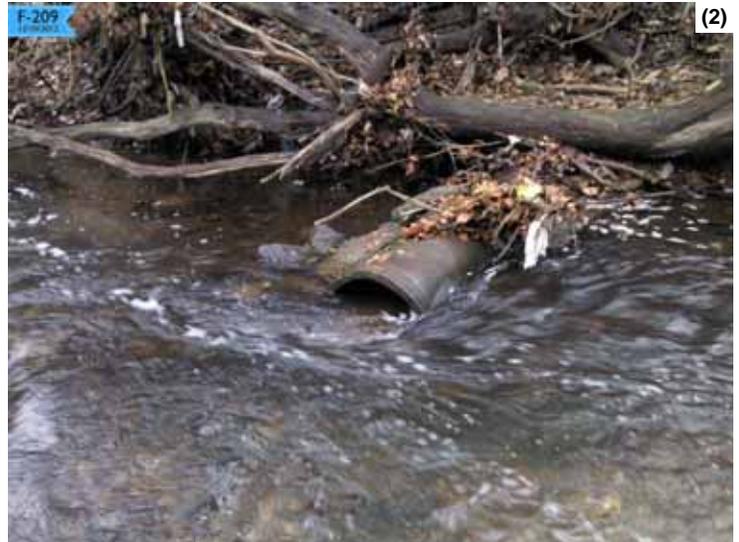
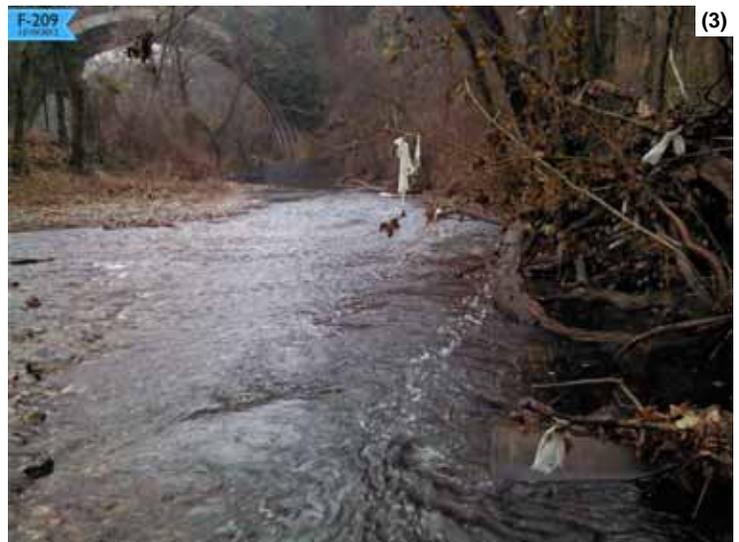
Stream Bank / Pool	<input type="text" value="2"/>	<input type="text" value="Active Erosion"/>	Repairs Recommended? <input checked="" type="button" value="YES"/>
Stream Bank / Pool (x2)	<input type="text" value="4"/>		
Structure	<input type="text" value="2"/>	<input type="text" value="Poor"/>	
Criticality	<input type="text" value="0"/>	<input type="text" value="Normal"/>	
Total Score	<input type="text" value="6"/>	<small>Total = Stream Bank / Pool x2 + Structure + Criticality</small>

Point Repair
