4.3 OUTFALL REPAIR SUMMARY REPORTS

OUTFALL SUMMARY REPORT

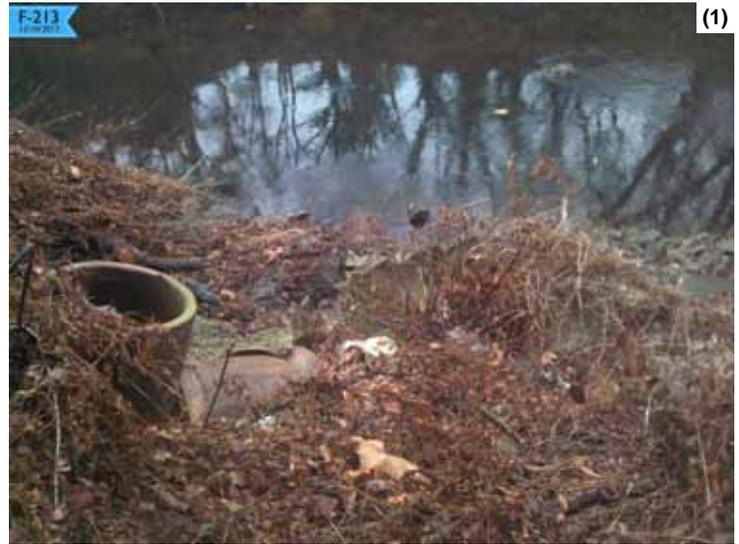
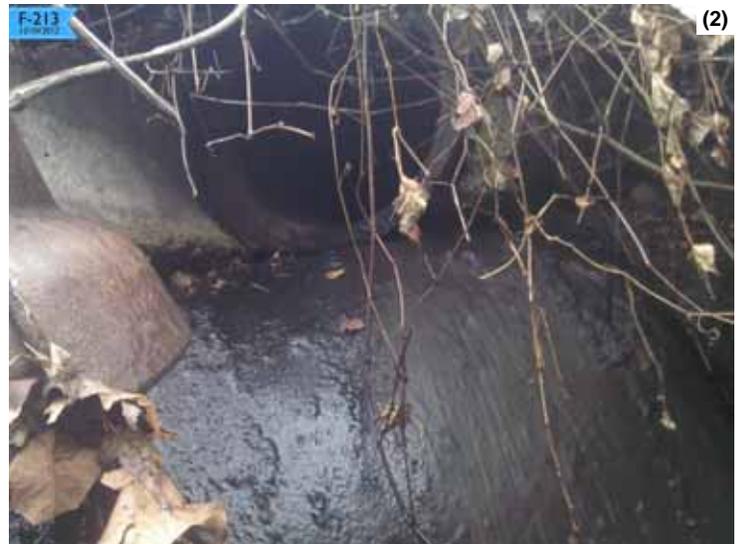
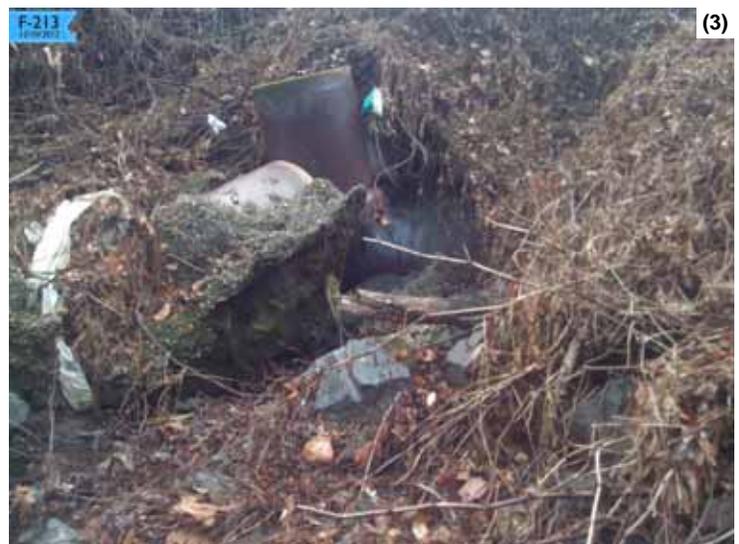
Stream Bank / Pool	<input type="text" value="2"/>	<input type="text" value="Active Erosion"/>	Repairs Recommended? YES
Stream Bank / Pool (x2)	<input type="text" value="4"/>		
Structure	<input type="text" value="2"/>	<input type="text" value="Poor"/>	
Criticality	<input type="text" value="1"/>	<input type="text" value="Important"/>	
Total Score	<input type="text" value="7"/>	<small>Total = Stream Bank / Pool x2 + Structure + Criticality</small>

Point Repair

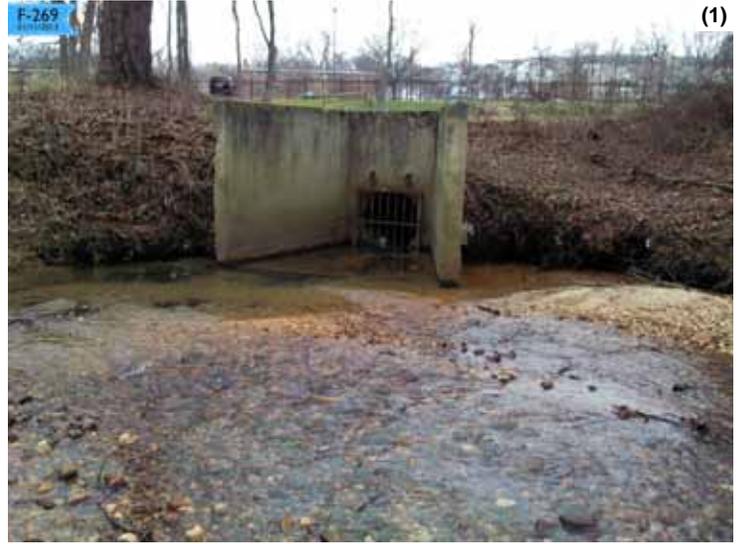
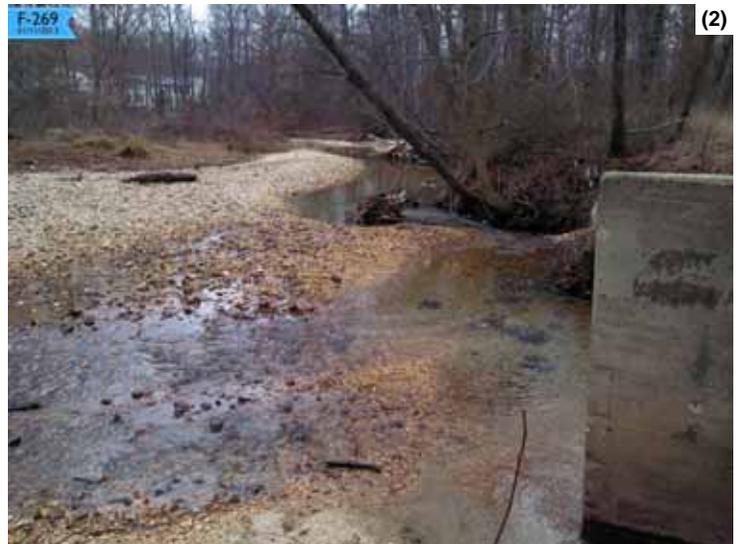
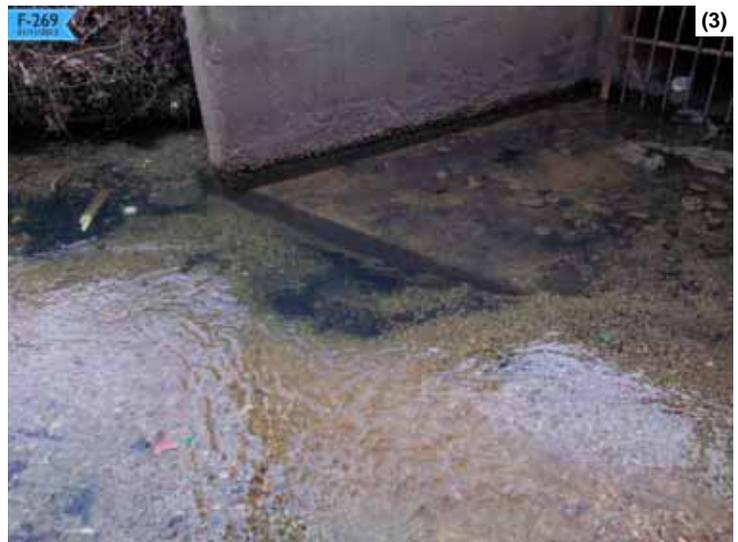
Stream Bank / Pool	<input type="text" value="2"/>	<input type="text" value="Active Erosion"/>	Repairs Recommended? YES
Stream Bank / Pool (x2)	<input type="text" value="4"/>		
Structure	<input type="text" value="0"/>	<input type="text" value="Excellent / Like New"/>	
Criticality	<input type="text" value="0"/>	<input type="text" value="Normal"/>	
Total Score	<input type="text" value="4"/>	<small>Total = Stream Bank / Pool x2 + Structure + Criticality</small>

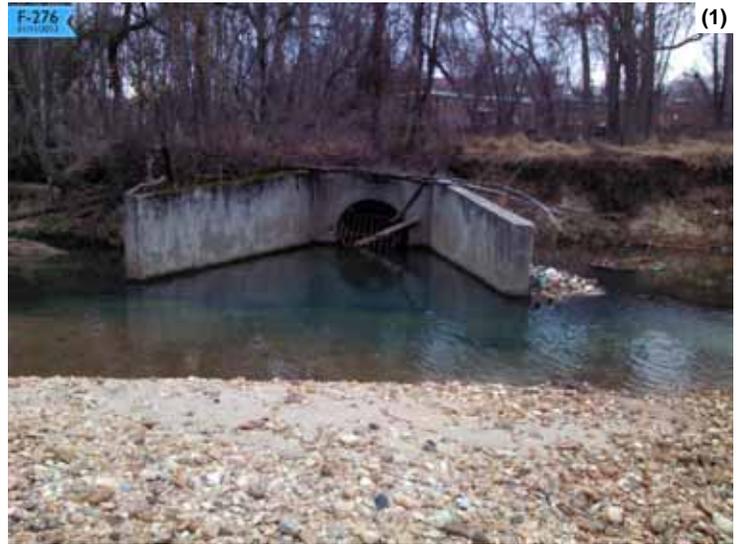
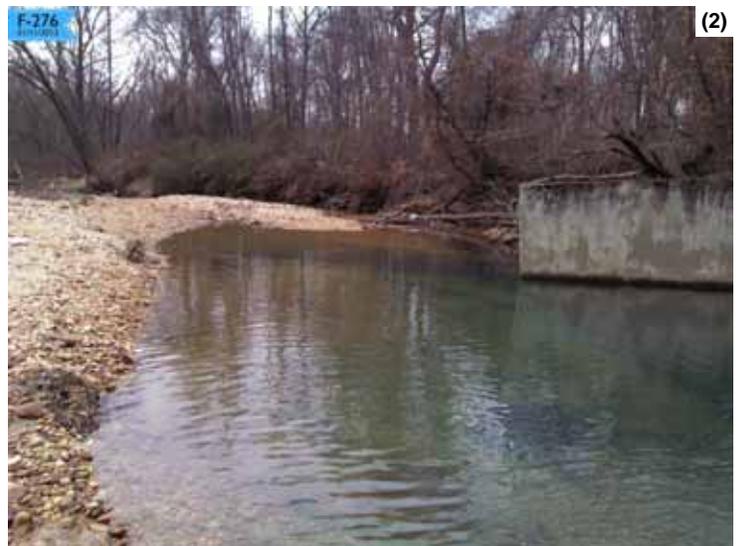
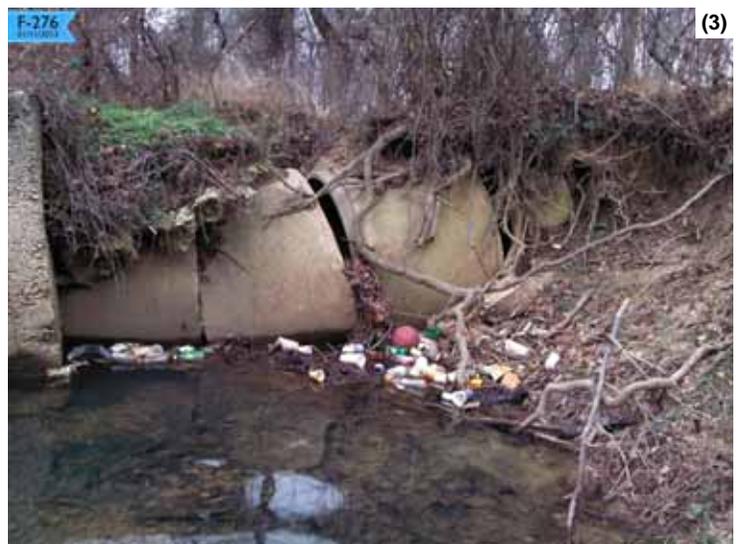
Stream Bank / Pool	<input type="text" value="2"/>	<input type="text" value="Active Erosion"/>	Repairs Recommended? <input checked="" type="checkbox"/> YES
Stream Bank / Pool (x2)	<input type="text" value="4"/>		
Structure	<input type="text" value="2"/>	<input type="text" value="Poor"/>	
Criticality	<input type="text" value="0"/>	<input type="text" value="Normal"/>	
Total Score	<input type="text" value="6"/>	<small>Total = Stream Bank / Pool x2 + Structure + Criticality</small>

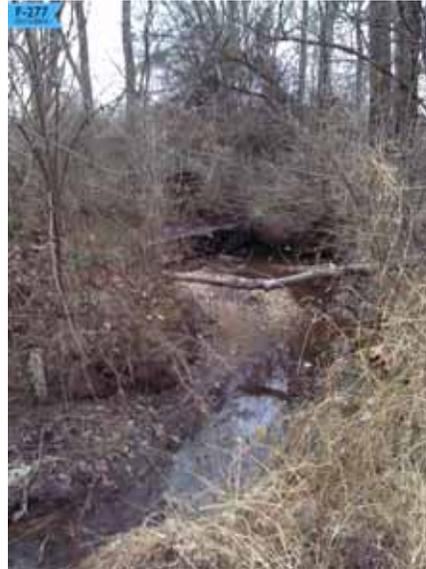
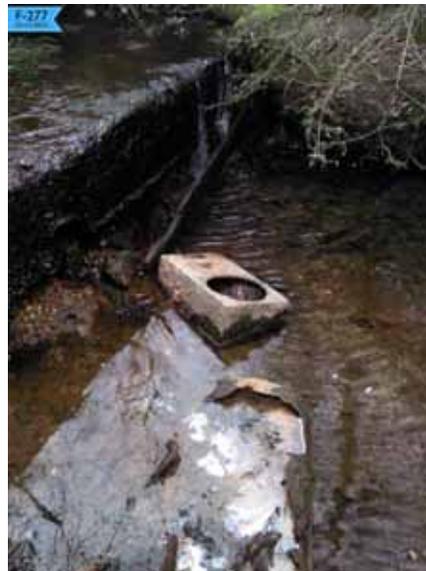
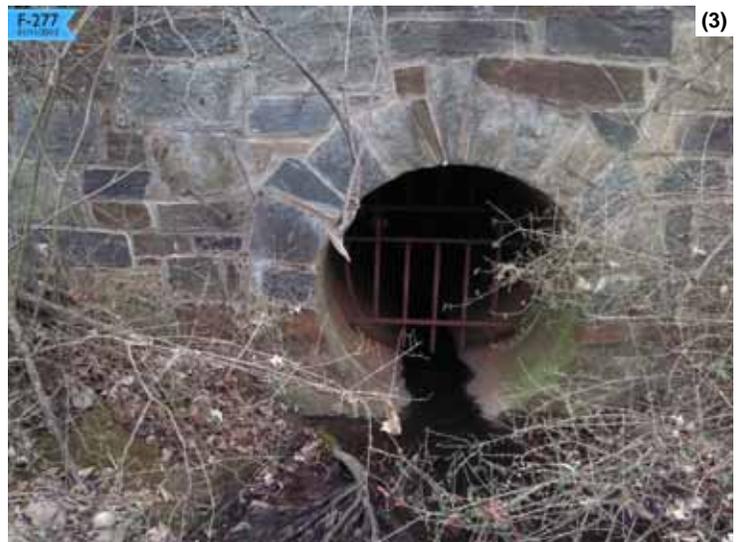
Stream Bank / Pool	<input type="text" value="2"/>	<input type="text" value="Active Erosion"/>	Repairs Recommended? YES
Stream Bank / Pool (x2)	<input type="text" value="4"/>		
Structure	<input type="text" value="0"/>	<input type="text" value="Excellent / Like New"/>	
Criticality	<input type="text" value="0"/>	<input type="text" value="Normal"/>	
Total Score	<input type="text" value="4"/>	<small>Total = Stream Bank / Pool x2 + Structure + Criticality</small>

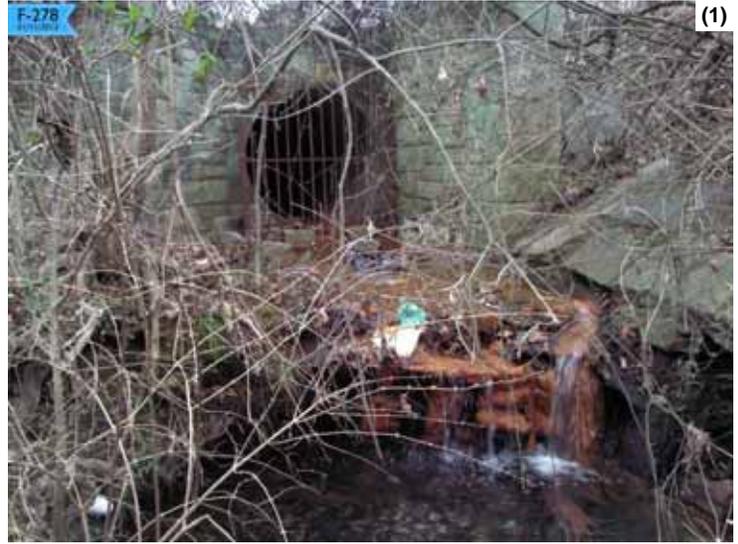
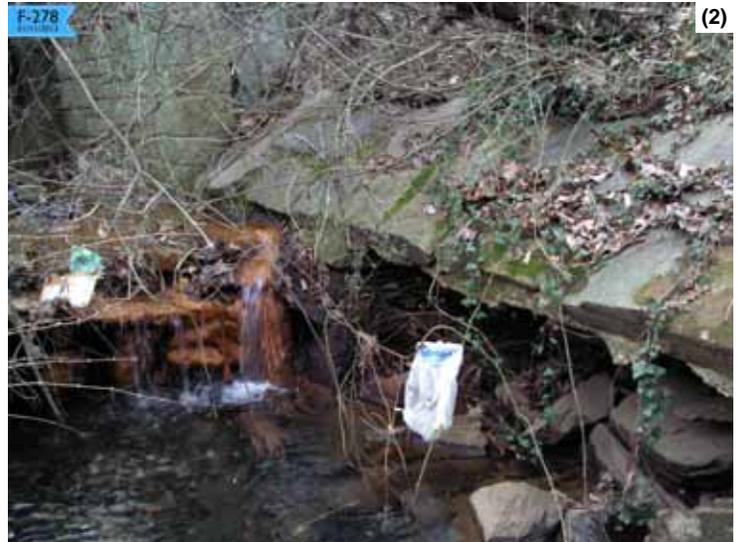
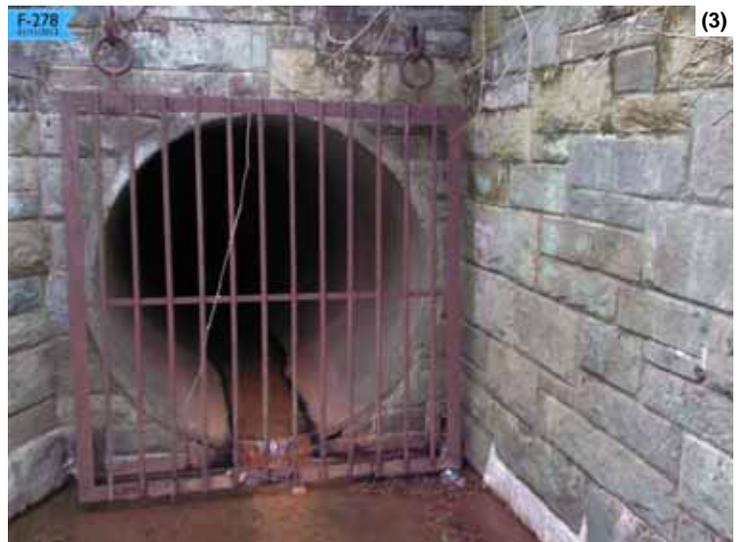
Stream Bank / Pool	<input type="text" value="2"/>	Active Erosion	Repairs Recommended? YES
Stream Bank / Pool (x2)	<input type="text" value="4"/>		
Structure	<input type="text" value="1"/>	Moderate	
Criticality	<input type="text" value="0"/>	Normal	
Total Score	<input type="text" value="5"/>	<small>Total = Stream Bank / Pool x2 + Structure + Criticality</small>

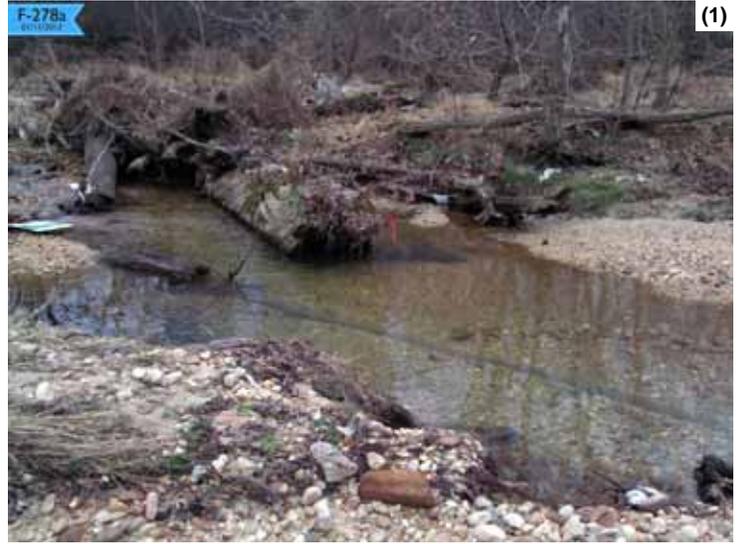
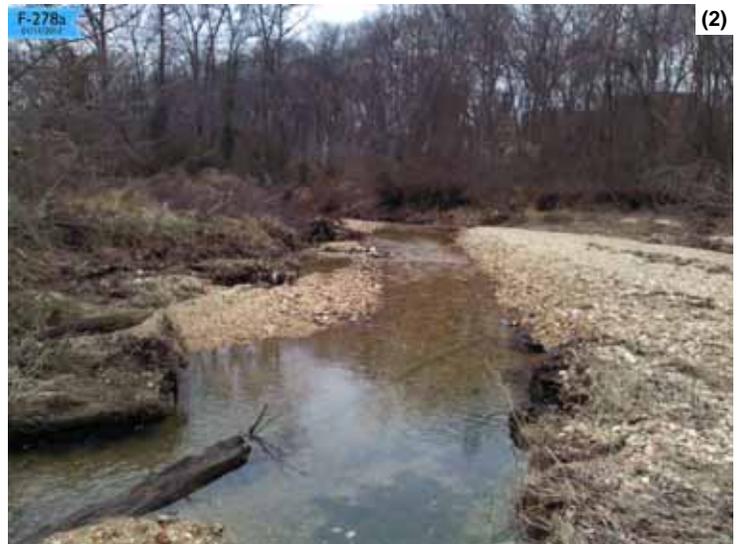
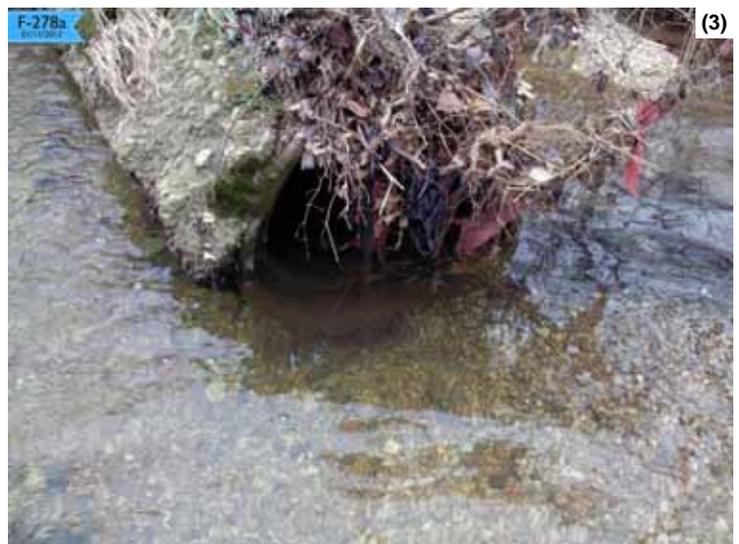
Stream Bank / Pool	<input type="text" value="1"/>	<input type="text" value="Some Erosion"/>	Repairs Recommended? NO
Stream Bank / Pool (x2)	<input type="text" value="2"/>		
Structure	<input type="text" value="2"/>	<input type="text" value="Poor"/>	
Criticality	<input type="text" value="0"/>	<input type="text" value="Normal"/>	
Total Score	<input type="text" value="4"/>	<small>Total = Stream Bank / Pool x2 + Structure + Criticality</small>

Appears to be a broken abandoned SS in the creek.

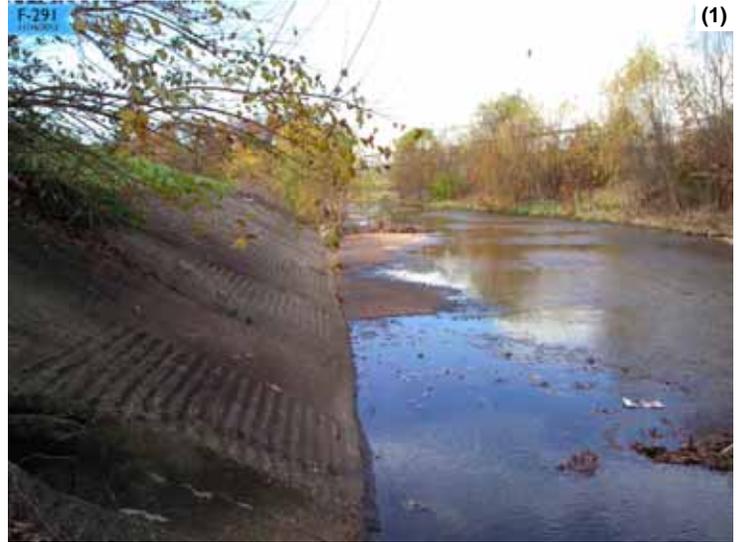
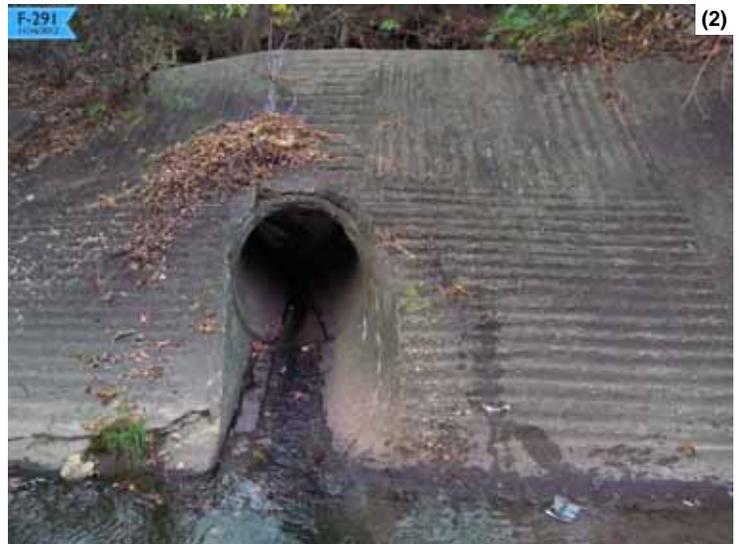
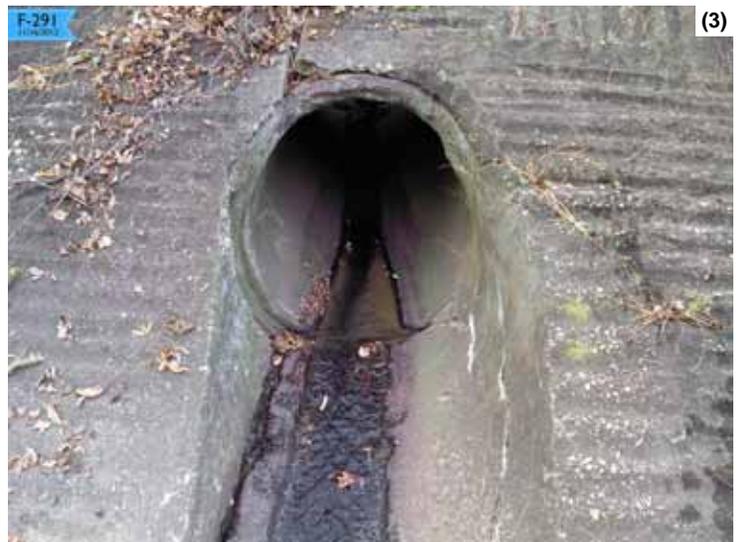
Stream Bank / Pool	<input type="text" value="0"/>	<input type="text" value="Stable"/>	Repairs Recommended? YES
Stream Bank / Pool (x2)	<input type="text" value="0"/>		
Structure	<input type="text" value="3"/>	<input type="text" value="Very Poor"/>	
Criticality	<input type="text" value="1"/>	<input type="text" value="Important"/>	
Total Score	<input type="text" value="4"/>	<small>Total = Stream Bank / Pool x2 + Structure + Criticality</small>

Significant erosion and undercutting behind wall has led to failure of storm manhole.

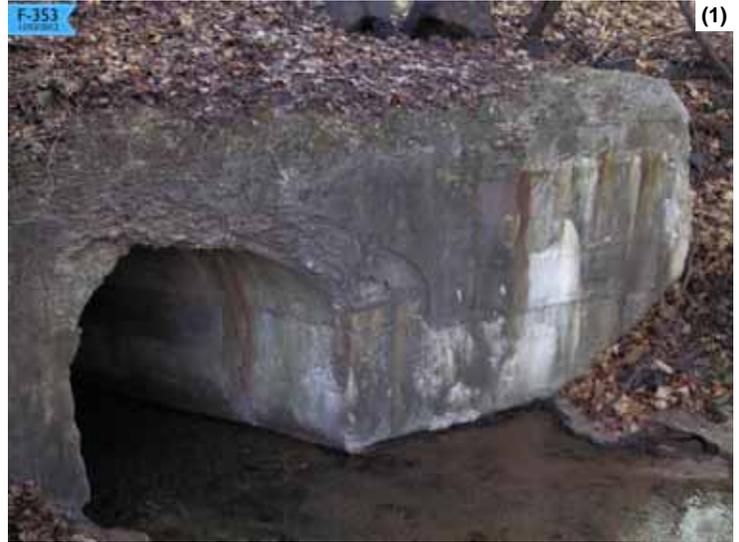
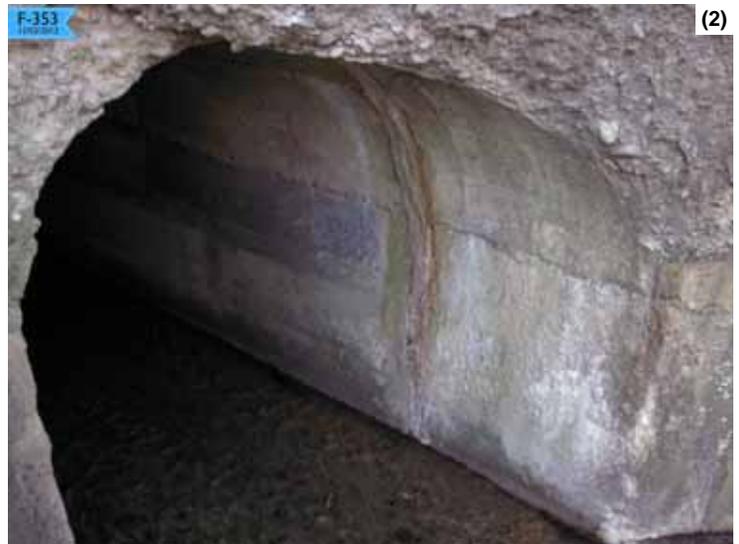
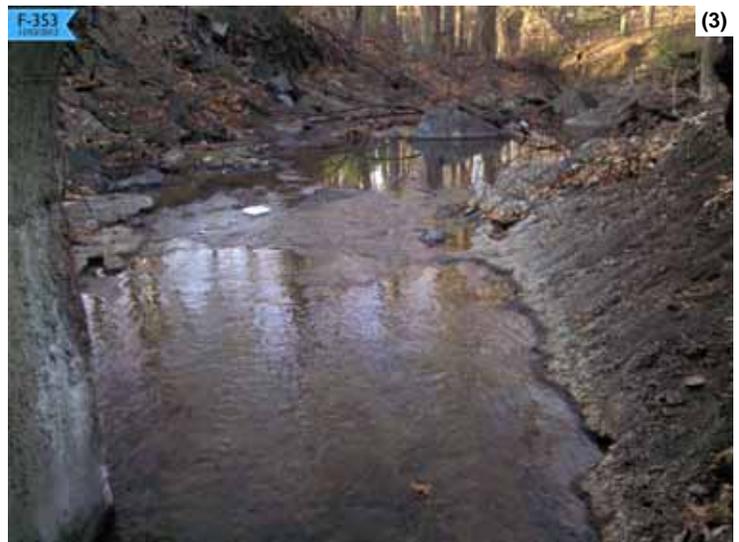
Stream Bank / Pool	<input type="text" value="2"/>	<input type="text" value="Active Erosion"/>	Repairs Recommended? NO
Stream Bank / Pool (x2)	<input type="text" value="4"/>		
Structure	<input type="text" value="0"/>	<input type="text" value="Excellent / Like New"/>	
Criticality	<input type="text" value="0"/>	<input type="text" value="Normal"/>	
Total Score	<input type="text" value="4"/>	<small>Total = Stream Bank / Pool x2 + Structure + Criticality</small>

Description of Repair Approach

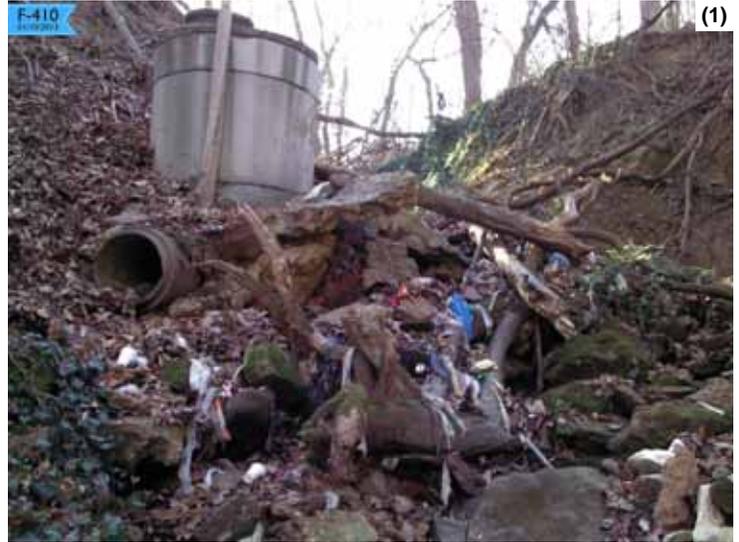
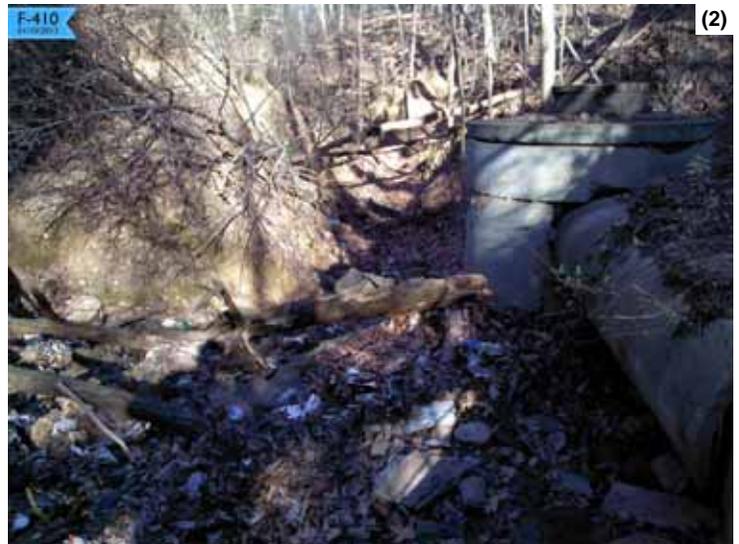
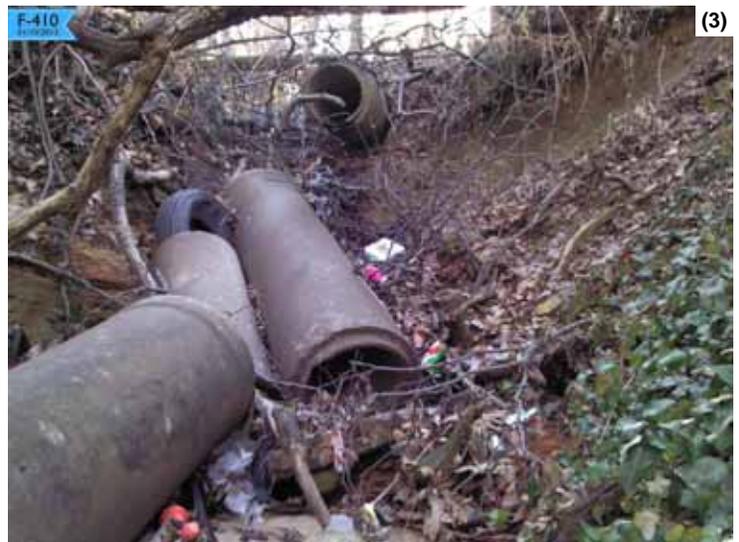
Stream Bank / Pool	<input type="text" value="3"/>	<input type="text" value="Severe Erosion"/>	Repairs Recommended? YES
Stream Bank / Pool (x2)	<input type="text" value="6"/>		
Structure	<input type="text" value="3"/>	<input type="text" value="Very Poor"/>	
Criticality	<input type="text" value="0"/>	<input type="text" value="Normal"/>	
Total Score	<input type="text" value="9"/>	<small>Total = Stream Bank / Pool x2 + Structure + Criticality</small>

Description of Repair Approach

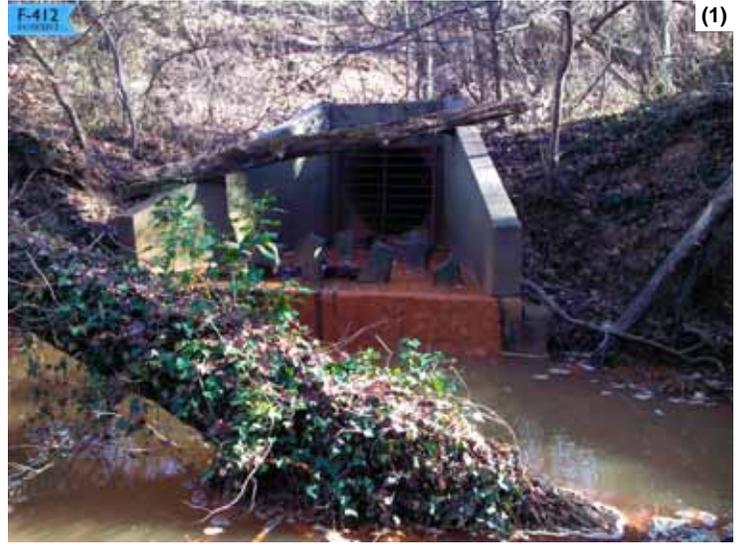
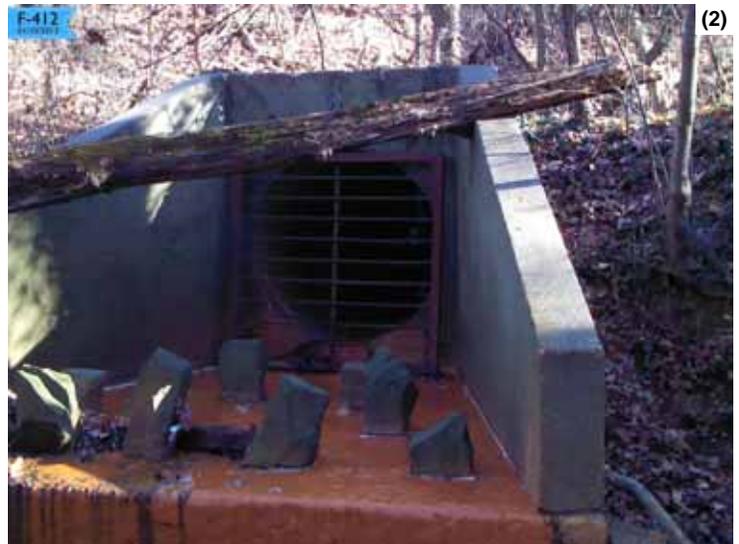
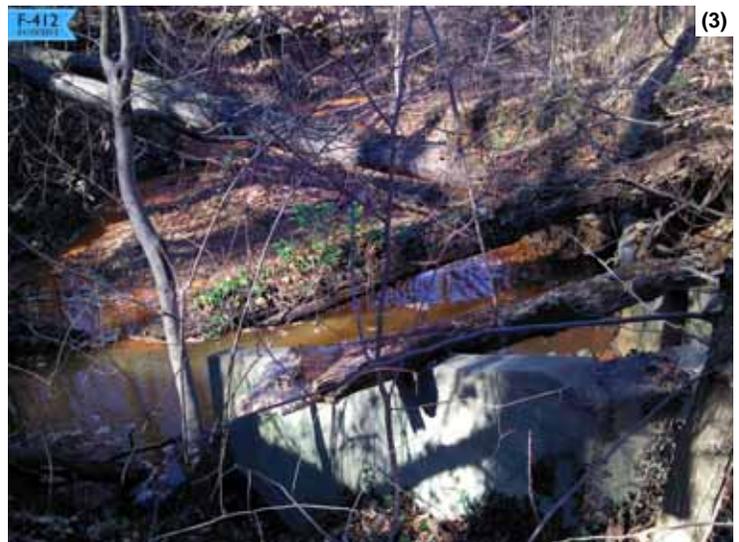
Stream Bank / Pool	<input type="text" value="2"/>	<input type="text" value="Active Erosion"/>	Repairs Recommended? YES
Stream Bank / Pool (x2)	<input type="text" value="4"/>		
Structure	<input type="text" value="0"/>	<input type="text" value="Excellent / Like New"/>	
Criticality	<input type="text" value="0"/>	<input type="text" value="Normal"/>	
Total Score	<input type="text" value="4"/>	<small>Total = Stream Bank / Pool x2 + Structure + Criticality</small>

Description of Repair Approach

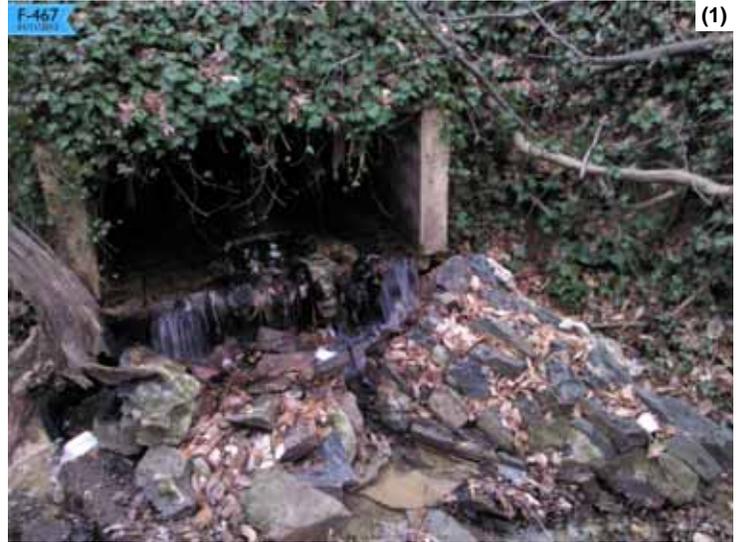
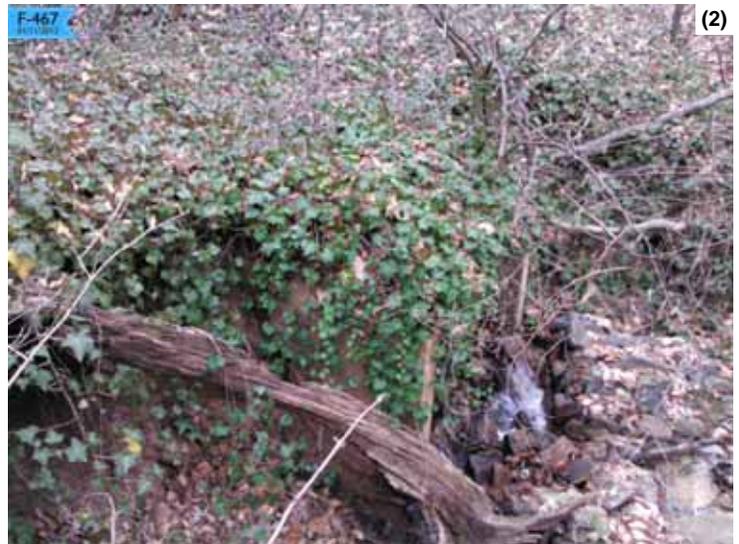
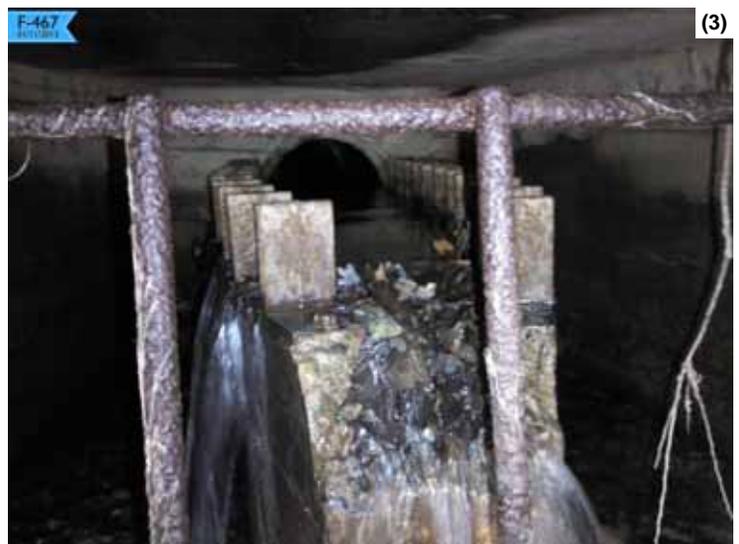
Stream Bank / Pool	<input type="text" value="3"/>	<input type="text" value="Severe Erosion"/>	Repairs Recommended? YES
Stream Bank / Pool (x2)	<input type="text" value="6"/>		
Structure	<input type="text" value="1"/>	<input type="text" value="Moderate"/>	
Criticality	<input type="text" value="0"/>	<input type="text" value="Normal"/>	
Total Score	<input type="text" value="7"/>	<small>Total = Stream Bank / Pool x2 + Structure + Criticality</small>

Description of Repair Approach

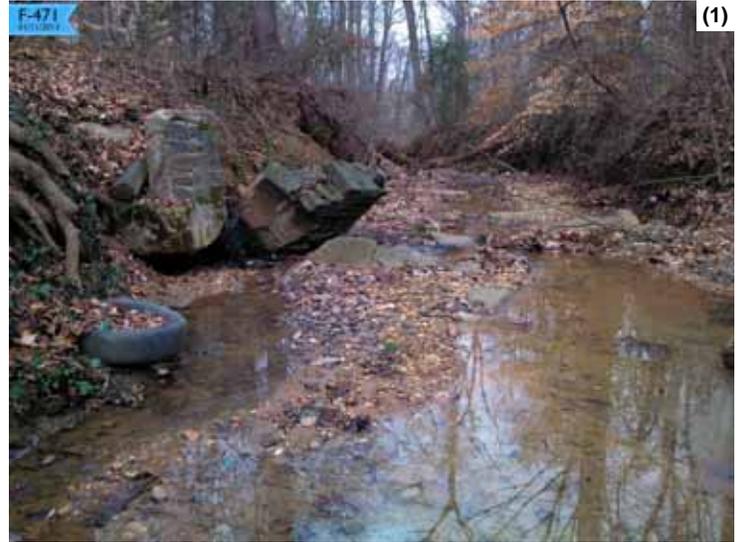
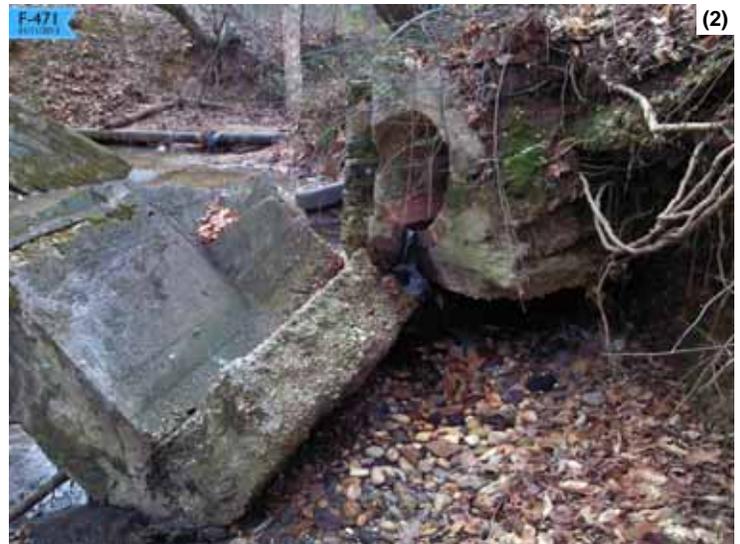
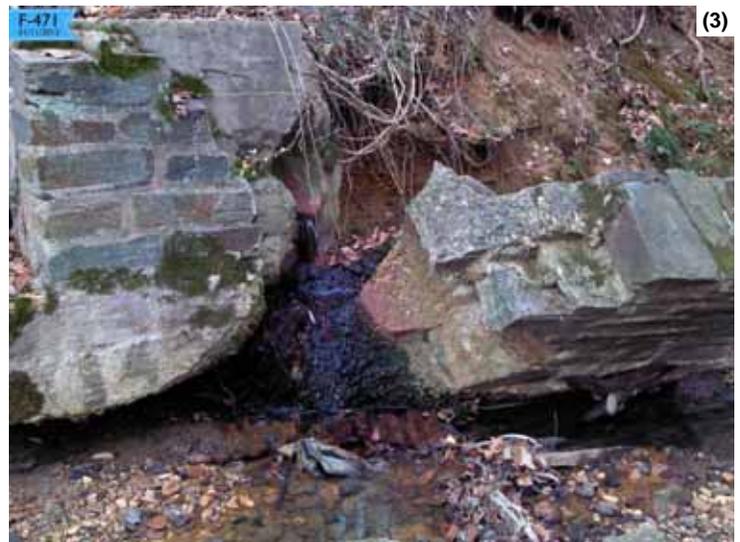
Stream Bank / Pool	<input type="text" value="3"/>	<input type="text" value="Severe Erosion"/>	Repairs Recommended? YES
Stream Bank / Pool (x2)	<input type="text" value="6"/>		
Structure	<input type="text" value="2"/>	<input type="text" value="Poor"/>	
Criticality	<input type="text" value="0"/>	<input type="text" value="Normal"/>	
Total Score	<input type="text" value="8"/>	<small>Total = Stream Bank / Pool x2 + Structure + Criticality</small>

Description of Repair Approach

Point Repair

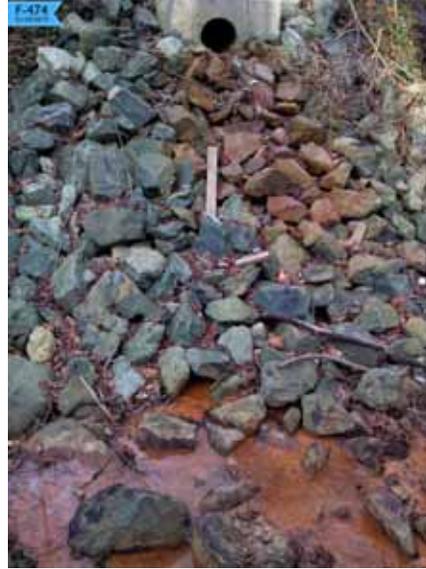
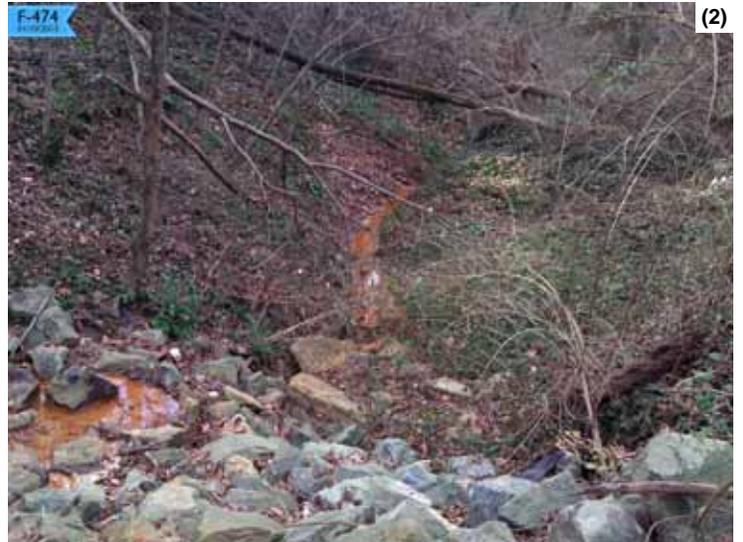
Stream Bank / Pool	<input type="text" value="2"/>	<input type="text" value="Active Erosion"/>	Repairs Recommended? NO
Stream Bank / Pool (x2)	<input type="text" value="4"/>		
Structure	<input type="text" value="0"/>	<input type="text" value="Excellent / Like New"/>	
Criticality	<input type="text" value="0"/>	<input type="text" value="Normal"/>	
Total Score	<input type="text" value="4"/>	<i>Total = Stream Bank / Pool x2 + Structure + Criticality</i>

Description of Repair Approach

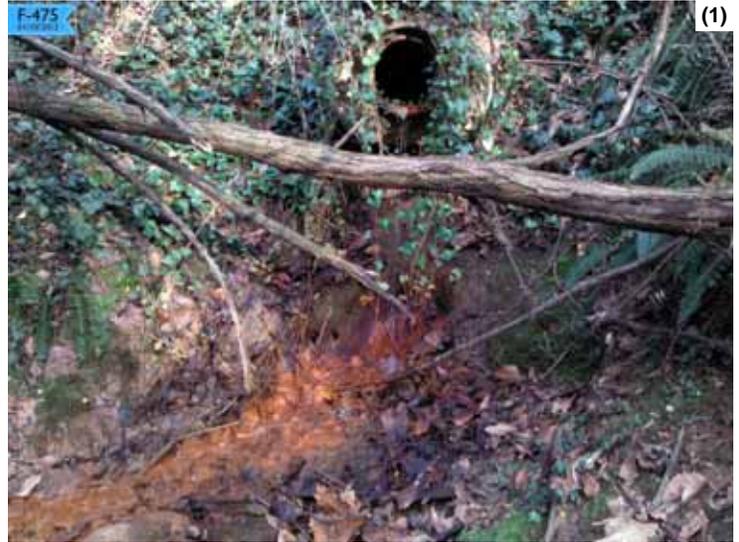
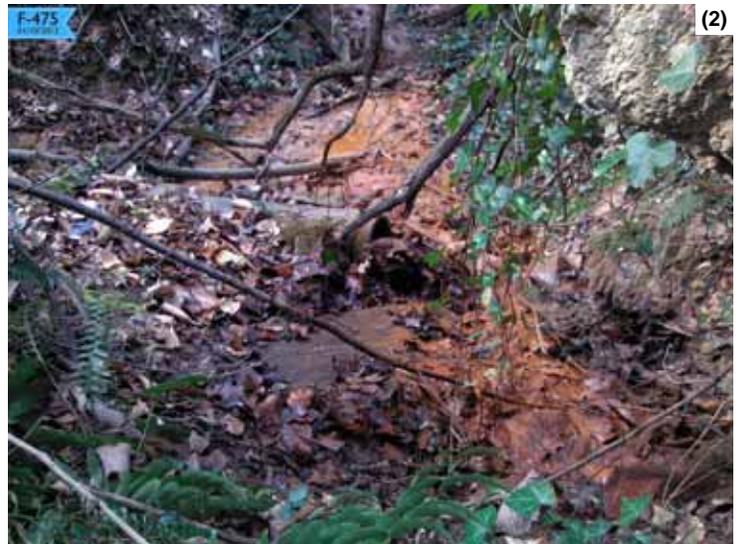
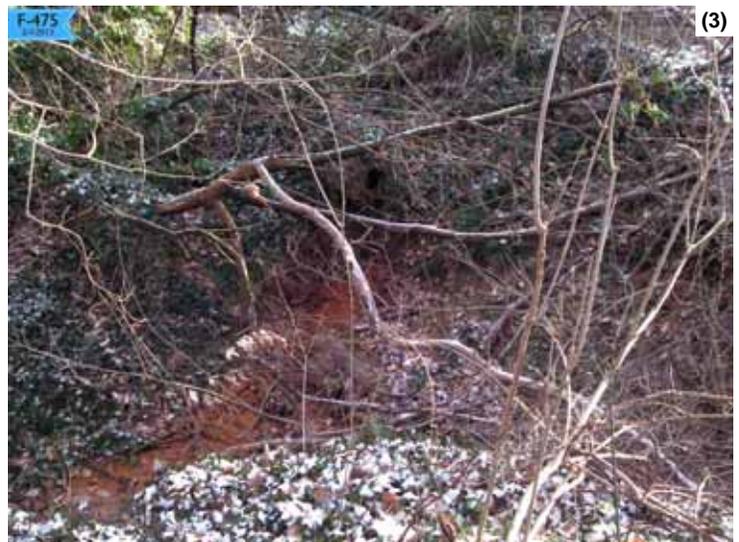
Stream Bank / Pool	<input type="text" value="3"/>	<input type="text" value="Severe Erosion"/>	Repairs Recommended? YES
Stream Bank / Pool (x2)	<input type="text" value="6"/>		
Structure	<input type="text" value="3"/>	<input type="text" value="Very Poor"/>	
Criticality	<input type="text" value="0"/>	<input type="text" value="Normal"/>	
Total Score	<input type="text" value="9"/>	<small>Total = Stream Bank / Pool x2 + Structure + Criticality</small>

Description of Repair Approach

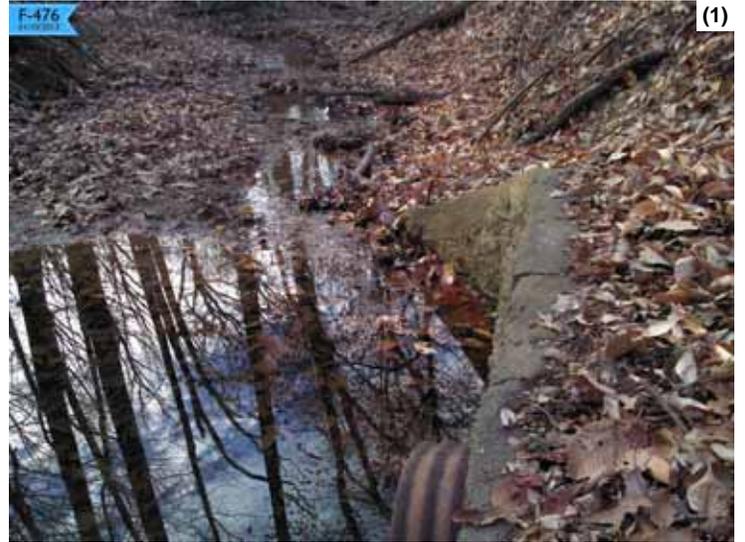
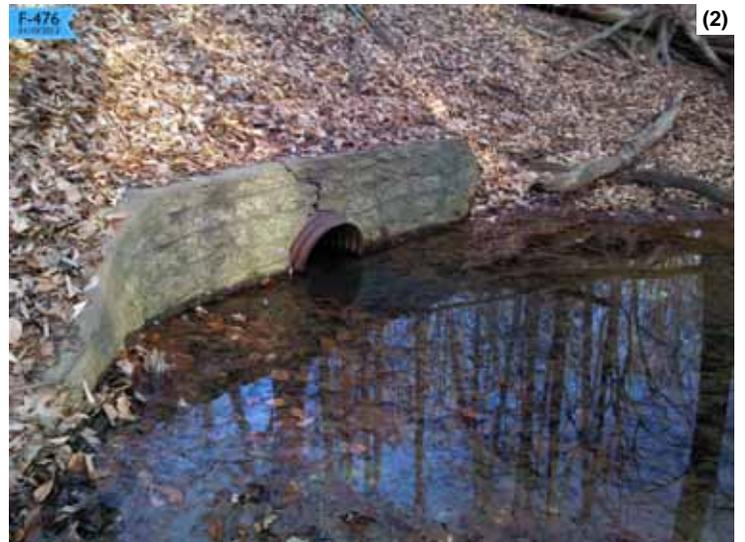
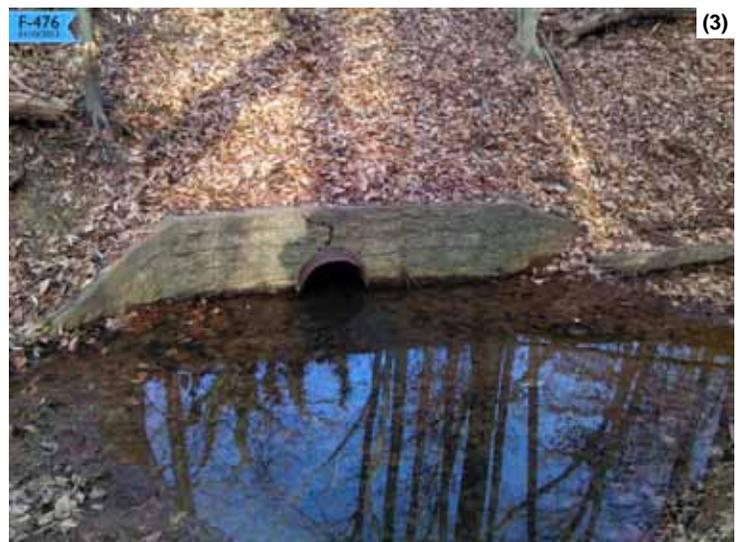
Stream Bank / Pool	<input type="text" value="2"/>	<input type="text" value="Active Erosion"/>	Repairs Recommended? NO
Stream Bank / Pool (x2)	<input type="text" value="4"/>		
Structure	<input type="text" value="0"/>	<input type="text" value="Excellent / Like New"/>	
Criticality	<input type="text" value="0"/>	<input type="text" value="Normal"/>	
Total Score	<input type="text" value="4"/>	<small>Total = Stream Bank / Pool x2 + Structure + Criticality</small>

Description of Repair Approach

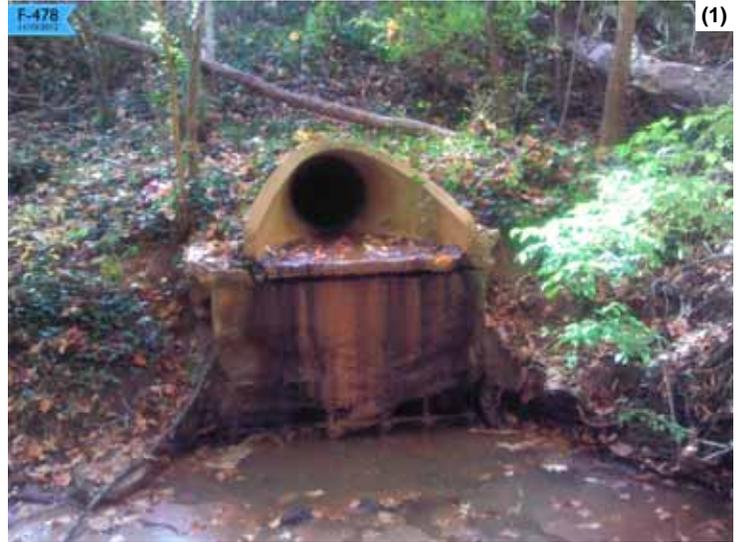
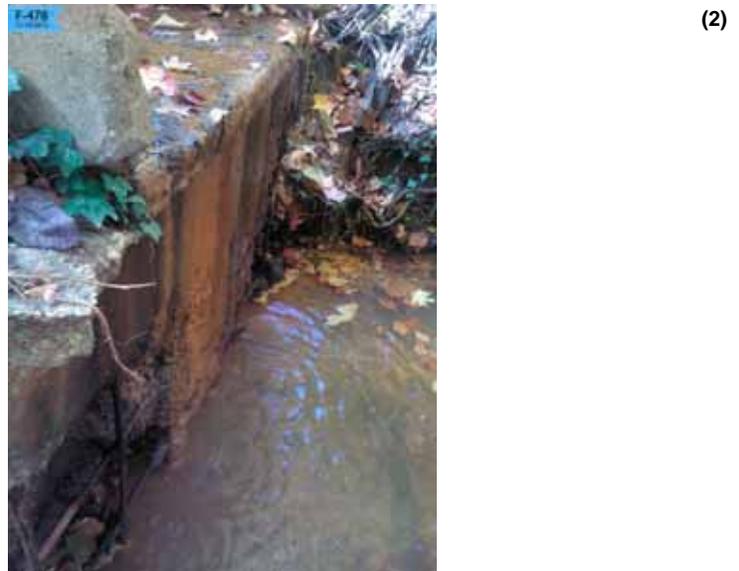
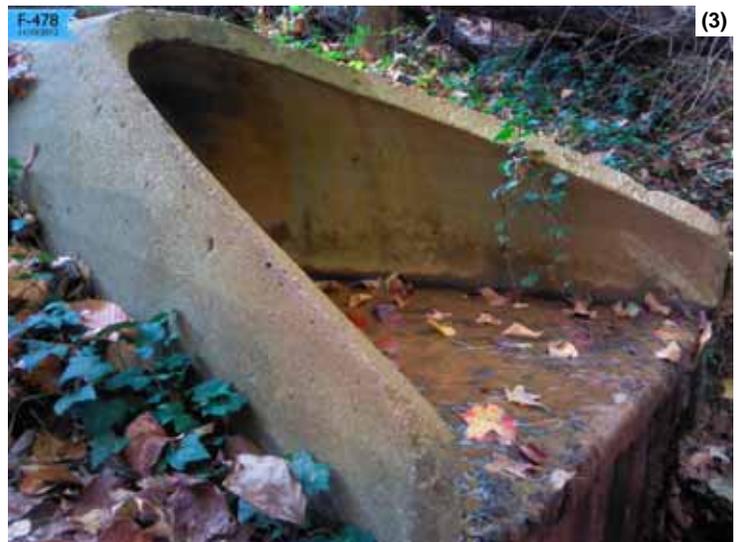
Stream Bank / Pool	<input type="text" value="2"/>	<input type="text" value="Active Erosion"/>	Repairs Recommended? NO
Stream Bank / Pool (x2)	<input type="text" value="4"/>		
Structure	<input type="text" value="1"/>	<input type="text" value="Moderate"/>	
Criticality	<input type="text" value="0"/>	<input type="text" value="Normal"/>	
Total Score	<input type="text" value="5"/>	<small>Total = Stream Bank / Pool x2 + Structure + Criticality</small>

Description of Repair Approach

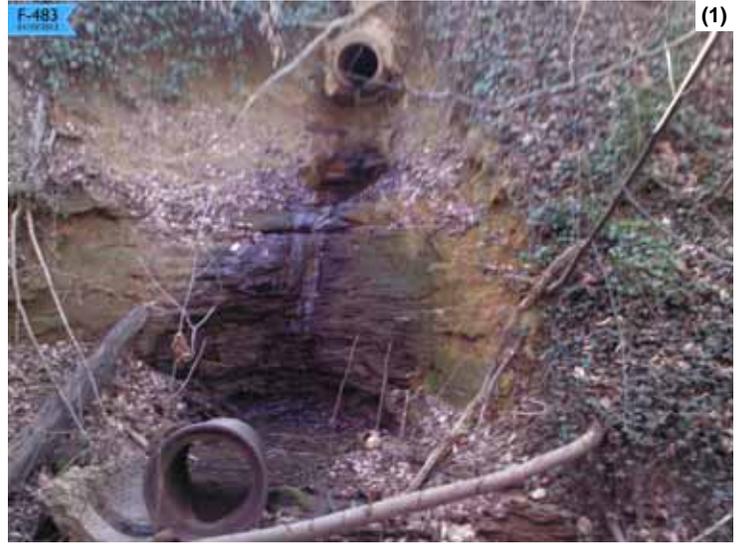
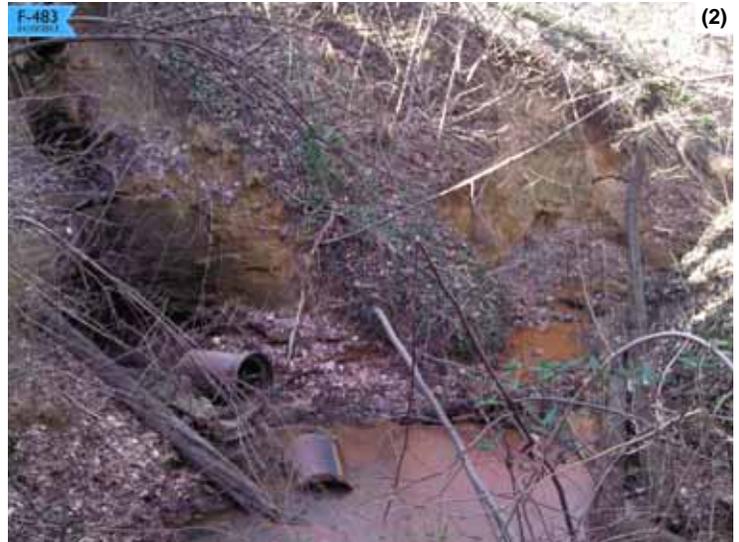
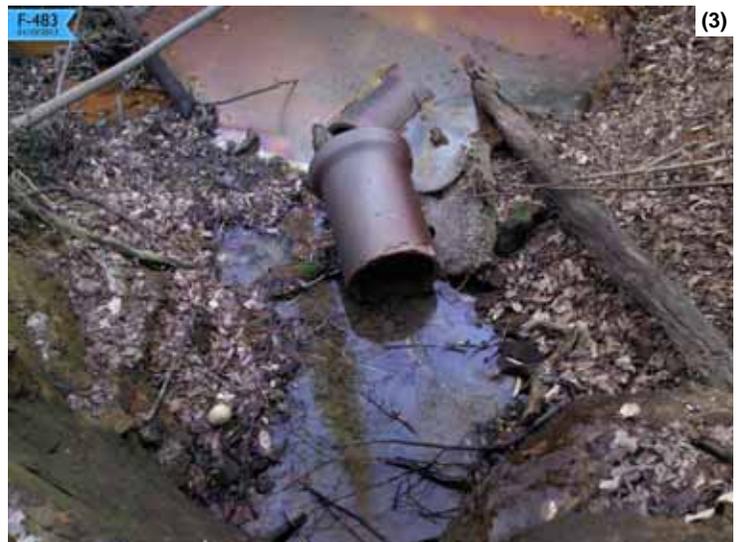
Stream Bank / Pool	<input type="text" value="3"/>	<input type="text" value="Severe Erosion"/>	Repairs Recommended? YES
Stream Bank / Pool (x2)	<input type="text" value="6"/>		
Structure	<input type="text" value="3"/>	<input type="text" value="Very Poor"/>	
Criticality	<input type="text" value="0"/>	<input type="text" value="Normal"/>	
Total Score	<input type="text" value="9"/>	<small>Total = Stream Bank / Pool x2 + Structure + Criticality</small>

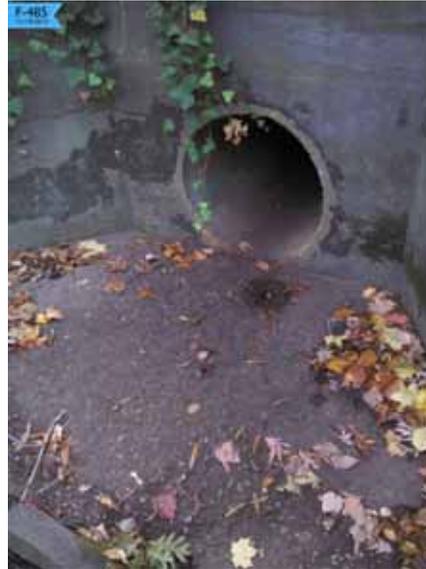
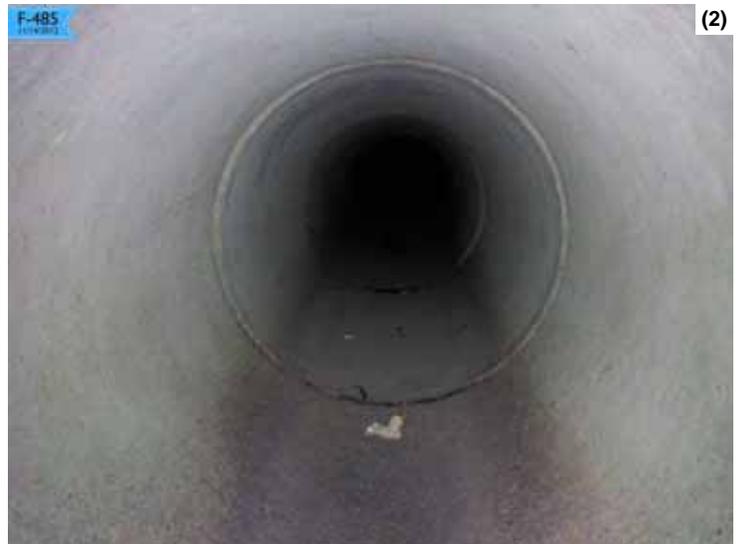
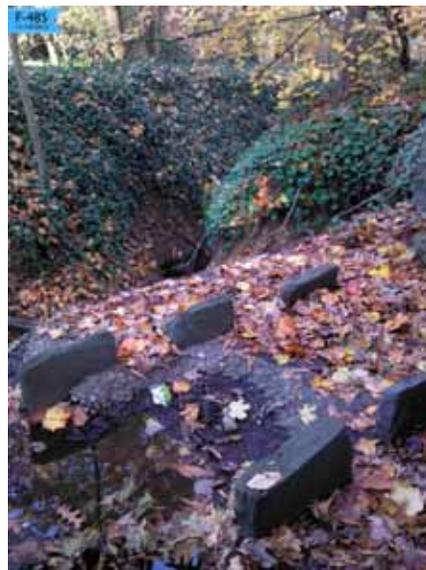
Stream Bank / Pool	<input type="text" value="3"/>	<input type="text" value="Severe Erosion"/>	Repairs Recommended? YES
Stream Bank / Pool (x2)	<input type="text" value="6"/>		
Structure	<input type="text" value="2"/>	<input type="text" value="Poor"/>	
Criticality	<input type="text" value="0"/>	<input type="text" value="Normal"/>	
Total Score	<input type="text" value="8"/>	<small>Total = Stream Bank / Pool x2 + Structure + Criticality</small>
