4.3 OUTFALL REPAIR SUMMARY REPORTS

OUTFALL SUMMARY REPORT

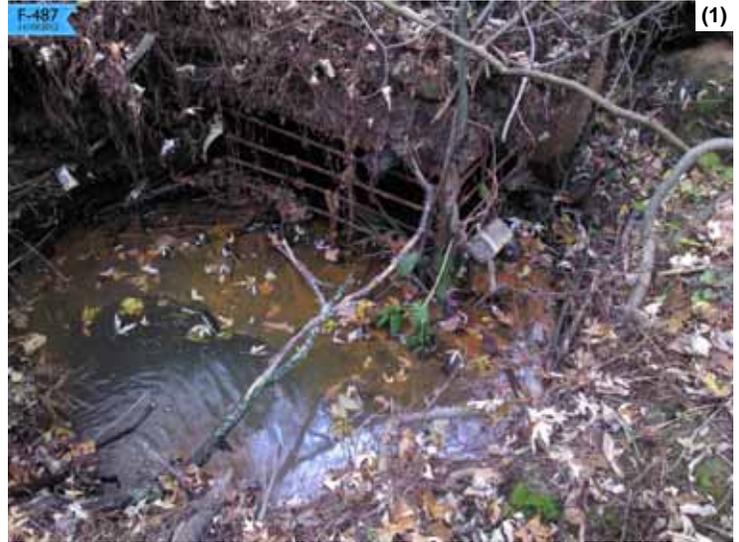
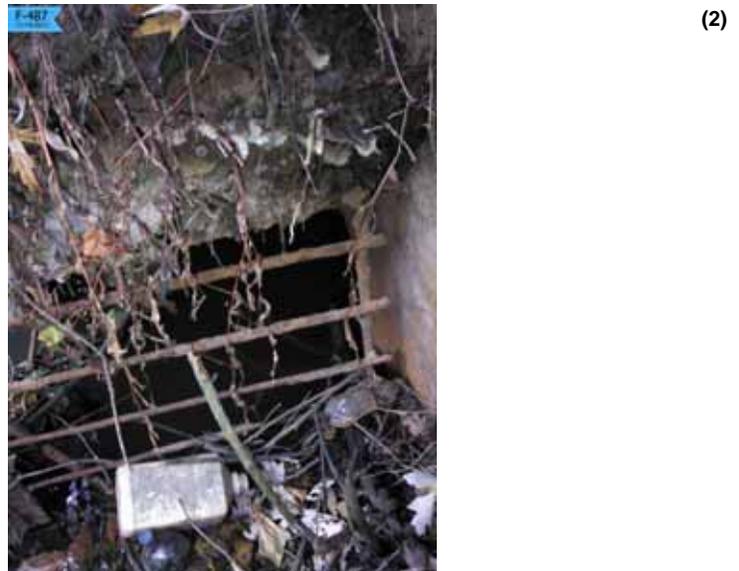
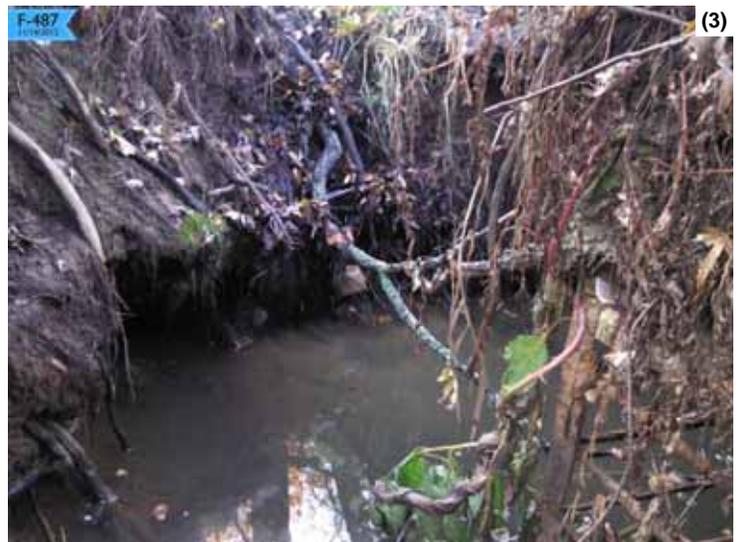
Stream Bank / Pool	<input type="text" value="1"/>	<input type="text" value="Some Erosion"/>	Repairs Recommended? YES
Stream Bank / Pool (x2)	<input type="text" value="2"/>		
Structure	<input type="text" value="2"/>	<input type="text" value="Poor"/>	
Criticality	<input type="text" value="0"/>	<input type="text" value="Normal"/>	
Total Score	<input type="text" value="4"/>	<small>Total = Stream Bank / Pool x2 + Structure + Criticality</small>

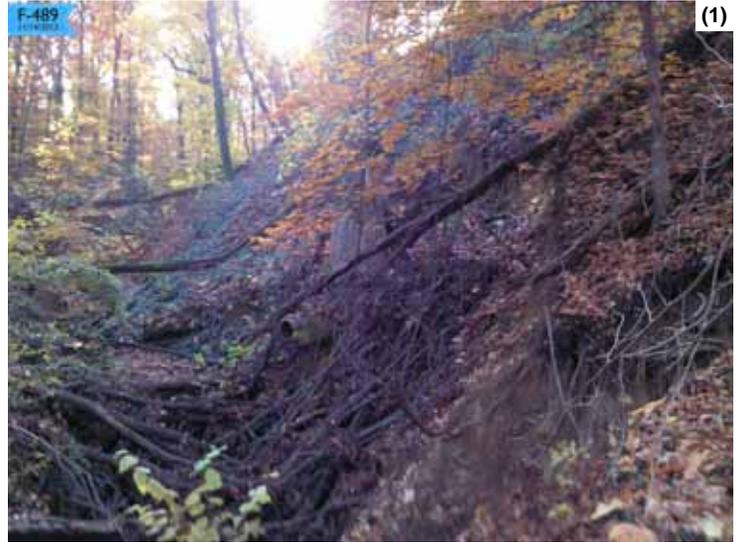
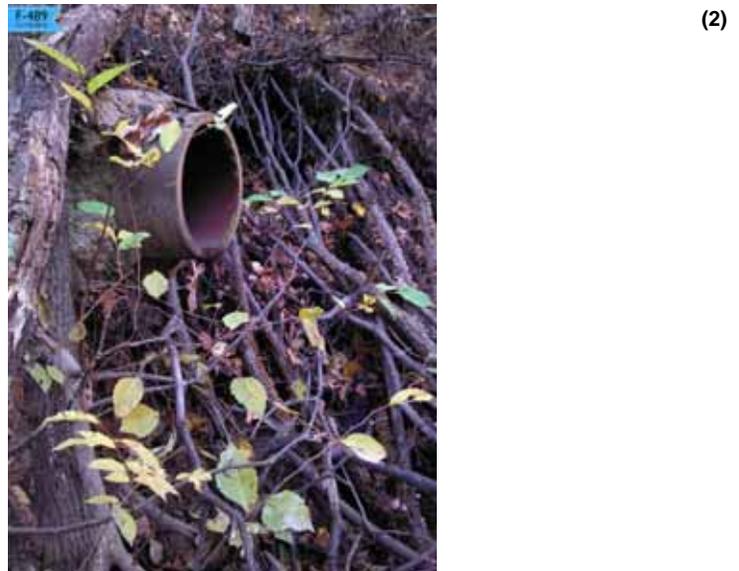
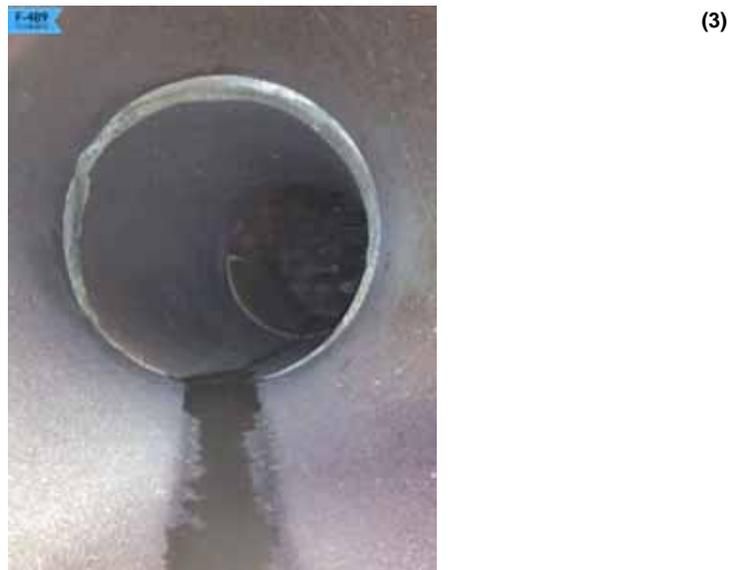
Stream Bank / Pool	<input type="text" value="2"/>	<input type="text" value="Active Erosion"/>	Repairs Recommended? YES
Stream Bank / Pool (x2)	<input type="text" value="4"/>		
Structure	<input type="text" value="2"/>	<input type="text" value="Poor"/>	
Criticality	<input type="text" value="0"/>	<input type="text" value="Normal"/>	
Total Score	<input type="text" value="6"/>	<small>Total = Stream Bank / Pool x2 + Structure + Criticality</small>

Severe erosion upstream, under pipe and downstream. Broken off headwall may be located under logs/brush pile.

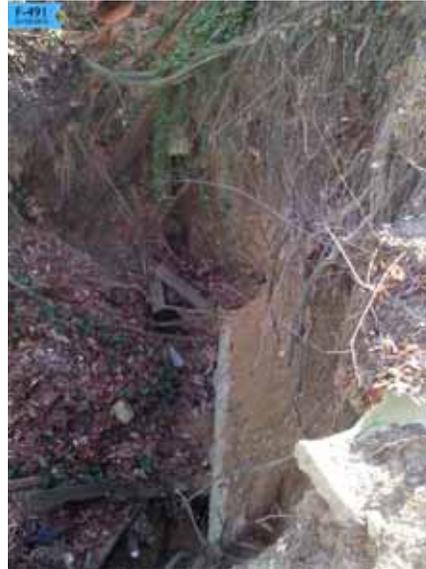
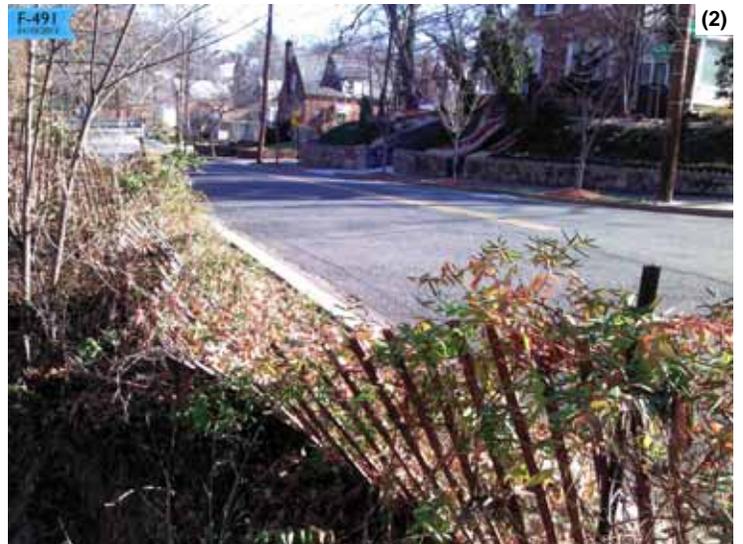
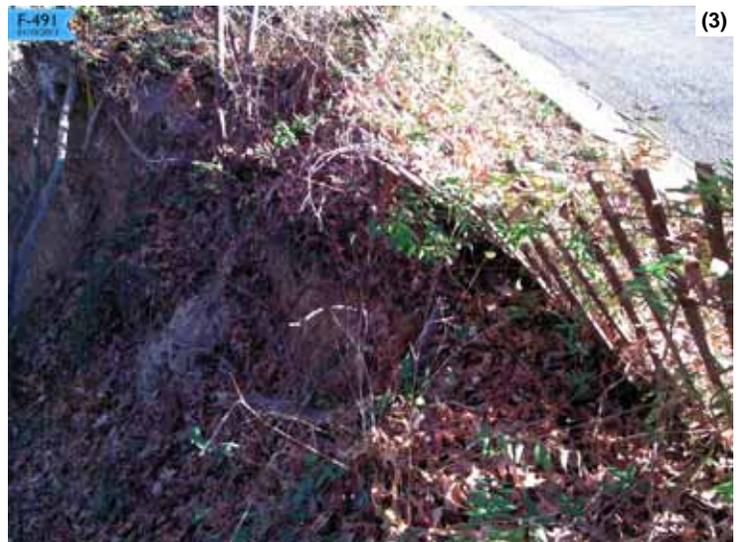
Stream Bank / Pool	<input type="text" value="3"/>	<input type="text" value="Severe Erosion"/>	Repairs Recommended? YES
Stream Bank / Pool (x2)	<input type="text" value="6"/>		
Structure	<input type="text" value="3"/>	<input type="text" value="Very Poor"/>	
Criticality	<input type="text" value="2"/>	<input type="text" value="Critical"/>	
Total Score	<input type="text" value="11"/>	<small>Total = Stream Bank / Pool x2 + Structure + Criticality</small>

Broken pipe and end structure. Severely eroded gully; depth approx 10-15 feet. Erosive sandy soils. Park Drive regenerative stormwater conveyance project is already in progress.

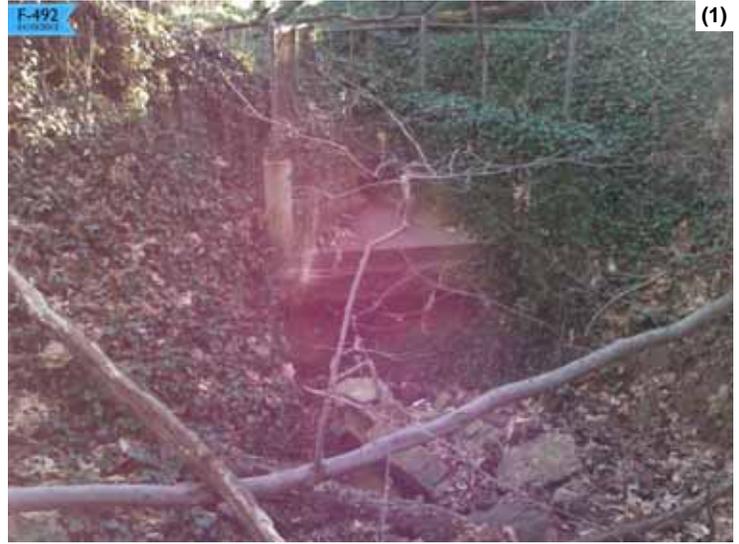
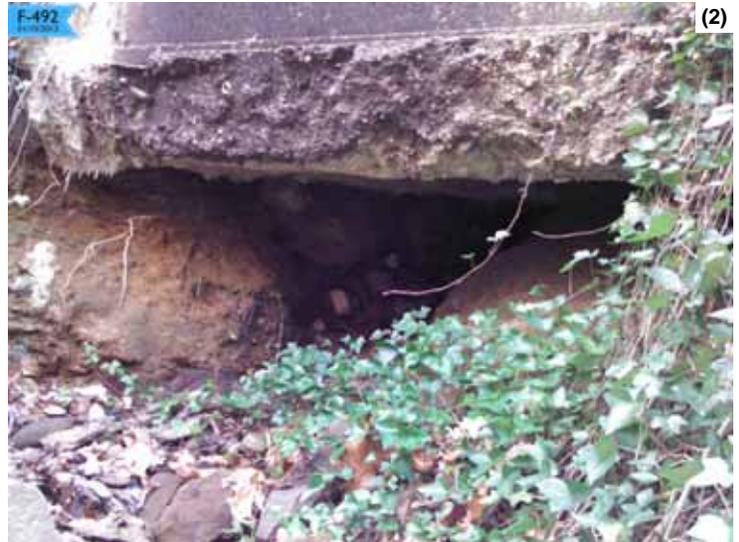
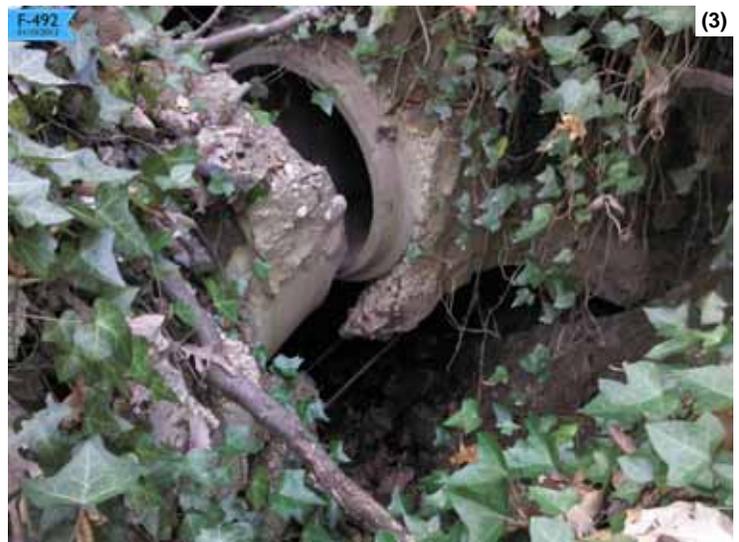
Stream Bank / Pool	<input type="text" value="3"/>	<input type="text" value="Severe Erosion"/>	Repairs Recommended? YES
Stream Bank / Pool (x2)	<input type="text" value="6"/>		
Structure	<input type="text" value="3"/>	<input type="text" value="Very Poor"/>	
Criticality	<input type="text" value="0"/>	<input type="text" value="Normal"/>	
Total Score	<input type="text" value="9"/>	<small>Total = Stream Bank / Pool x2 + Structure + Criticality</small>

Outfall has caused a erosion of a ravine downstream. Outfall structure has collapsed and been undermined. Water now flows from pipe behind headwall.

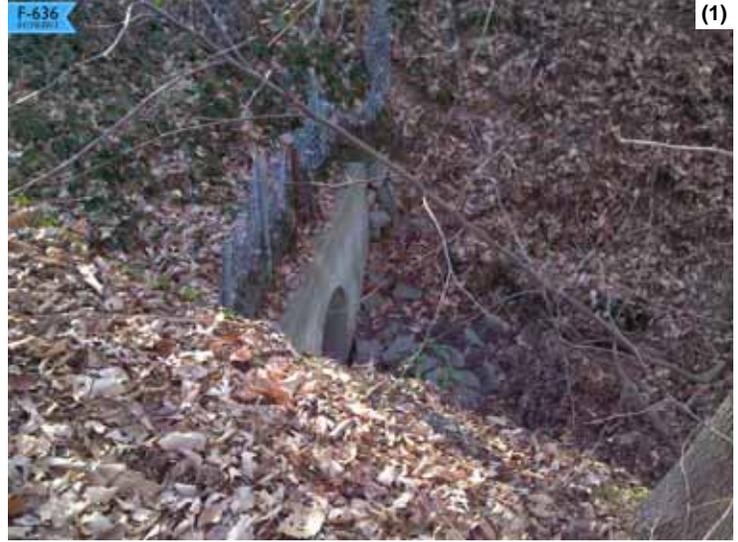
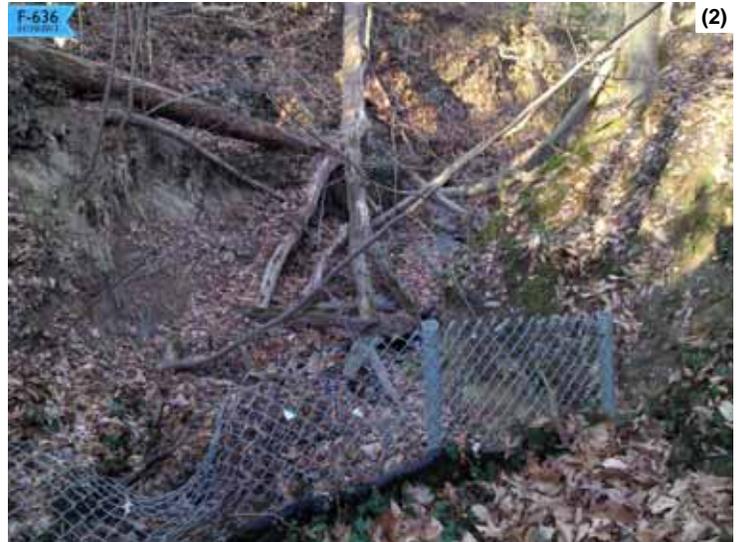
Stream Bank / Pool	<input type="text" value="3"/>	<input type="text" value="Severe Erosion"/>	Repairs Recommended? YES
Stream Bank / Pool (x2)	<input type="text" value="6"/>		
Structure	<input type="text" value="0"/>	<input type="text" value="Excellent / Like New"/>	
Criticality	<input type="text" value="0"/>	<input type="text" value="Normal"/>	
Total Score	<input type="text" value="6"/>	<small>Total = Stream Bank / Pool x2 + Structure + Criticality</small>

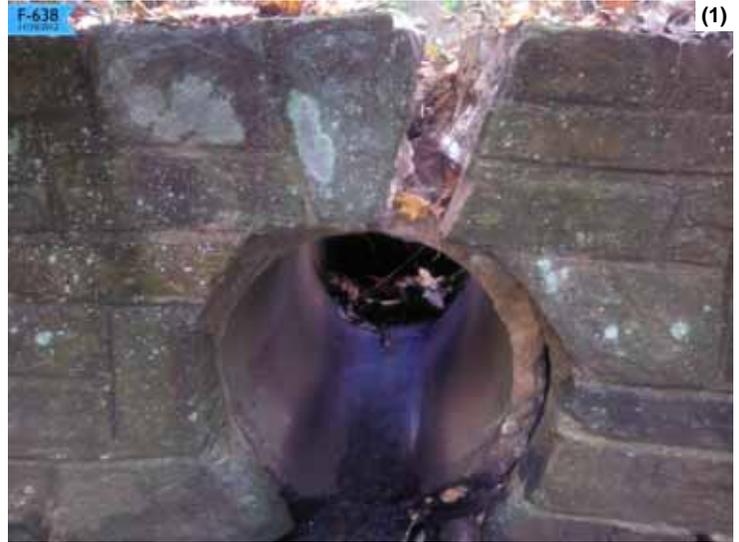
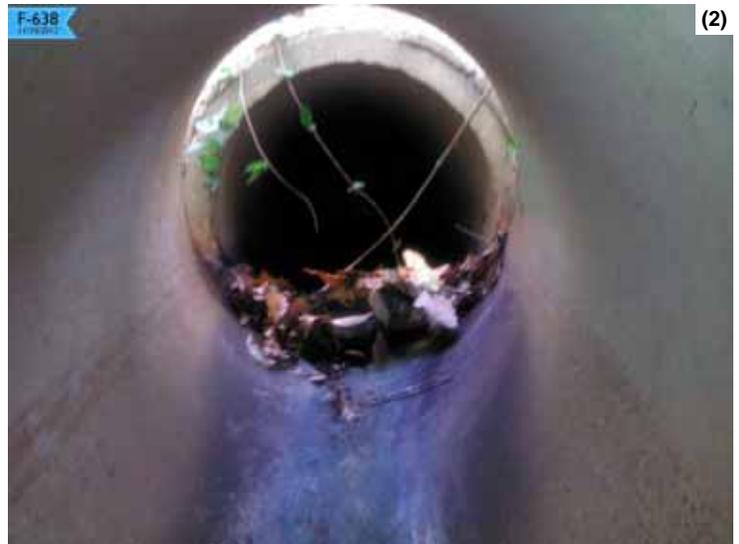
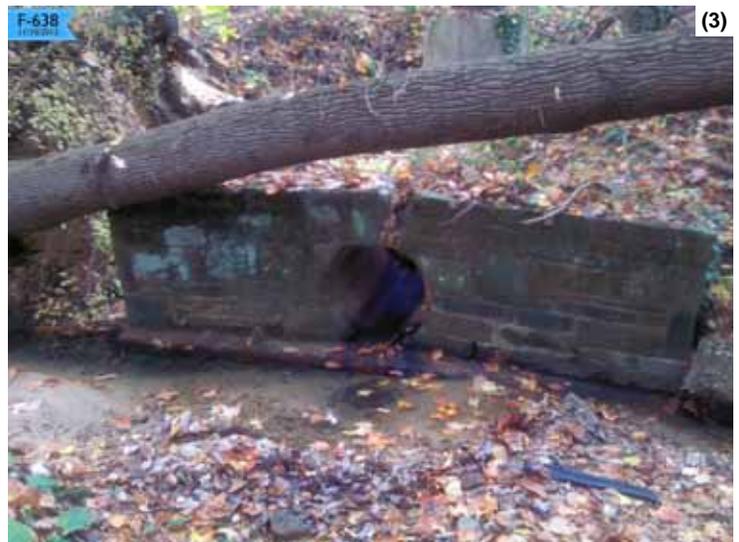
Stream Bank / Pool	<input type="text" value="2"/>	Active Erosion	Repairs Recommended? YES
Stream Bank / Pool (x2)	<input type="text" value="4"/>		
Structure	<input type="text" value="3"/>	Very Poor	
Criticality	<input type="text" value="0"/>	Normal	
Total Score	<input type="text" value="7"/>	<small>Total = Stream Bank / Pool x2 + Structure + Criticality</small>

Collapsed outfall with pipe separation at first joint. Note recent sanitary sewer point repair behind headwall. Evidence of downstream erosion but somewhat stable now.

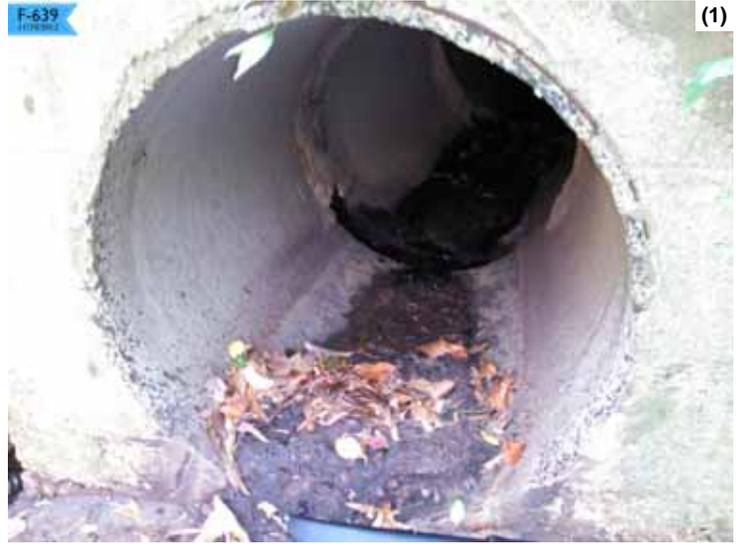
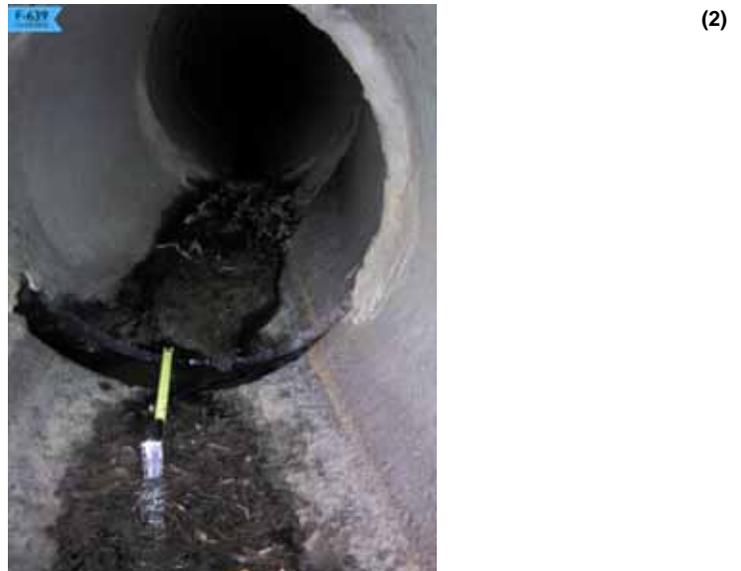
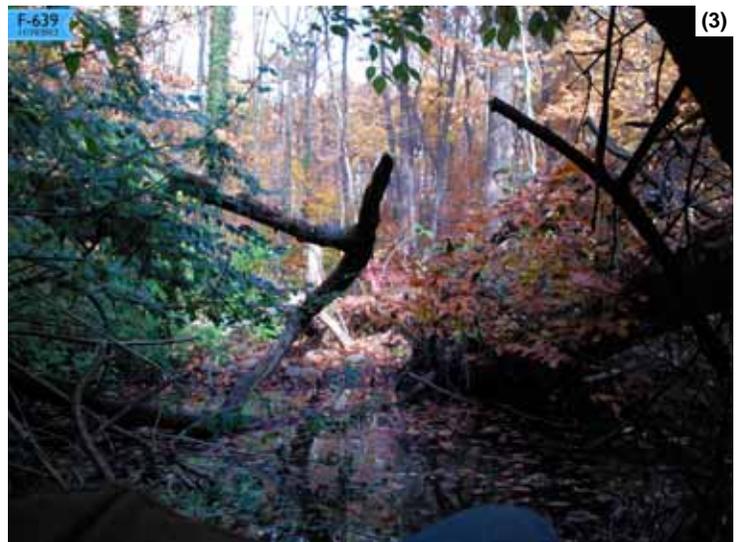
Stream Bank / Pool	<input type="text" value="2"/>	<input type="text" value="Active Erosion"/>	Repairs Recommended? YES
Stream Bank / Pool (x2)	<input type="text" value="4"/>		
Structure	<input type="text" value="1"/>	<input type="text" value="Moderate"/>	
Criticality	<input type="text" value="0"/>	<input type="text" value="Normal"/>	
Total Score	<input type="text" value="5"/>	<small>Total = Stream Bank / Pool x2 + Structure + Criticality</small>

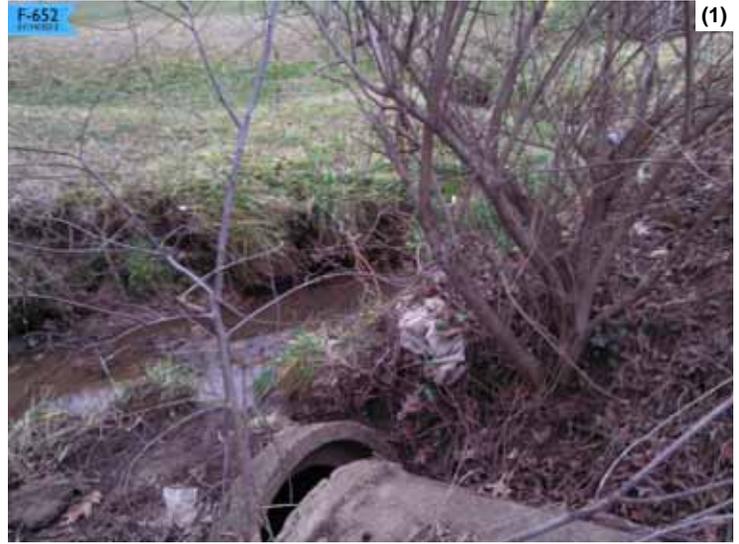
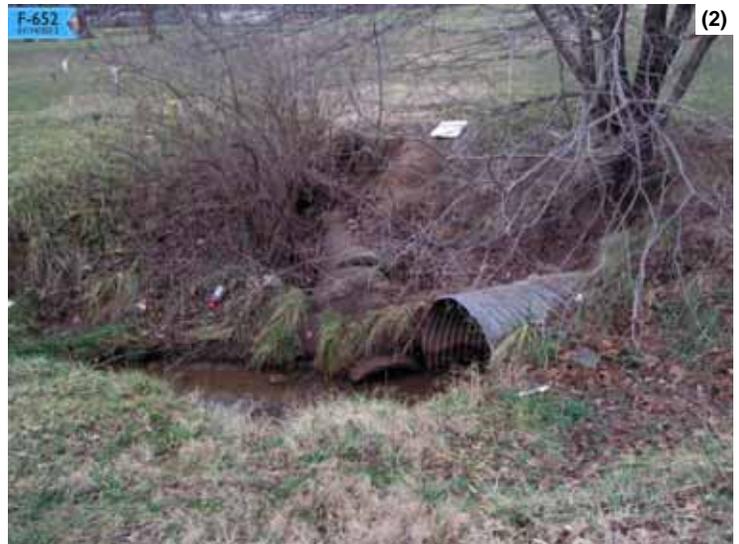
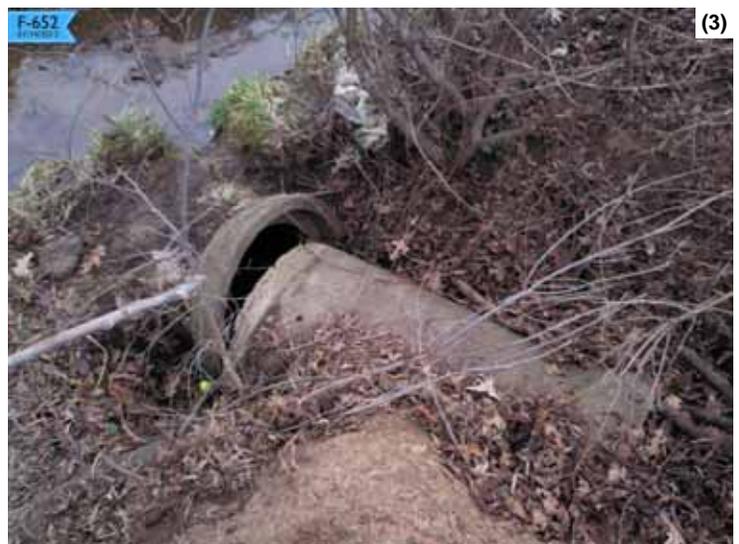
Stream Bank / Pool	<input type="text" value="2"/>	<input type="text" value="Active Erosion"/>	Repairs Recommended? YES
Stream Bank / Pool (x2)	<input type="text" value="4"/>		
Structure	<input type="text" value="2"/>	<input type="text" value="Poor"/>	
Criticality	<input type="text" value="0"/>	<input type="text" value="Normal"/>	
Total Score	<input type="text" value="6"/>	<i>Total = Stream Bank / Pool x2 + Structure + Criticality</i>

Point Repair

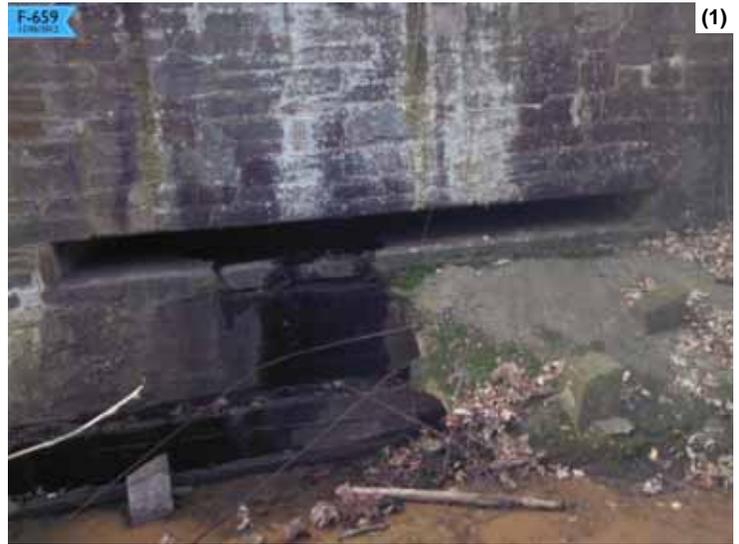
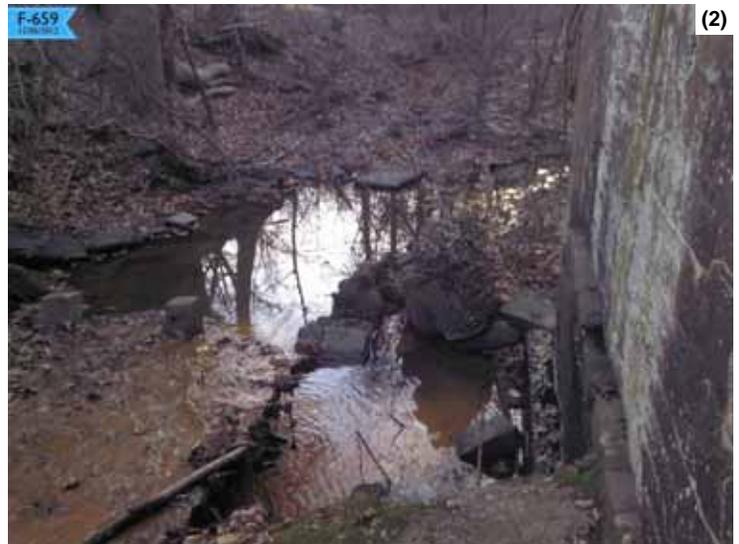
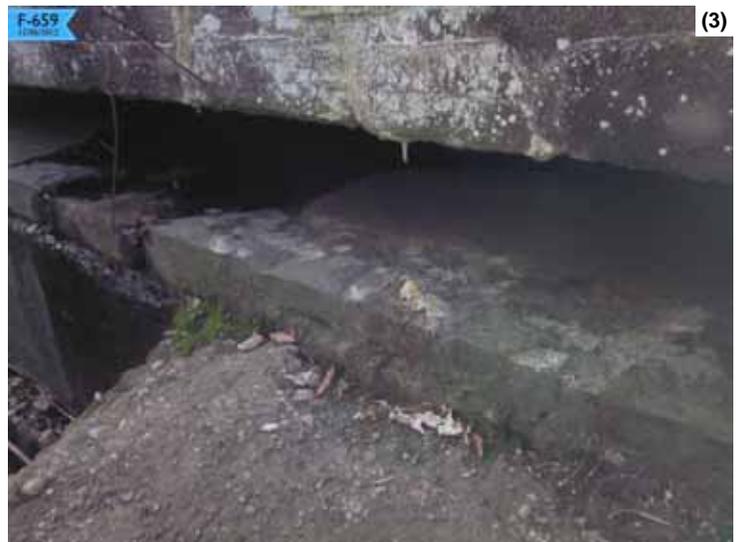
Stream Bank / Pool	<input type="text" value="2"/>	<input type="text" value="Active Erosion"/>	Repairs Recommended? YES
Stream Bank / Pool (x2)	<input type="text" value="4"/>		
Structure	<input type="text" value="1"/>	<input type="text" value="Moderate"/>	
Criticality	<input type="text" value="0"/>	<input type="text" value="Normal"/>	
Total Score	<input type="text" value="5"/>	<small>Total = Stream Bank / Pool x2 + Structure + Criticality</small>

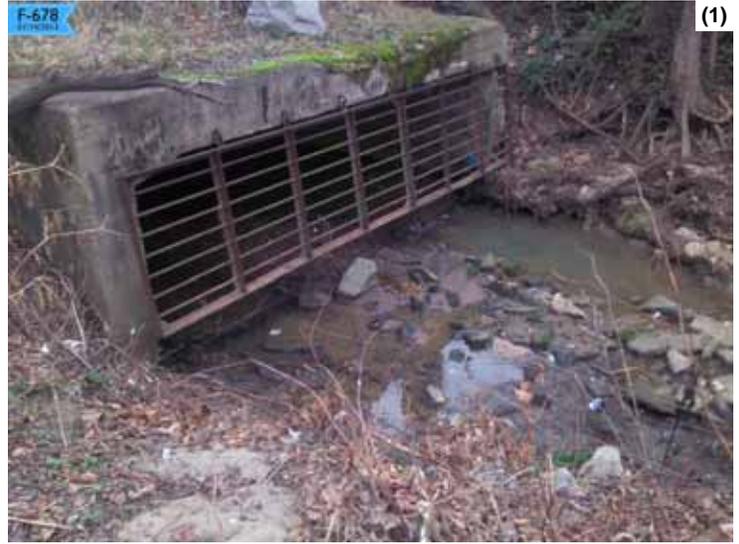
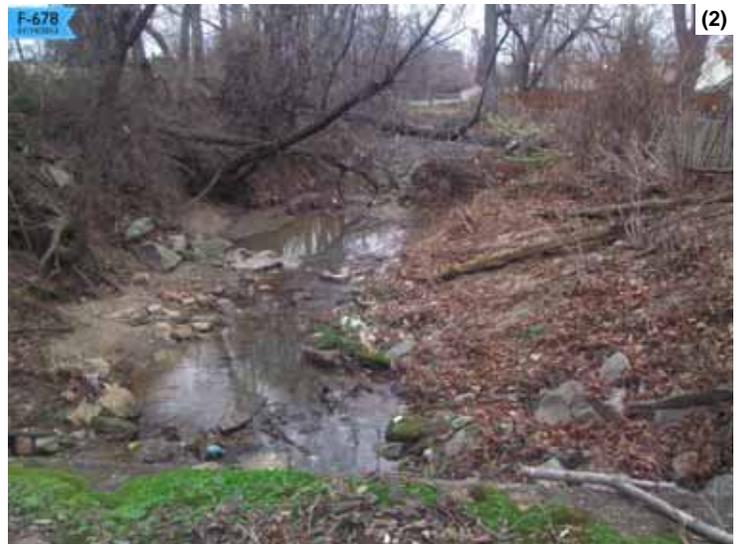
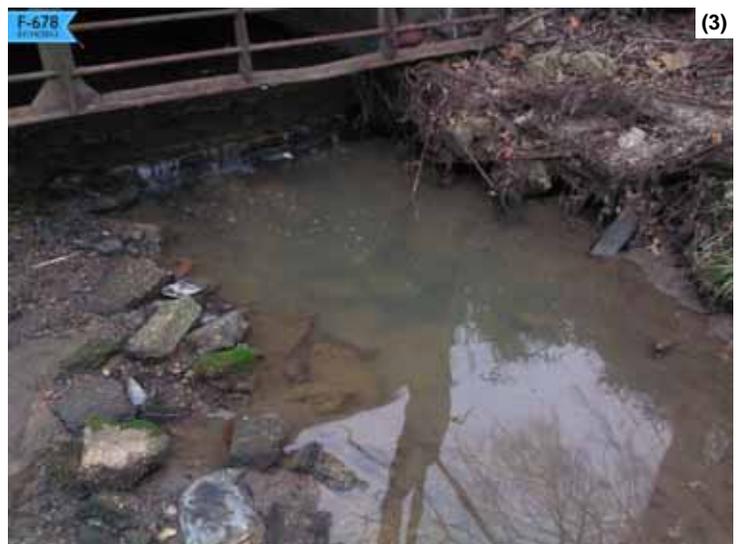
Stream Bank / Pool	<input type="text" value="2"/>	<input type="text" value="Active Erosion"/>	Repairs Recommended? YES
Stream Bank / Pool (x2)	<input type="text" value="4"/>		
Structure	<input type="text" value="0"/>	<input type="text" value="Excellent / Like New"/>	
Criticality	<input type="text" value="0"/>	<input type="text" value="Normal"/>	
Total Score	<input type="text" value="4"/>	<small>Total = Stream Bank / Pool x2 + Structure + Criticality</small>

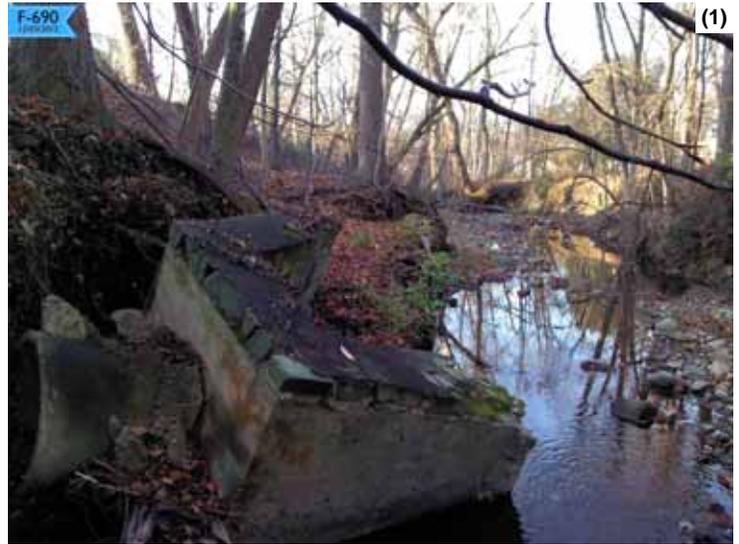
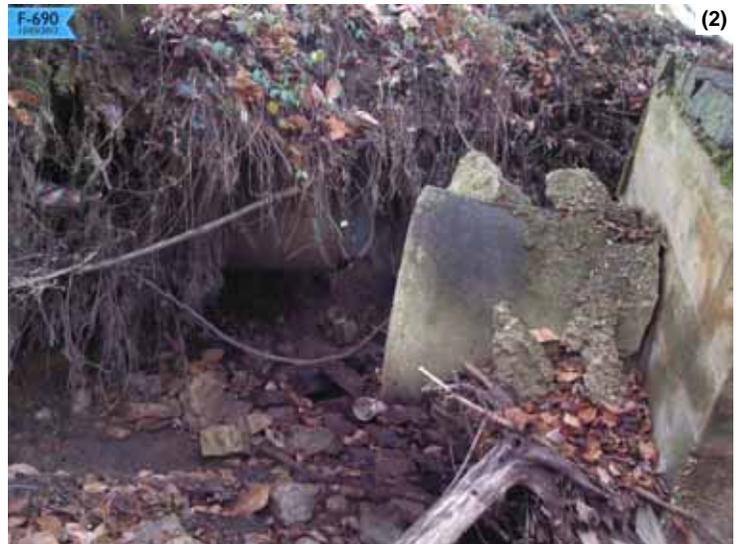
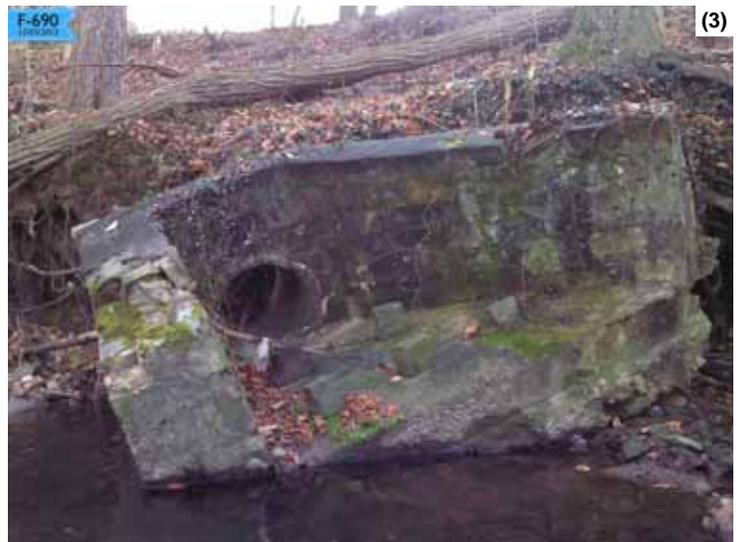
Stream Bank / Pool	<input type="text" value="2"/>	<input type="text" value="Active Erosion"/>	Repairs Recommended? YES
Stream Bank / Pool (x2)	<input type="text" value="4"/>		
Structure	<input type="text" value="2"/>	<input type="text" value="Poor"/>	
Criticality	<input type="text" value="0"/>	<input type="text" value="Normal"/>	
Total Score	<input type="text" value="6"/>	<small>Total = Stream Bank / Pool x2 + Structure + Criticality</small>

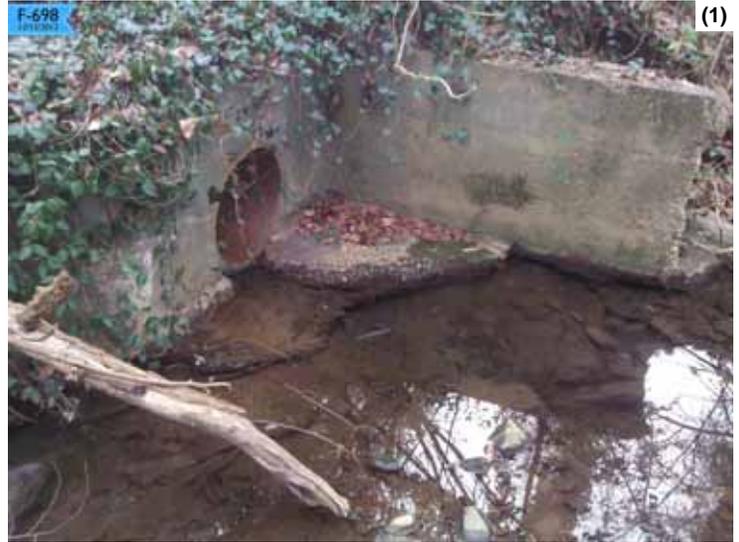
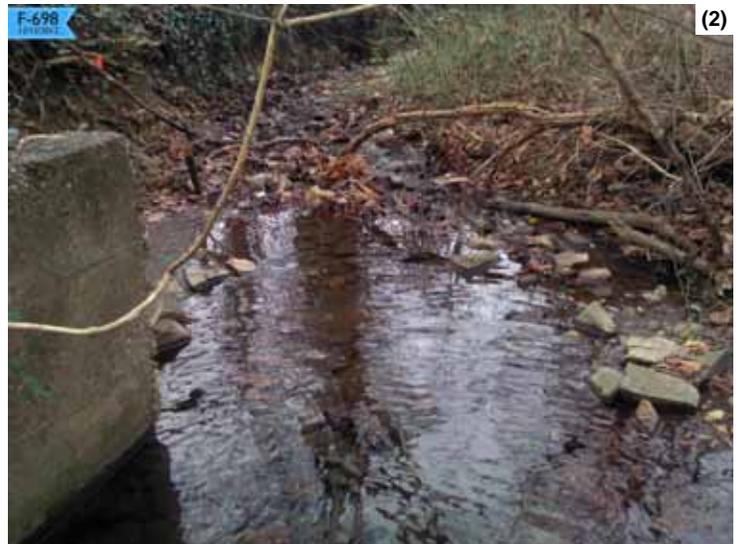
Stream Bank / Pool	<input type="text" value="2"/>	<input type="text" value="Active Erosion"/>	Repairs Recommended? YES
Stream Bank / Pool (x2)	<input type="text" value="4"/>		
Structure	<input type="text" value="0"/>	<input type="text" value="Excellent / Like New"/>	
Criticality	<input type="text" value="0"/>	<input type="text" value="Normal"/>	
Total Score	<input type="text" value="4"/>	<small>Total = Stream Bank / Pool x2 + Structure + Criticality</small>

Need additional photos to determine limits of repair.

Point Repair

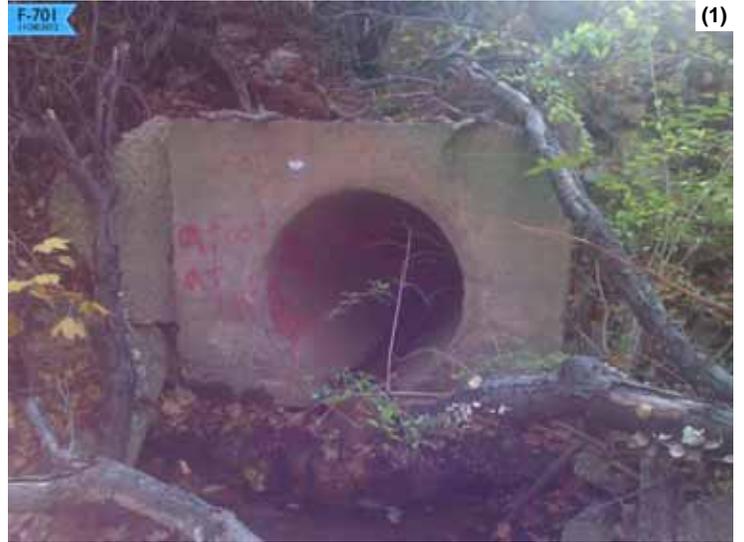
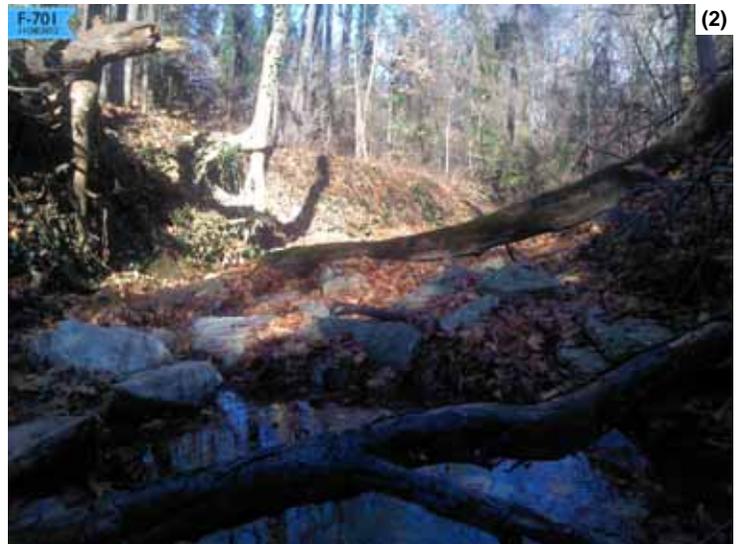
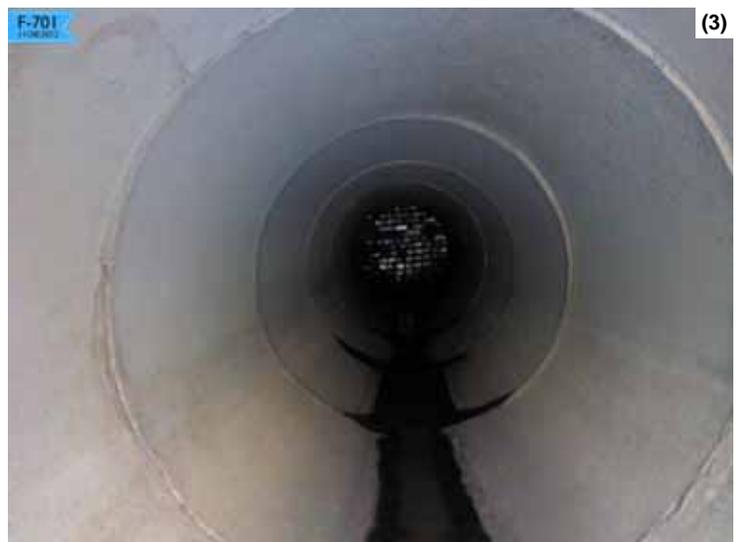
Stream Bank / Pool	<input type="text" value="2"/>	<input type="text" value="Active Erosion"/>	Repairs Recommended? YES
Stream Bank / Pool (x2)	<input type="text" value="4"/>		
Structure	<input type="text" value="1"/>	<input type="text" value="Moderate"/>	
Criticality	<input type="text" value="0"/>	<input type="text" value="Normal"/>	
Total Score	<input type="text" value="5"/>	<small>Total = Stream Bank / Pool x2 + Structure + Criticality</small>

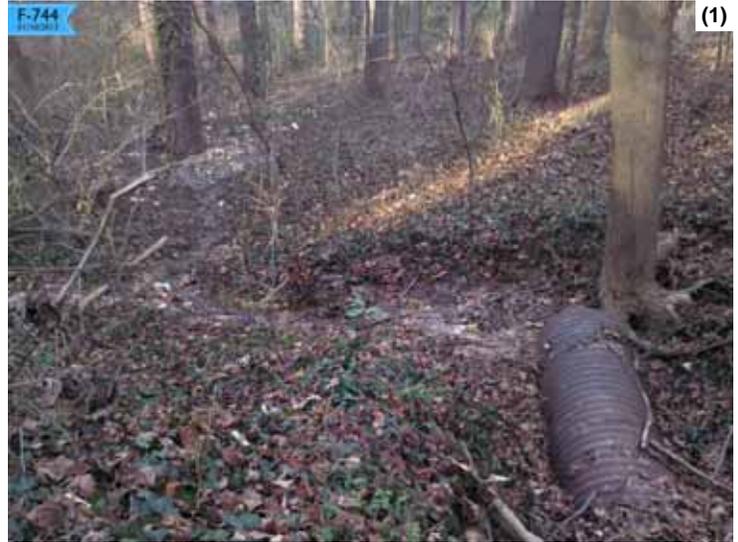
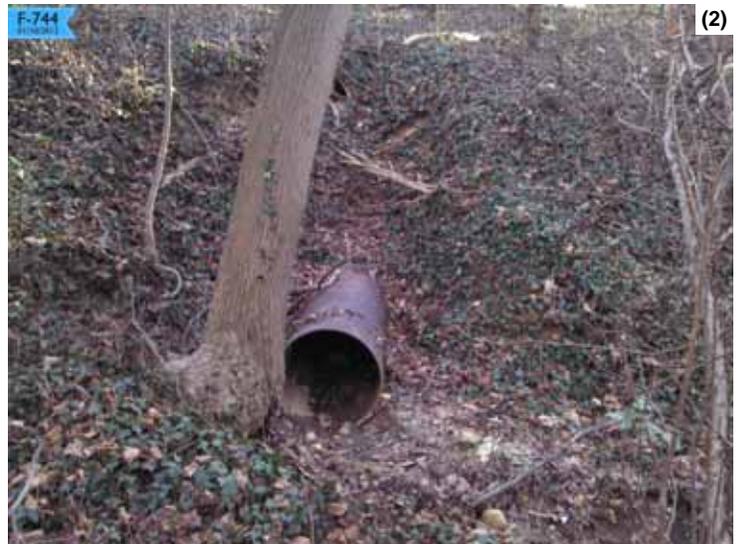
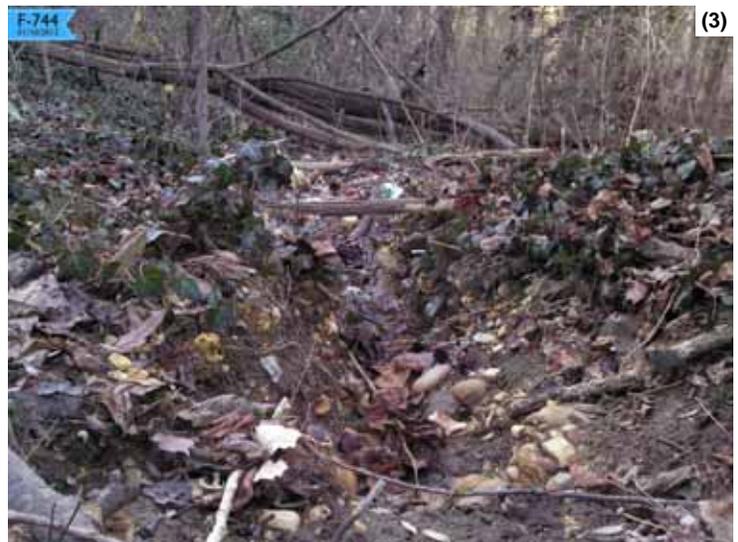
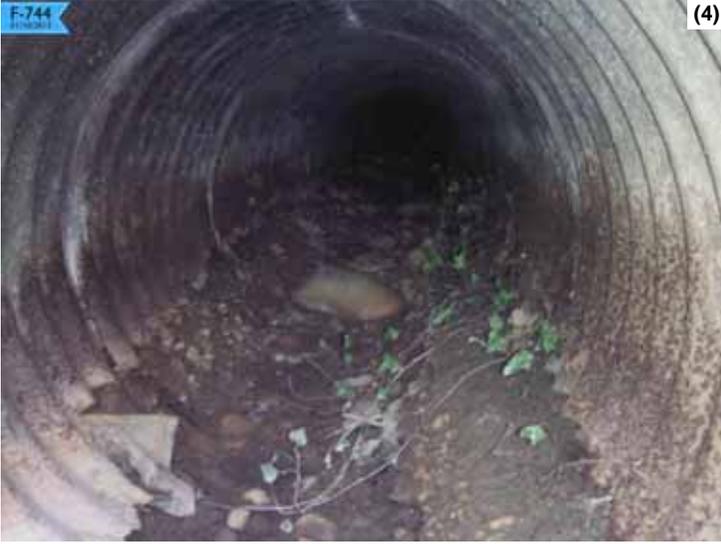
GIS Outfall / Photo ID #	F-744	
Inspection Date / By	1/10/2013	SPM
GPS Longitude	-76.95476	
GPS Latitude	38.86564

Stream Bank / Pool	<input type="text" value="2"/>	<input type="text" value="Active Erosion"/>	Repairs Recommended? <input checked="" type="checkbox"/> YES
Stream Bank / Pool (x2)	<input type="text" value="4"/>		
Structure	<input type="text" value="2"/>	<input type="text" value="Poor"/>	
Criticality	<input type="text" value="0"/>	<input type="text" value="Normal"/>	
Total Score	<input type="text" value="6"/>	<small>Total = Stream Bank / Pool x2 + Structure + Criticality</small>

Pipe is eroding a channel downstream and depositing lots of garbage in the woods. Bottom is rusted out of CMP.

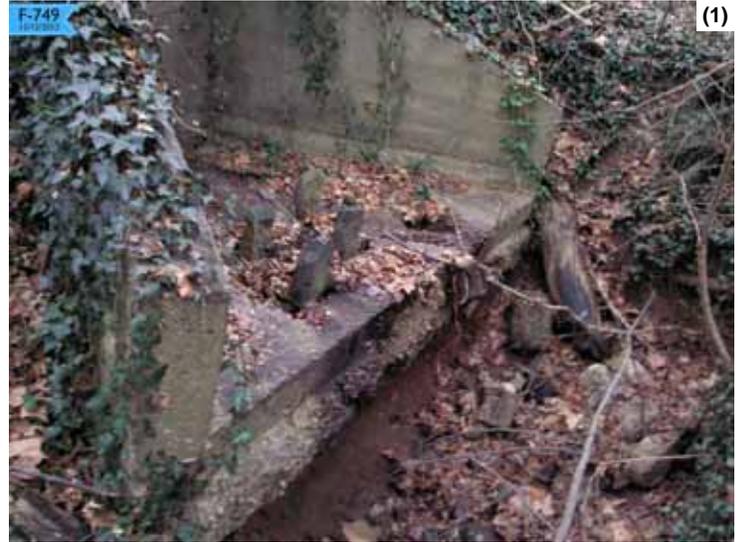
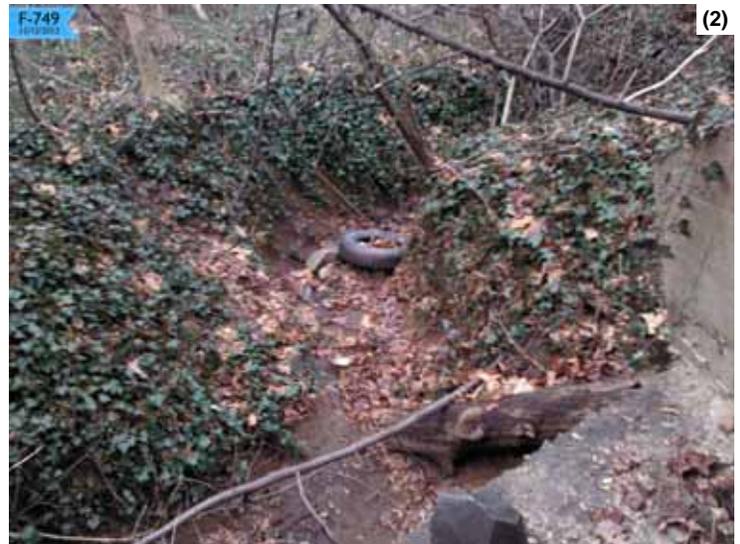
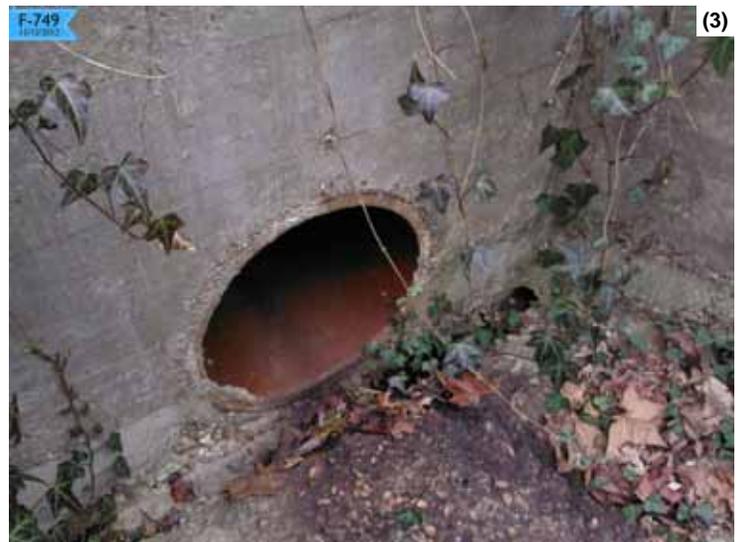
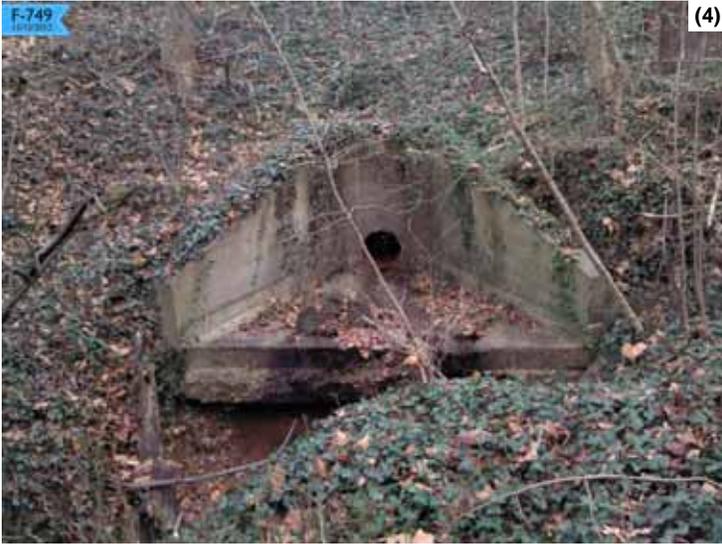
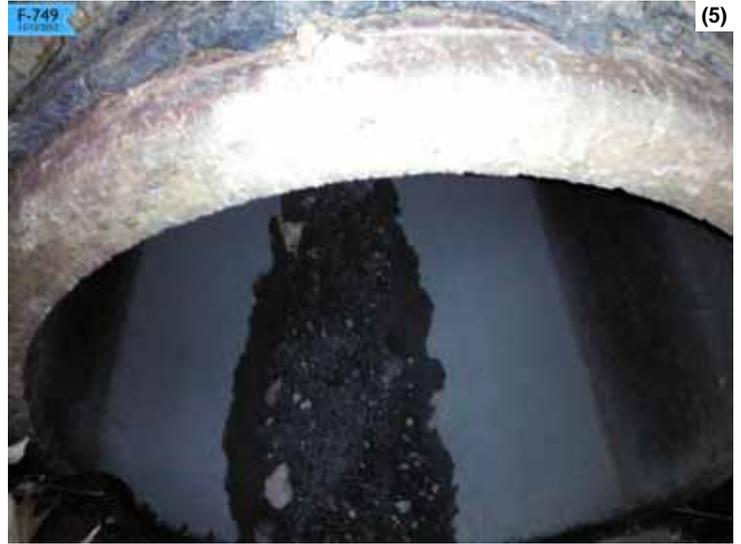
GIS Outfall / Photo ID #	F-749	
Inspection Date / By	12/12/2012	SPM
GPS Longitude	-77.09080	
GPS Latitude	38.92624

Stream Bank / Pool	<input type="text" value="2"/>	<input type="text" value="Active Erosion"/>	Repairs Recommended? YES
Stream Bank / Pool (x2)	<input type="text" value="4"/>		
Structure	<input type="text" value="0"/>	<input type="text" value="Excellent / Like New"/>	
Criticality	<input type="text" value="0"/>	<input type="text" value="Normal"/>	
Total Score	<input type="text" value="4"/>	<small>Total = Stream Bank / Pool x2 + Structure + Criticality</small>

Erosion under spillway and downstream. Pipe broken at first joint and separated from structure.

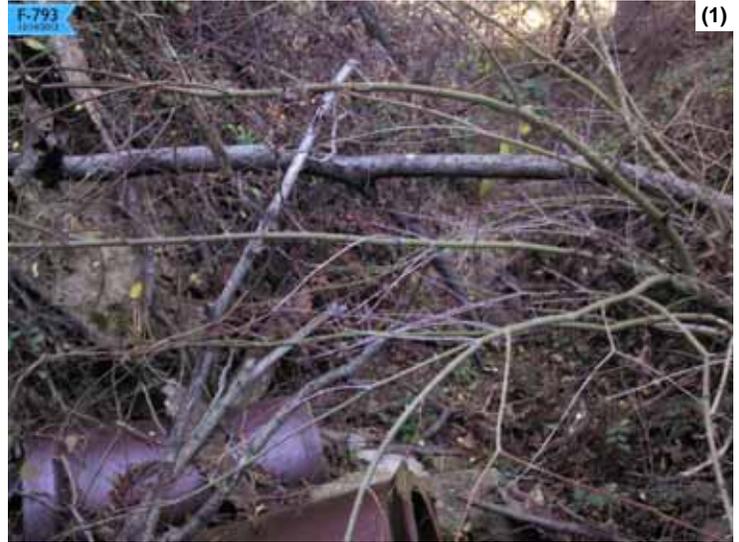
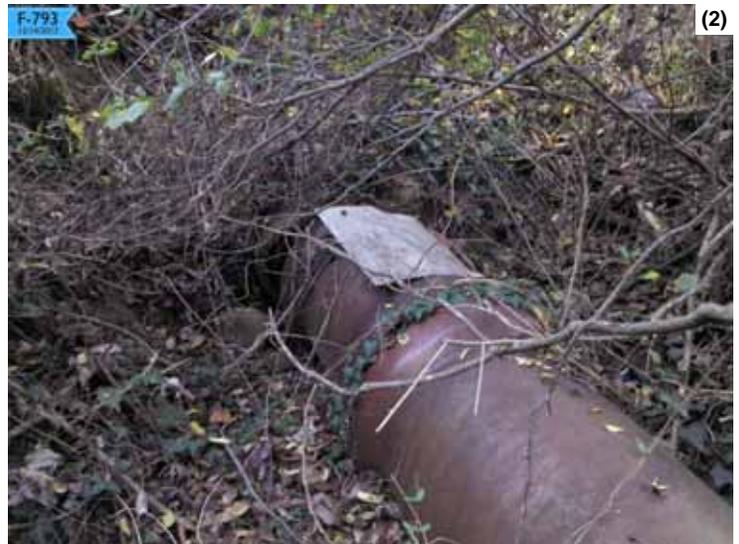
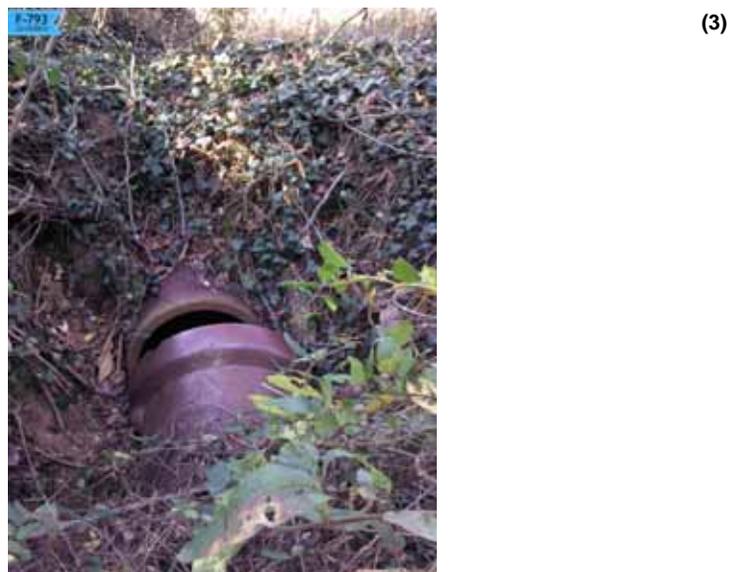
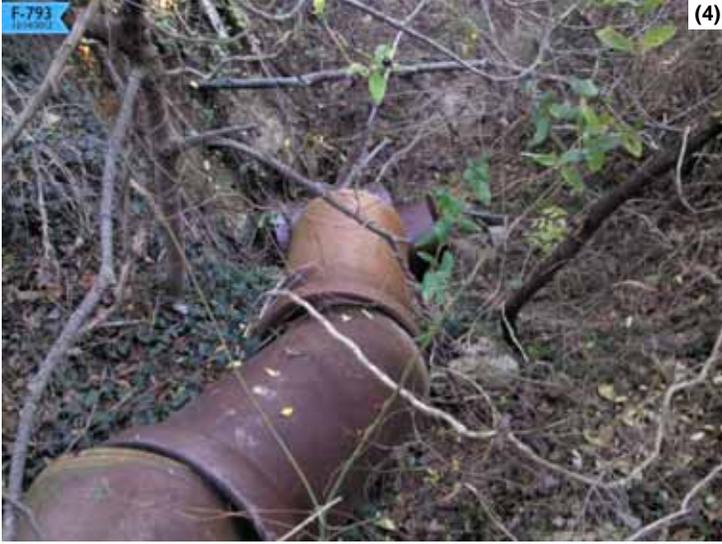
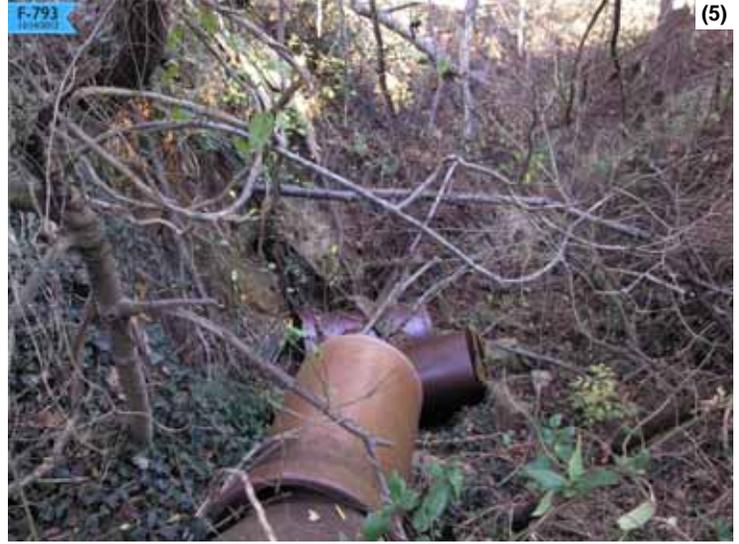
GIS Outfall / Photo ID #	F-793	
Inspection Date / By	12/14/2012	SPM
GPS Longitude	-76.95570	
GPS Latitude	38.91631

Stream Bank / Pool	<input type="text" value="2"/>	<input type="text" value="Active Erosion"/>	Repairs Recommended? YES
Stream Bank / Pool (x2)	<input type="text" value="4"/>		
Structure	<input type="text" value="2"/>	<input type="text" value="Poor"/>	
Criticality	<input type="text" value="0"/>	<input type="text" value="Normal"/>	
Total Score	<input type="text" value="6"/>	<small>Total = Stream Bank / Pool x2 + Structure + Criticality</small>

Erosion around pipe has caused large ravine. Total depth of ravine is approx 10 ft
