4.3 OUTFALL REPAIR SUMMARY REPORTS

OUTFALL SUMMARY REPORT

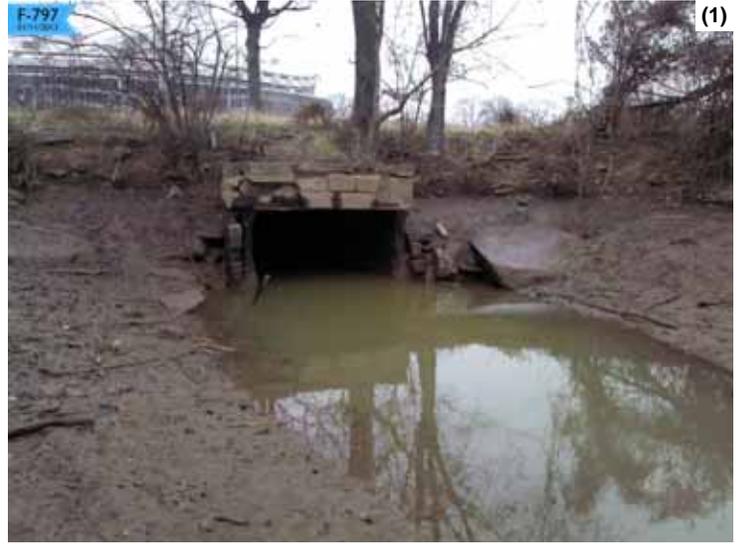
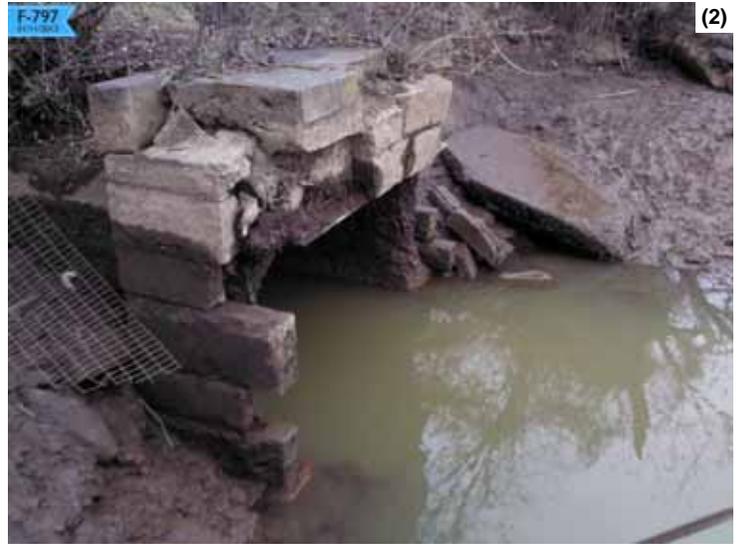
Stream Bank / Pool	<input type="text" value="1"/>	<input type="text" value="Some Erosion"/>	Repairs Recommended? YES
Stream Bank / Pool (x2)	<input type="text" value="2"/>		
Structure	<input type="text" value="2"/>	<input type="text" value="Poor"/>	
Criticality	<input type="text" value="0"/>	<input type="text" value="Normal"/>	
Total Score	<input type="text" value="4"/>	<small>Total = Stream Bank / Pool x2 + Structure + Criticality</small>

Structure interior concrete walls are deteriorated. Headwall is broken and near collapse.

Point Repair

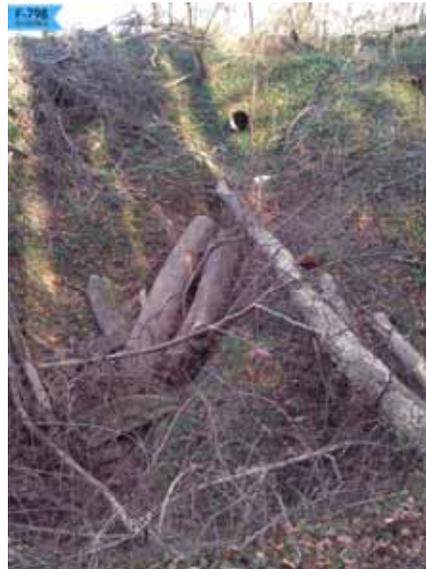
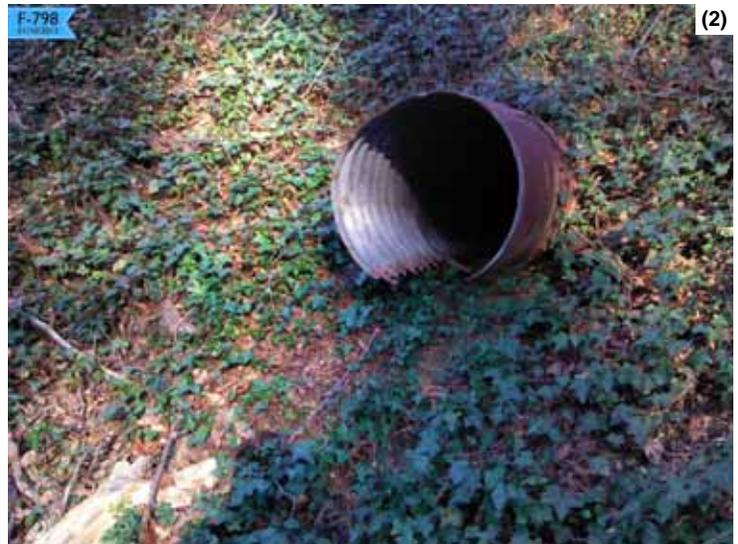
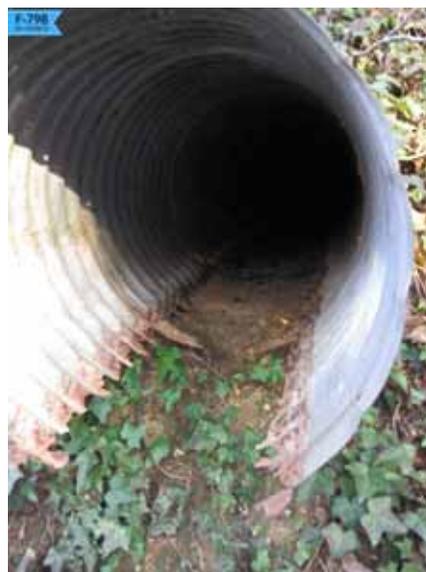
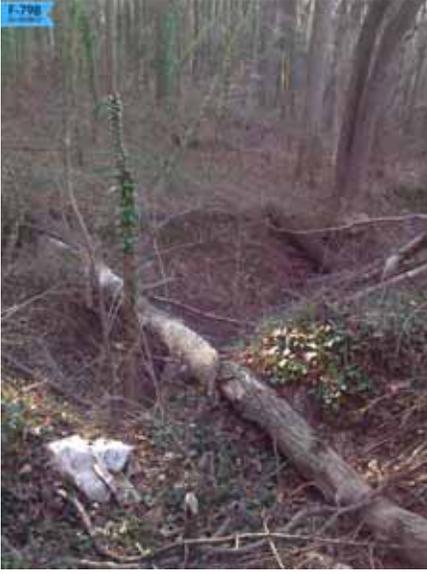
GIS Outfall / Photo ID #	F-798	
Inspection Date / By	1/10/2013	SPM
GPS Longitude	-76.95345	
GPS Latitude	38.86619

Stream Bank / Pool	<input type="text" value="2"/>	<input type="text" value="Active Erosion"/>	Repairs Recommended? YES
Stream Bank / Pool (x2)	<input type="text" value="4"/>		
Structure	<input type="text" value="2"/>	<input type="text" value="Poor"/>	
Criticality	<input type="text" value="0"/>	<input type="text" value="Normal"/>	
Total Score	<input type="text" value="6"/>	<i>Total = Stream Bank / Pool x2 + Structure + Criticality</i>

Bottom of pipe is deteriorated. Severe downstream erosion.

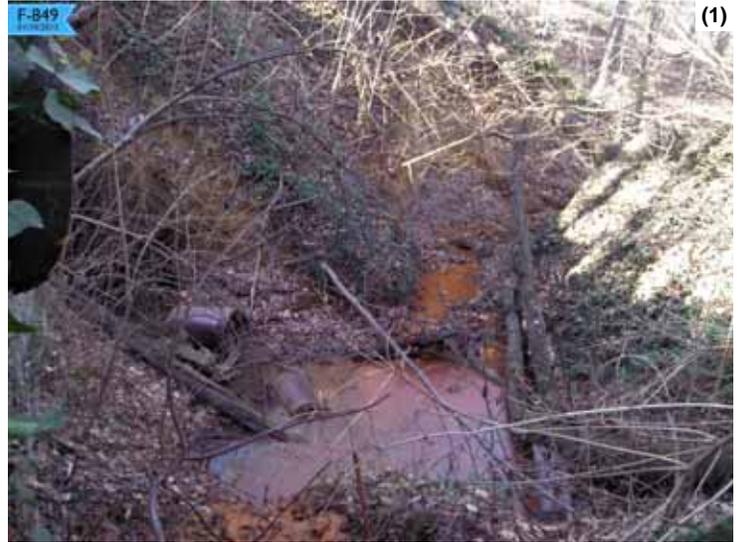
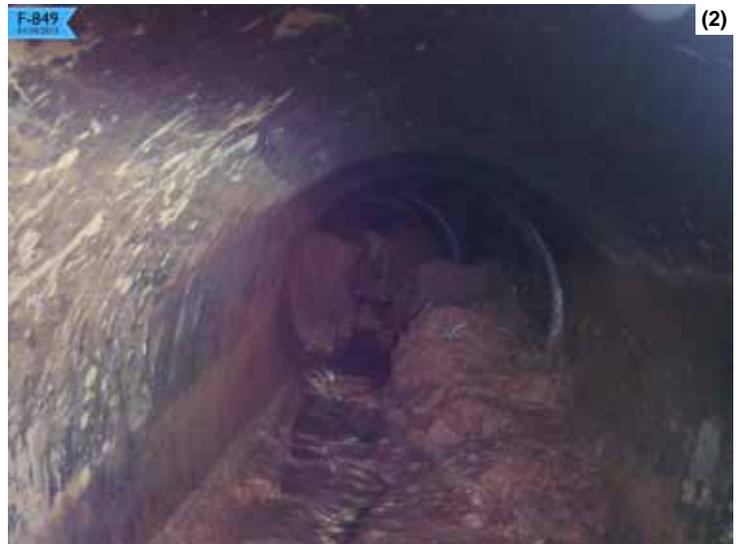
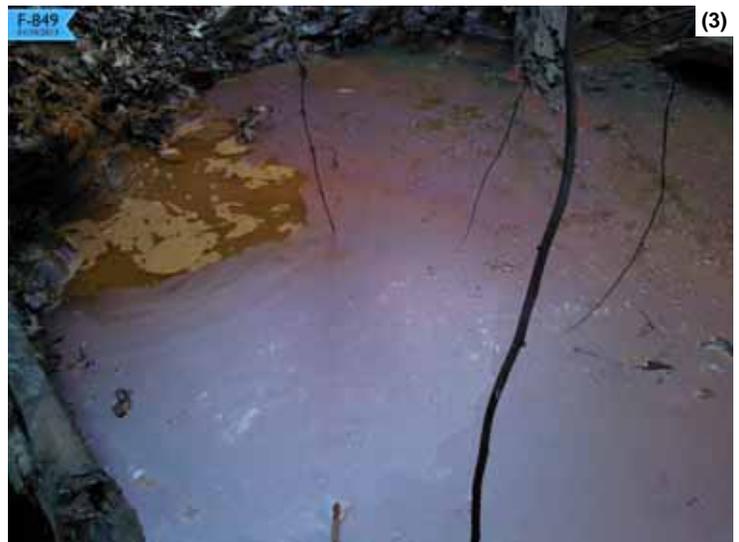
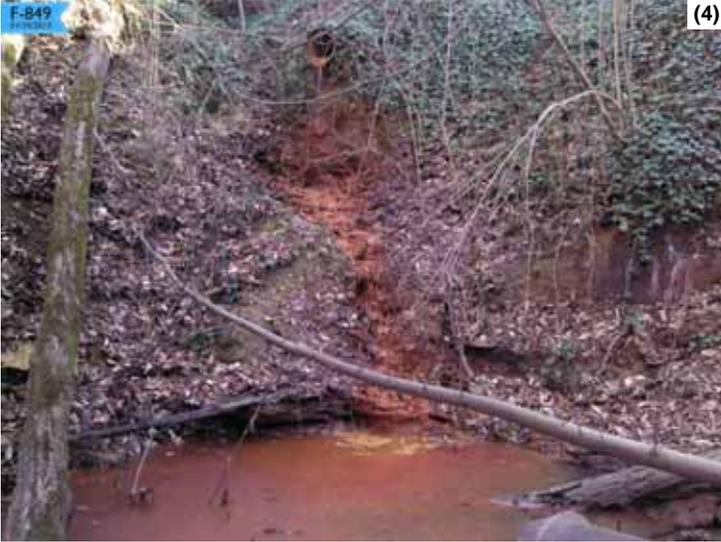
GIS Outfall / Photo ID #	F-849	
Inspection Date / By	1/10/2013	SPM
GPS Longitude	-76.96035	
GPS Latitude	38.86654

Stream Bank / Pool	<input type="text" value="3"/>	<input type="text" value="Severe Erosion"/>	Repairs Recommended? YES
Stream Bank / Pool (x2)	<input type="text" value="6"/>		
Structure	<input type="text" value="3"/>	<input type="text" value="Very Poor"/>	
Criticality	<input type="text" value="0"/>	<input type="text" value="Normal"/>	
Total Score	<input type="text" value="9"/>	<small>Total = Stream Bank / Pool x2 + Structure + Criticality</small>

Ravine erosion 5ft drop at outfall. Severe erosion caused a large ravine downstream. Pipe is clogged. Pipe joints are open and misaligned.

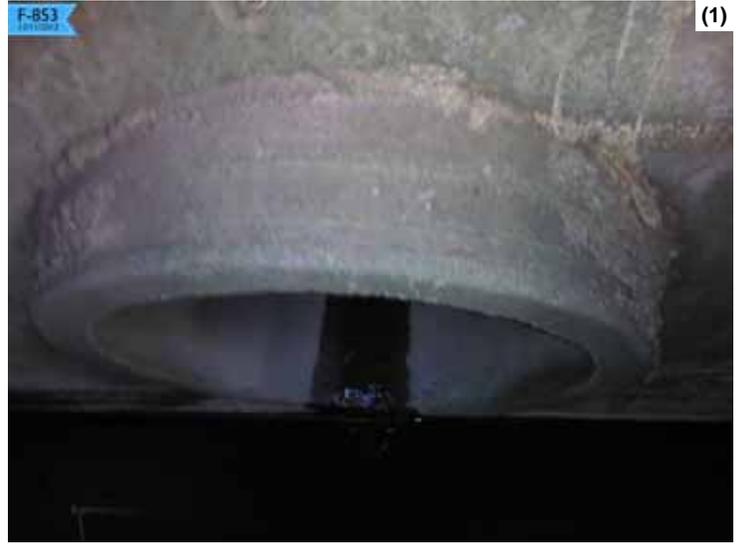
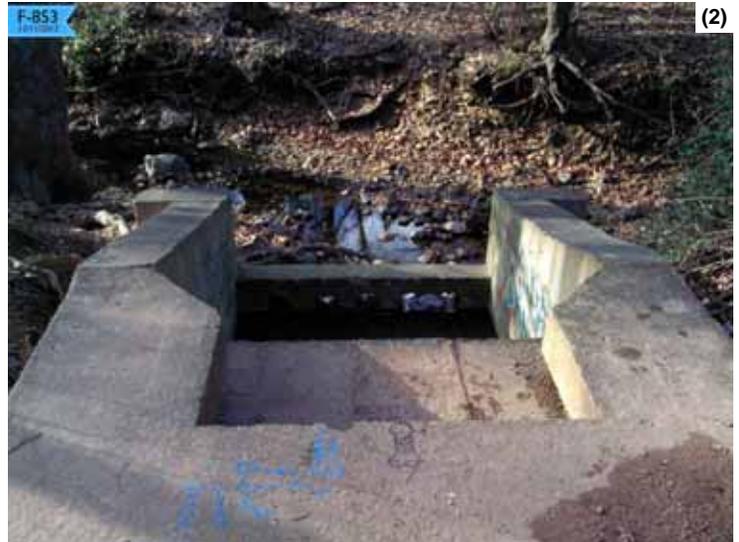
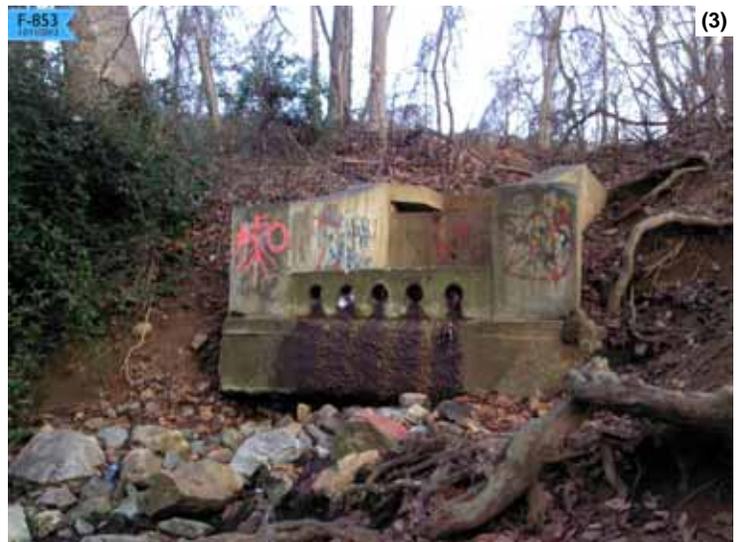
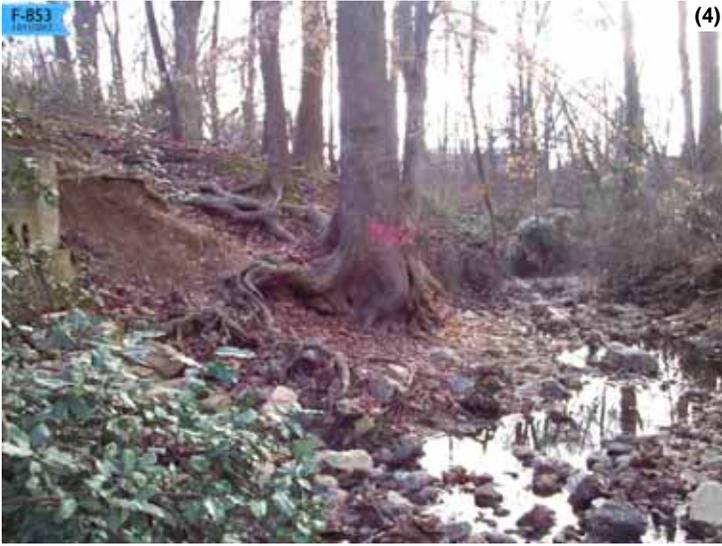
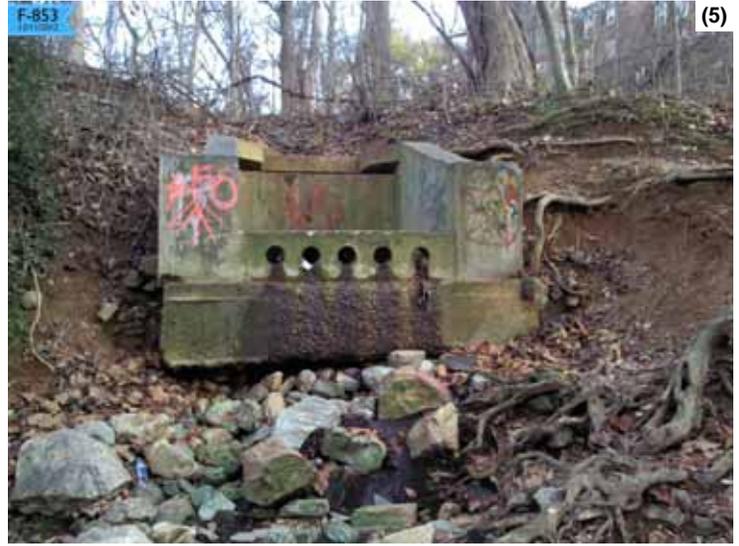
GIS Outfall / Photo ID #	F-853	
Inspection Date / By	12/11/2012	SPM
GPS Longitude	-77.07920	
GPS Latitude	38.94027

Stream Bank / Pool	<input type="text" value="2"/>	<input type="text" value="Active Erosion"/>	Repairs Recommended? YES
Stream Bank / Pool (x2)	<input type="text" value="4"/>		
Structure	<input type="text" value="1"/>	<input type="text" value="Moderate"/>	
Criticality	<input type="text" value="0"/>	<input type="text" value="Normal"/>	
Total Score	<input type="text" value="5"/>	<small>Total = Stream Bank / Pool x2 + Structure + Criticality</small>

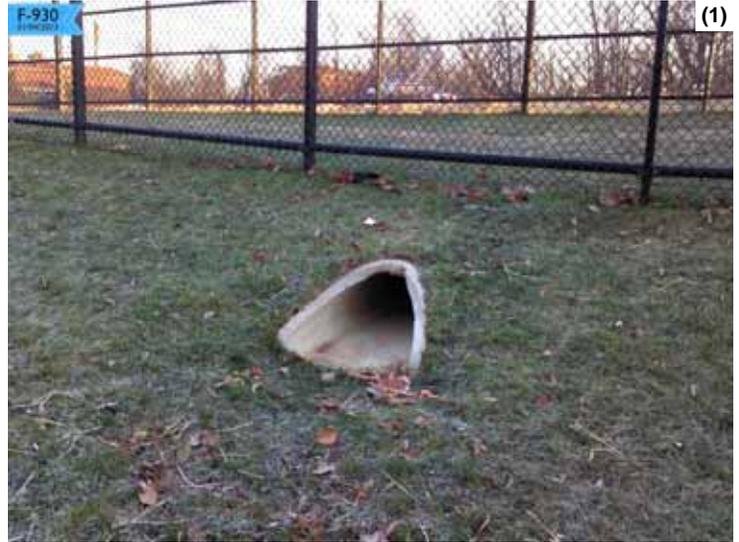
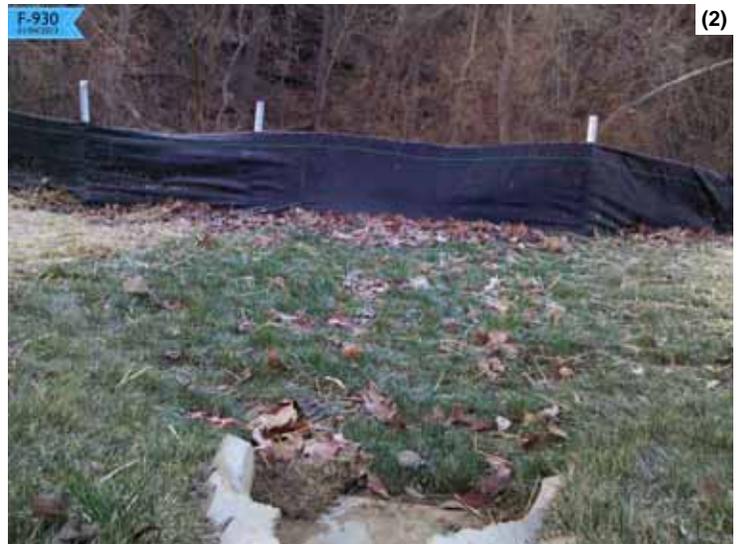
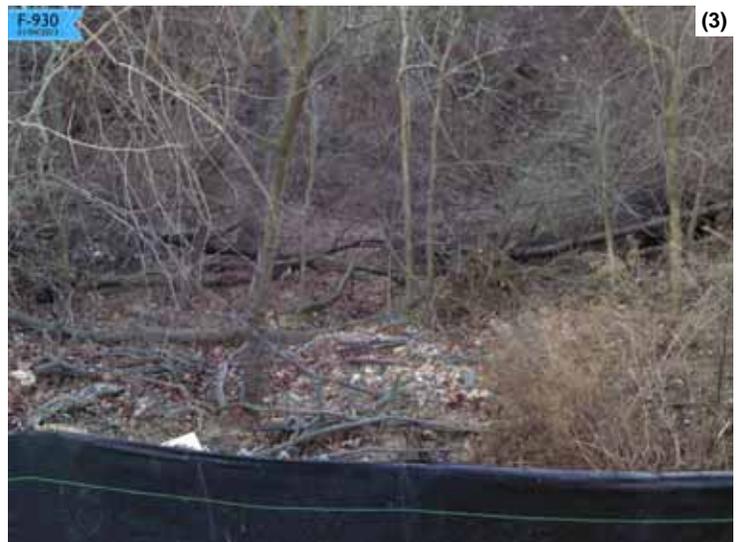
Significant erosion formed a ravine down the hillside on other side of erosion control barrier. May want to perform inspection of downstream channel to see if repair is needed.

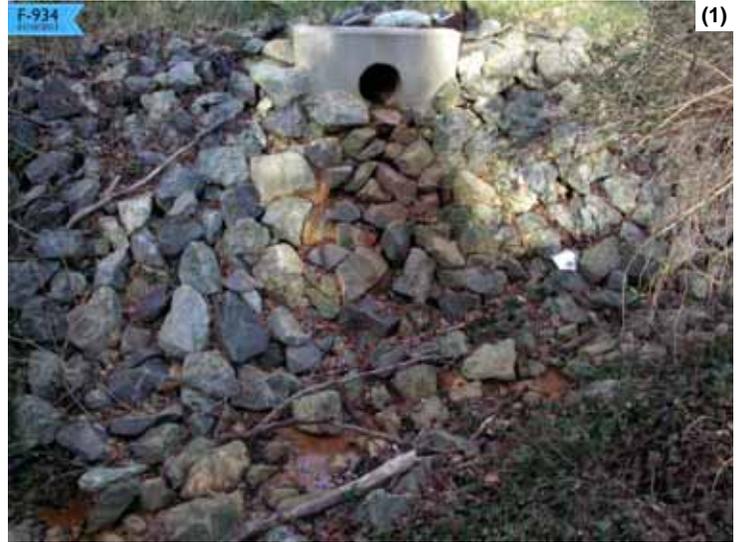
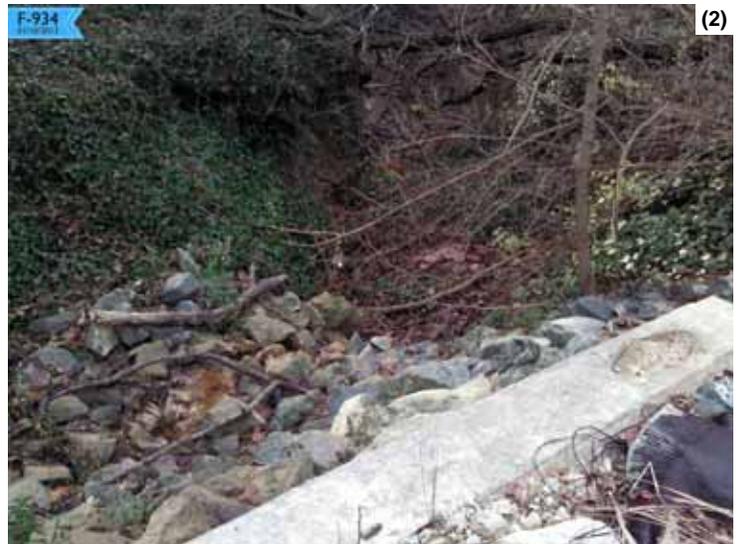
Stream Bank / Pool	<input type="text" value="3"/>	<input type="text" value="Severe Erosion"/>	Repairs Recommended? <input checked="" type="checkbox"/> YES
Stream Bank / Pool (x2)	<input type="text" value="6"/>		
Structure	<input type="text" value="0"/>	<input type="text" value="Excellent / Like New"/>	
Criticality	<input type="text" value="0"/>	<input type="text" value="Normal"/>	
Total Score	<input type="text" value="6"/>	<i>Total = Stream Bank / Pool x2 + Structure + Criticality</i>

Outfall has been repaired in the recent past. Severe erosion remains a problem downstream.

Description of Repair Approach

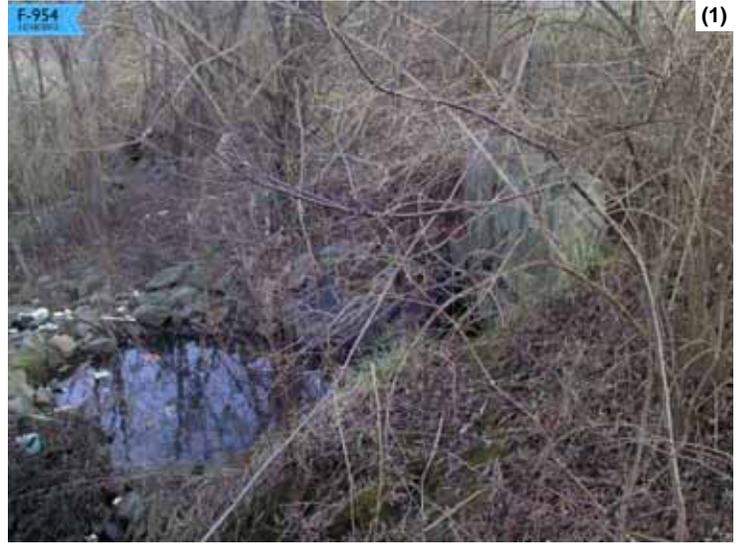
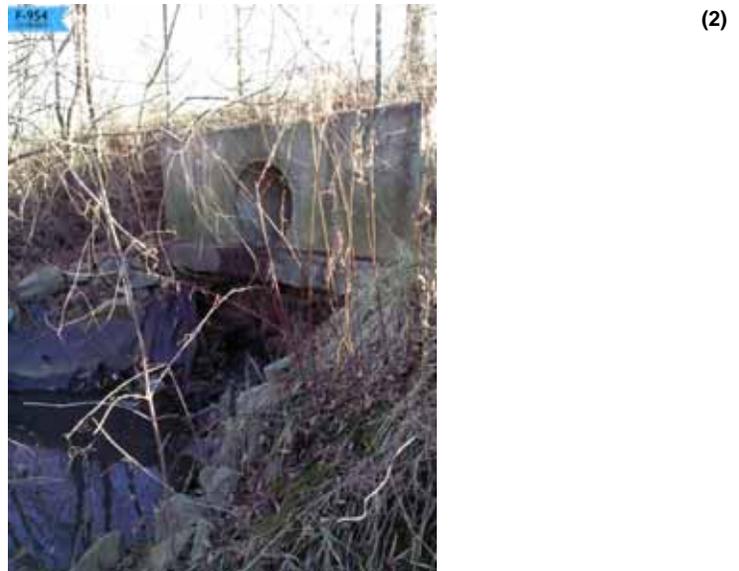
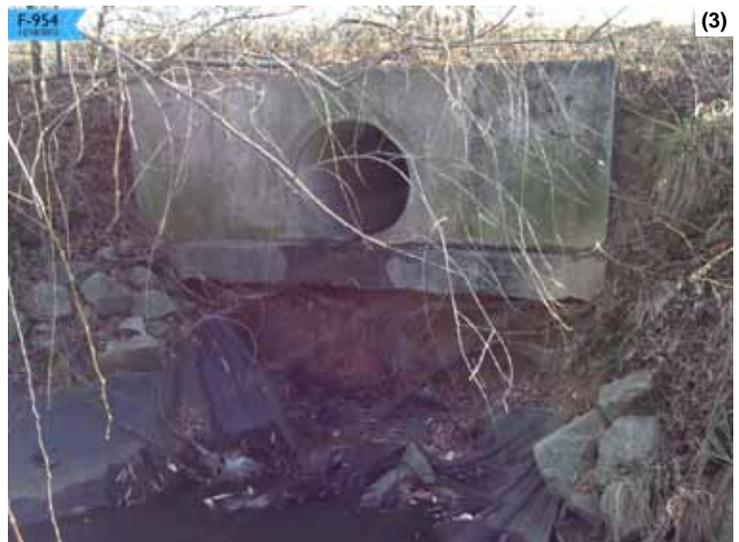
Stream Bank / Pool	<input type="text" value="2"/>	<input type="text" value="Active Erosion"/>	Repairs Recommended? YES
Stream Bank / Pool (x2)	<input type="text" value="4"/>		
Structure	<input type="text" value="1"/>	<input type="text" value="Moderate"/>	
Criticality	<input type="text" value="0"/>	<input type="text" value="Normal"/>	
Total Score	<input type="text" value="5"/>	<small>Total = Stream Bank / Pool x2 + Structure + Criticality</small>

30" deep erosion under outfall headwall. - Notify DDOT of repairs needed?

Description of Repair Approach

Point Repair
